A Comprehensive Assessment of Wetland Condition in Cucumber Gulch Preserve, Breckenridge, Colorado.

Report Submitted to the Town of Breckenridge, CO

10/31/11

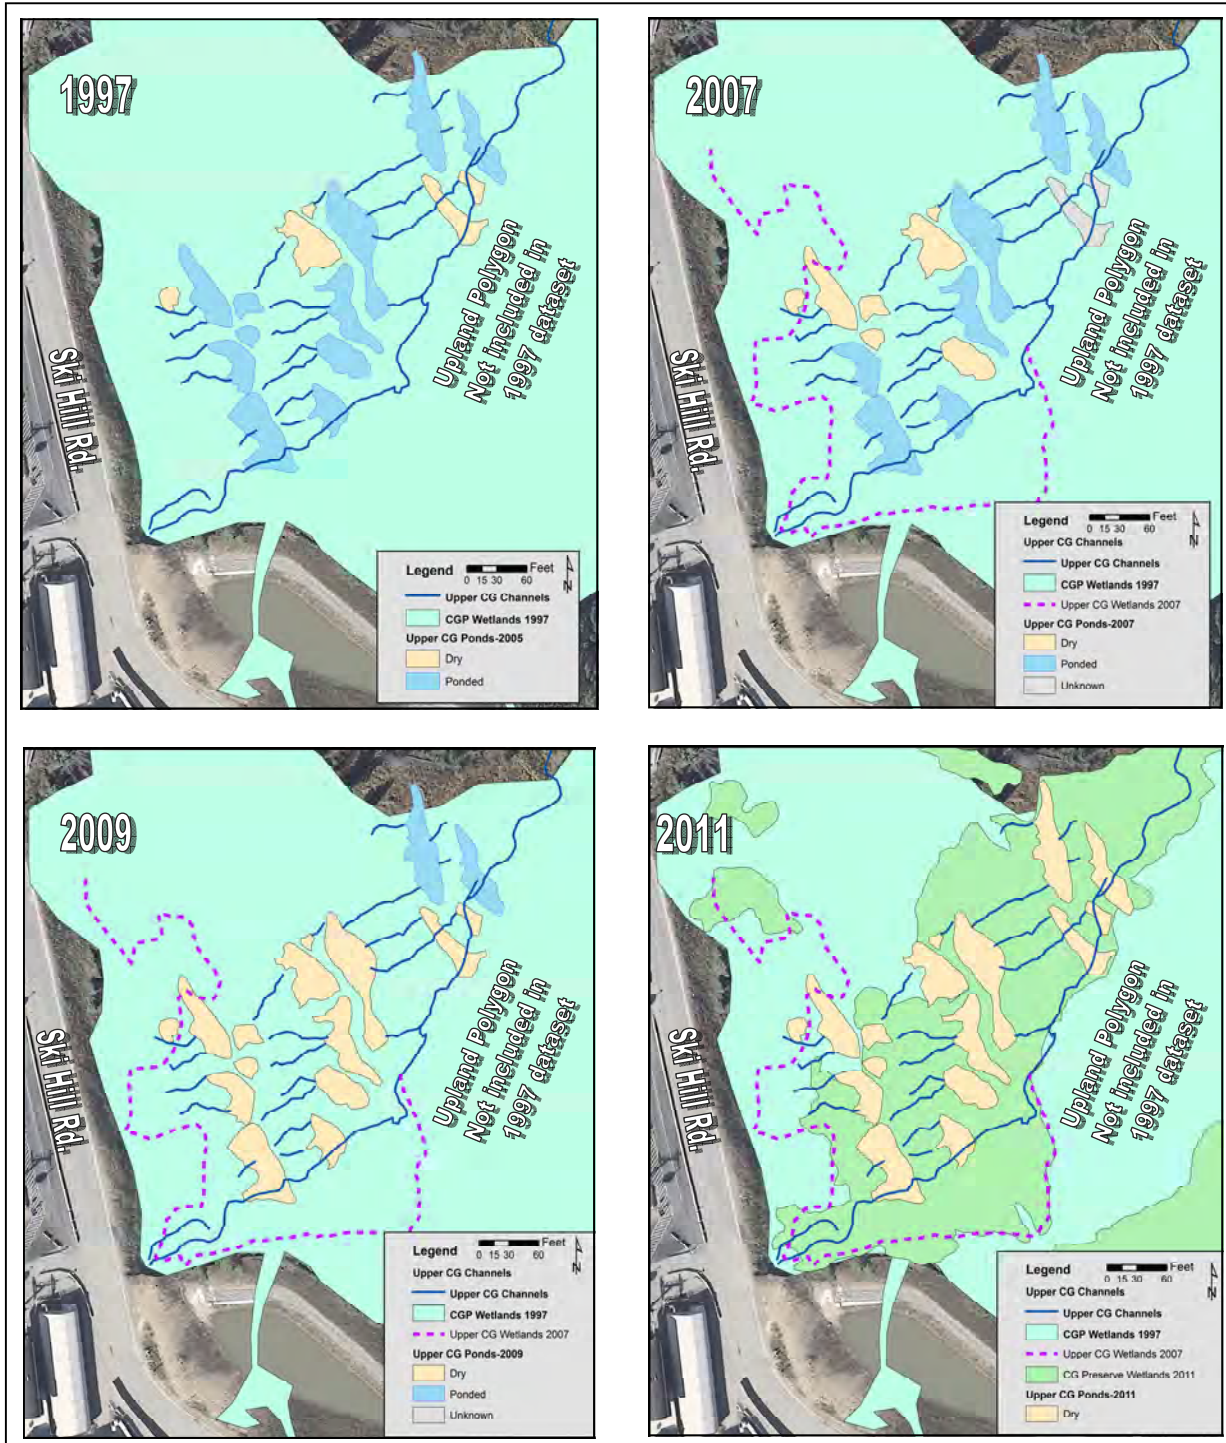
In Upper CG, a comparison of the past and present wetland delineations shows an inward movement of the boundary. Based on an overwhelming amount of evidence, the change in the wetland boundary location documents a real phenomenon of wetland recession, rather than an aberration of mapping. The trend in habitat loss is corroborated by the WER 2008 study²⁵ which revised a portion of the wetland boundary inward based on results from a delineation that they performed in 2007, combined with quantitative monitoring data. Together the 1997, 2007 and 2011 mappings neatly describe an east and southeastward trajectory of wetland recession which spatially follows the terrain and temporally tracks adjacent development activity (Fig. 7). In other words, the wetland has been retreating down valley in step with intensifying land use in the adjacent, up-gradient Peak 8 base area development.

Consistent with the rapid ecological change that is occurring in Upper CG, indicators of wetland conditions were inconclusive in a number of locations near of the western edge of the 2011 delineation (Fig. 7). This is because soils there are either hydric or relic hydric, and because the vegetation typically consists of borderline wetland species that can persist for years on sites that have lost wetland hydrology. Indicators of wetland hydrology were also unclear and hydrologic conditions, in fact, changed markedly throughout the 2011 season in response to the unstable conditions at the head of the gulch. In delineating the wetland boundary we therefore adopted a highly conservative approach. That is, if indicators were indeterminate for an area, we included it as wetland rather than mapping it as being converted to upland. A more precise determination of these “borderline” or suspect wetland areas could be made in the future by installing soil and hydrology monitoring instruments to quantitatively describe soil chemistry and hydrologic conditions on a site-level basis.

Fig. 7. Time-series illustration showing the sequential drying of beaver ponds in Upper CG along with the inward movement of the wetland boundary. The area labeled as missing 1997 data should be disregarded in terms of wetland boundary changes. We suspect that this area was mapped as upland in 1997 (WER 2008₂₅), but we do not have those data. The 2007 line is shown in the lower left panel for reference, but we do not mean to imply that there was no movement of the boundary between 2007 and 2011. Wetland boundaries were not mapped in 2009.

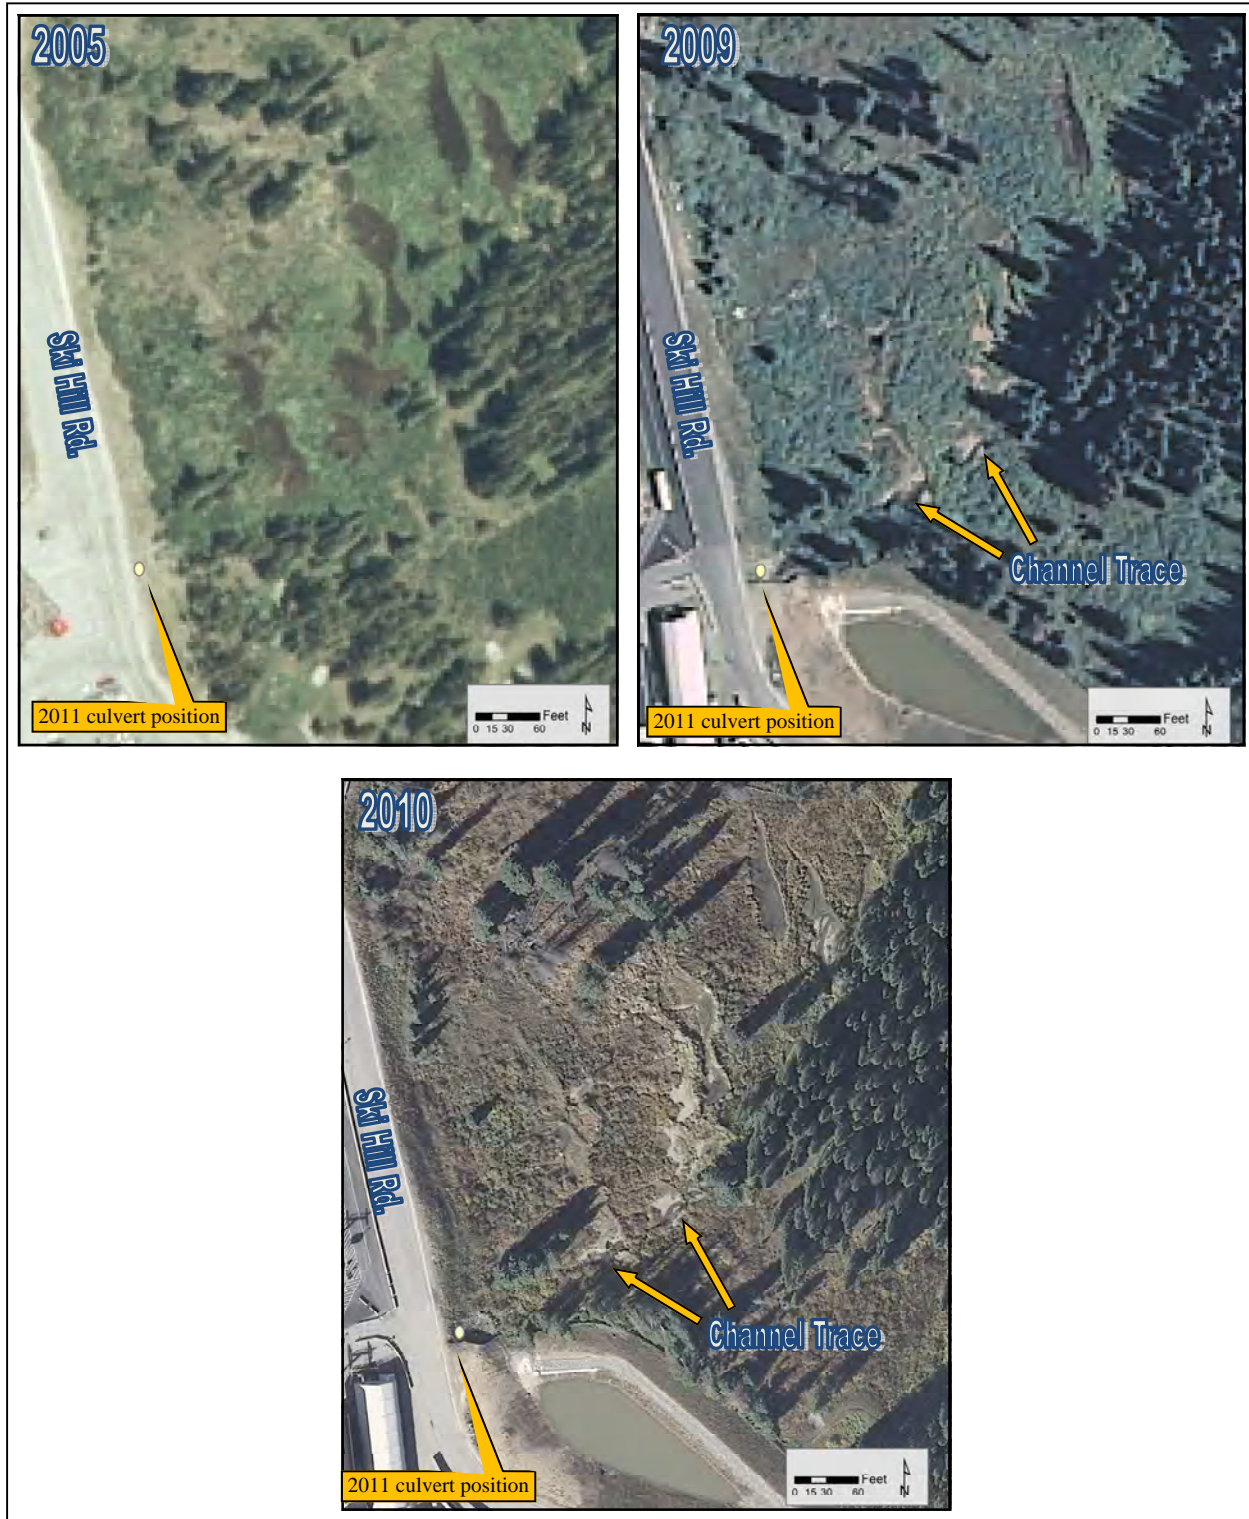
Fig. 14. Aerial photographs of the top of Upper CG in 2005, 2009 and 2010 showing the development of the Boreas Creek channel as a result of the southern breach of the upper “Spreader Pond” dam. The current position of the culvert is marked on each photograph for reference.

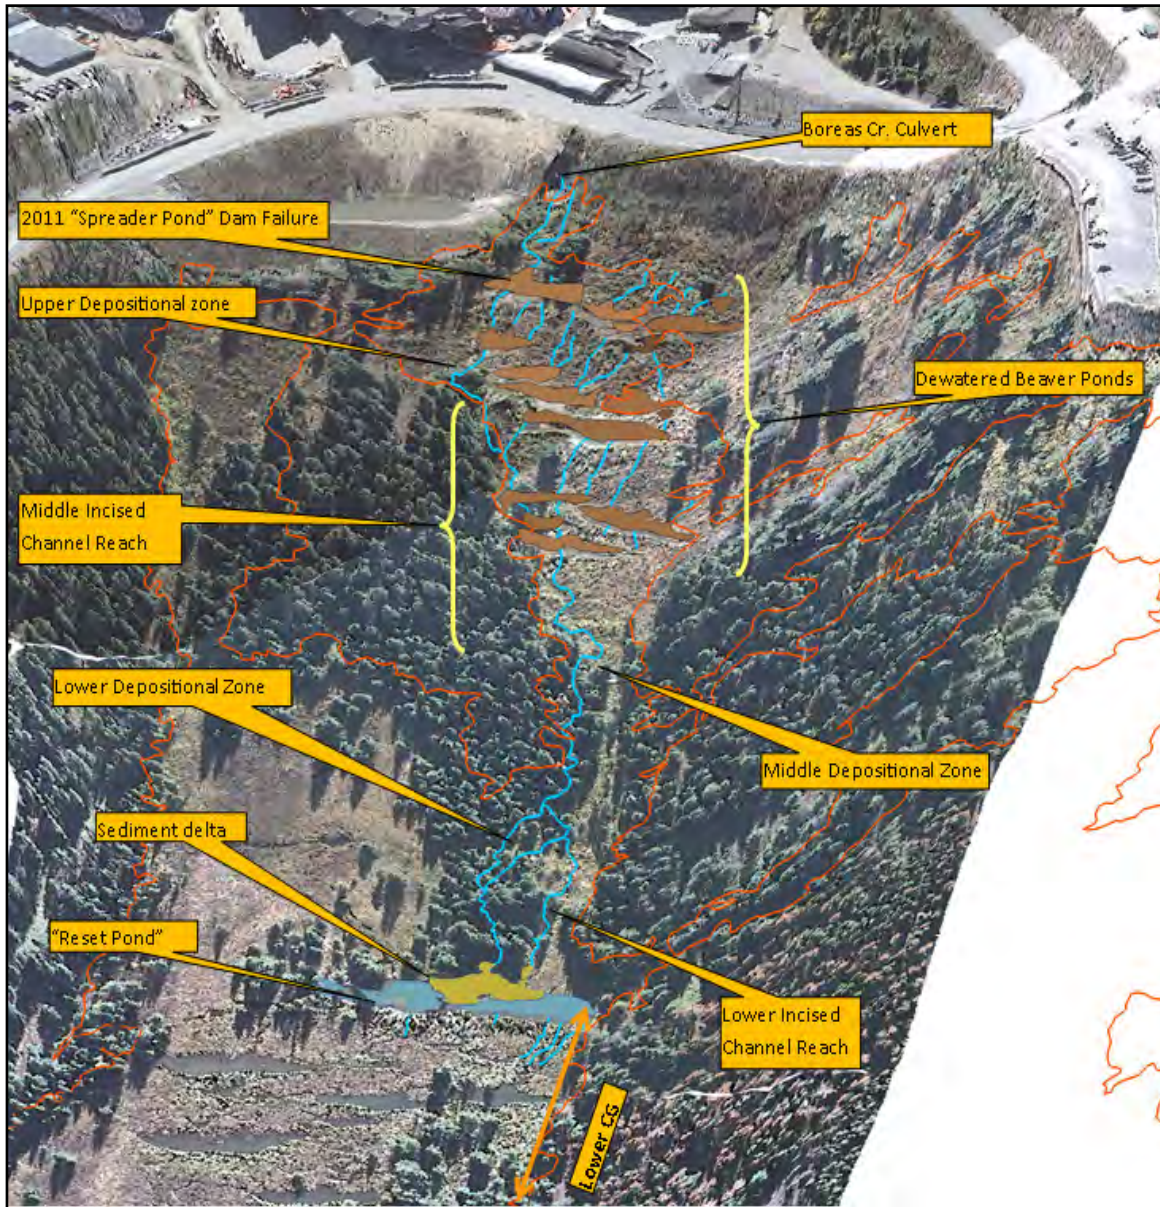
Fig. 18. An overview of the Upper CG unit showing locations where significant incision or deposition was observed in or near the Boreas Creek channel during 2011. Red lines show wetland boundaries. Note that topography in this figure had a 3:1 vertical exaggeration

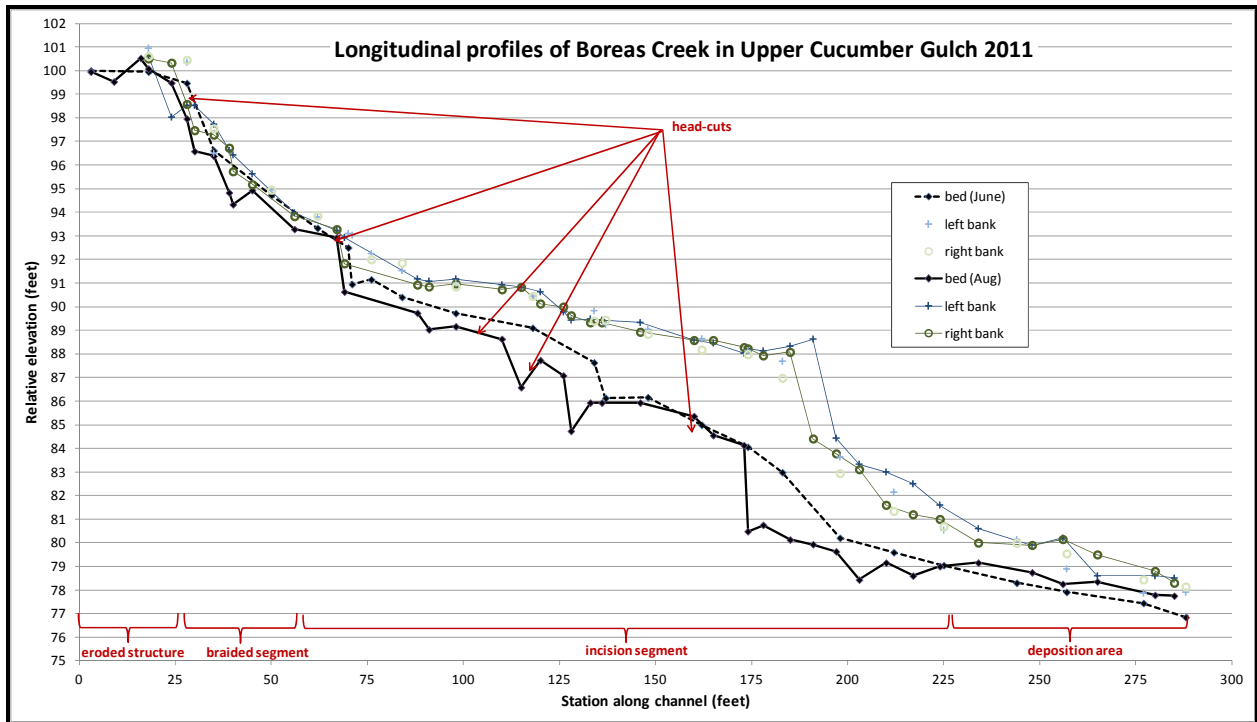
Fig. 19. Overlaid longitudinal profile surveys of the upper 300 ft. of Boreas Creek channel beginning at the Boreas Creek culvert. Surveys are from June 4 and Aug 5, 2011. The survey clearly shows areas of active incision (degradation) and deposition (aggradation).

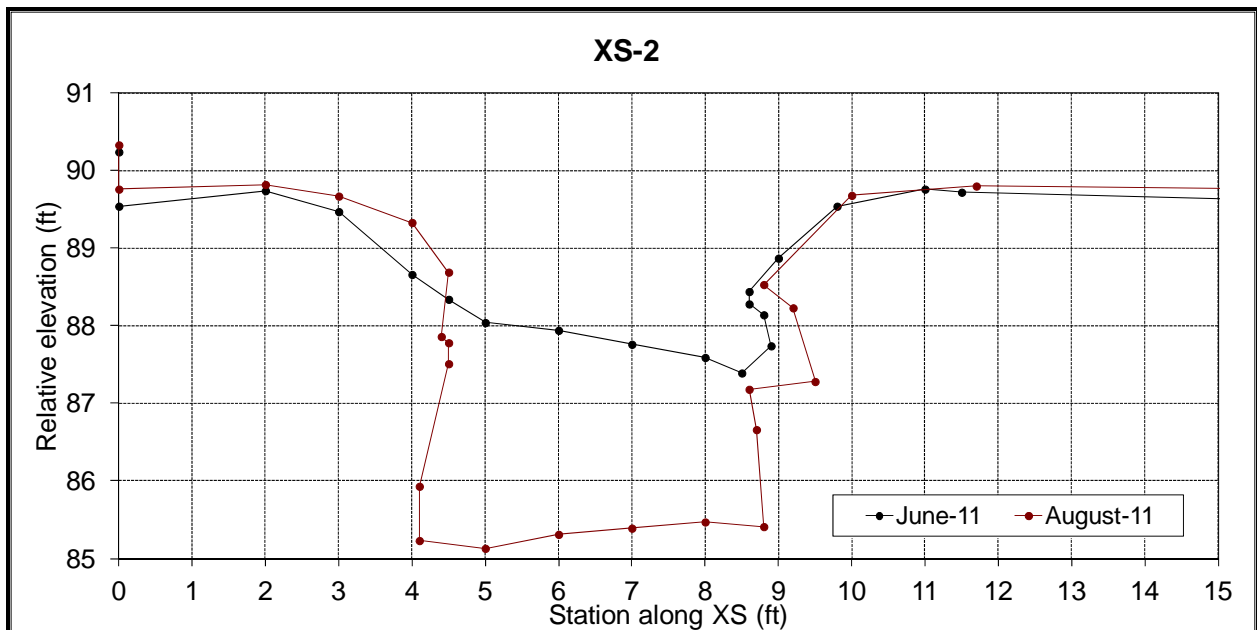
Fig. 20. Overlaid cross section surveys on XS-2 show 2.5 ft. of channel incision at this location.

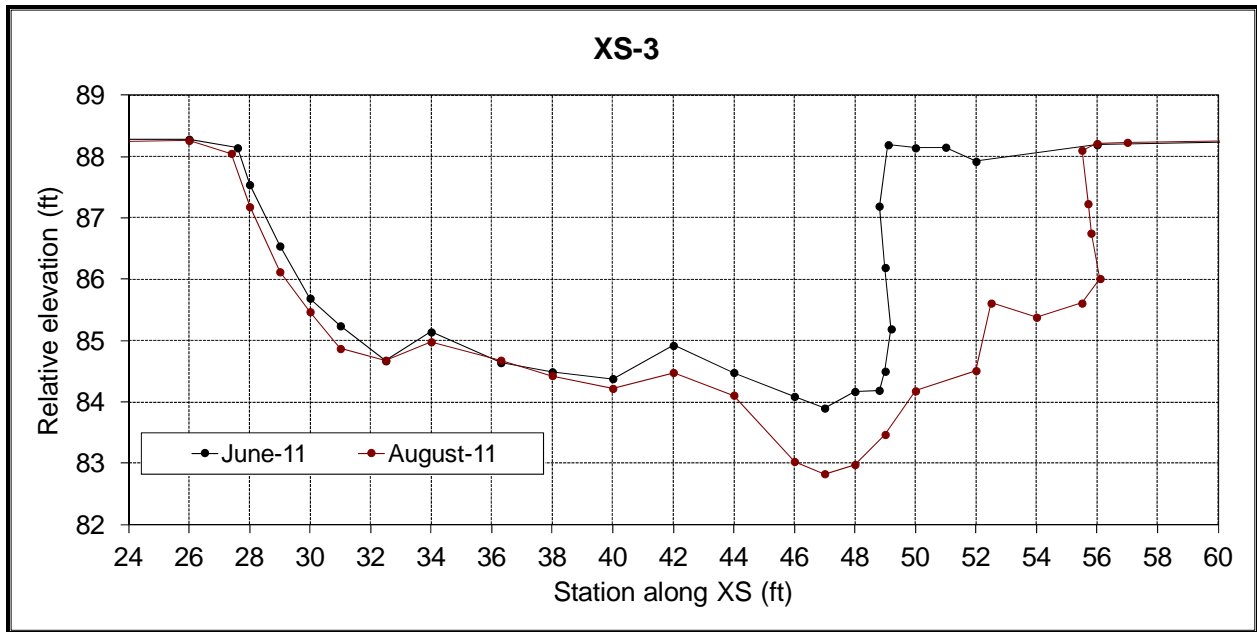
Fig. 21. Overlaid cross section surveys on XS-3, which is immediately upstream from the major head-cut show that the bed still dropped about 1 ft. at this location. Extreme bank erosion resulted in channel enlargement and generation of a large amount of sediment. This channel is fully entrenched.

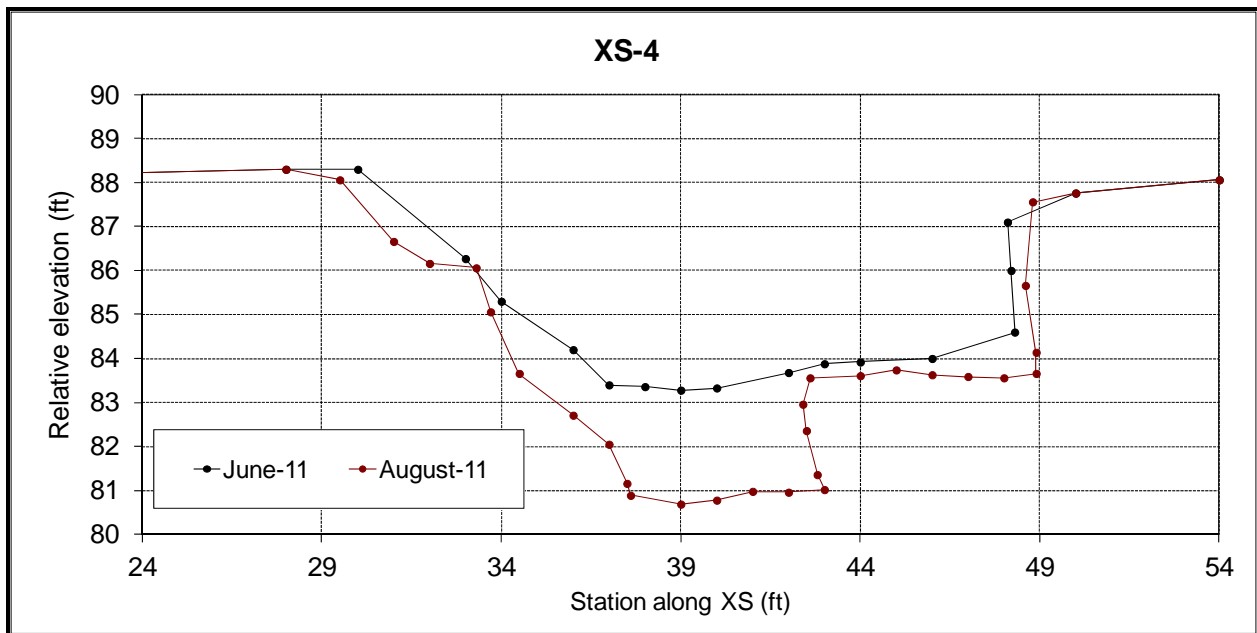
Fig. 22. Overlaid cross section surveys on XS-4 (just downstream of the major head-cut) show 2.5 ft. of channel incision at this location. Bank heights are nearly 7 feet at this location. This channel has become deeply entrenched.

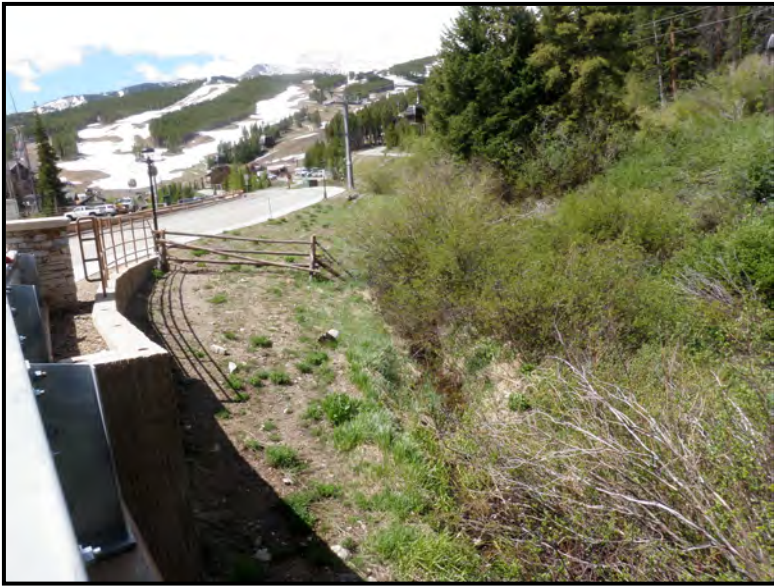
Photo 1. Ski Hill Road runs across the top of the Upper CG and Peak 7 SS wetland areas making it a key stressor to habitat connectivity and buffer capacity.

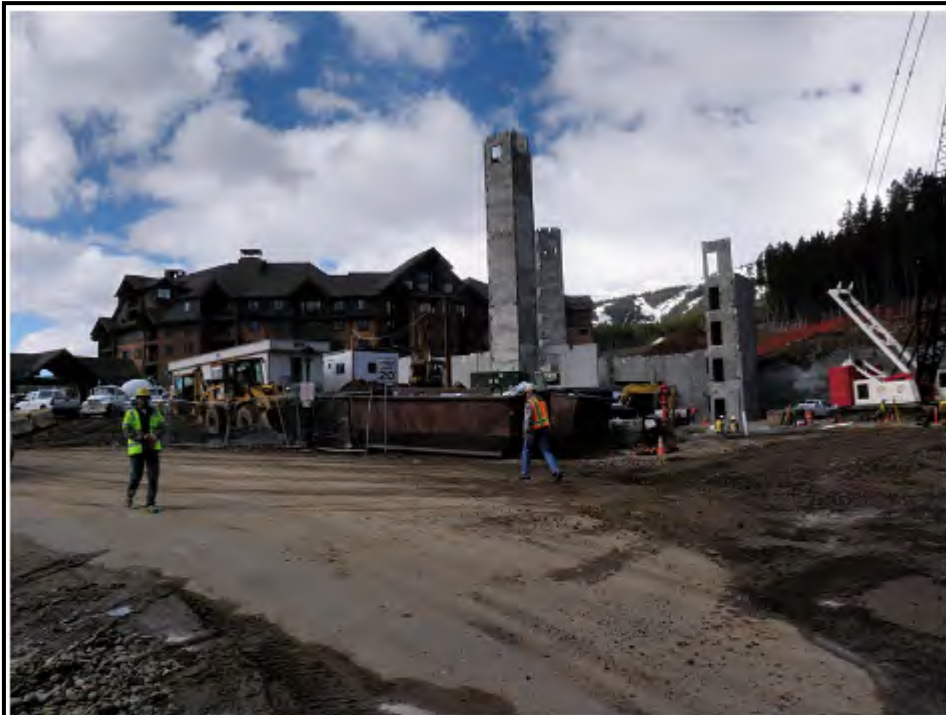
Photo 2. Major stressors to habitat connectivity and buffer capacity along the Peak 7 SS edge include dense commercial development, Ski Hill Road (above), and an engineered drainage/ water redistribution system (below).

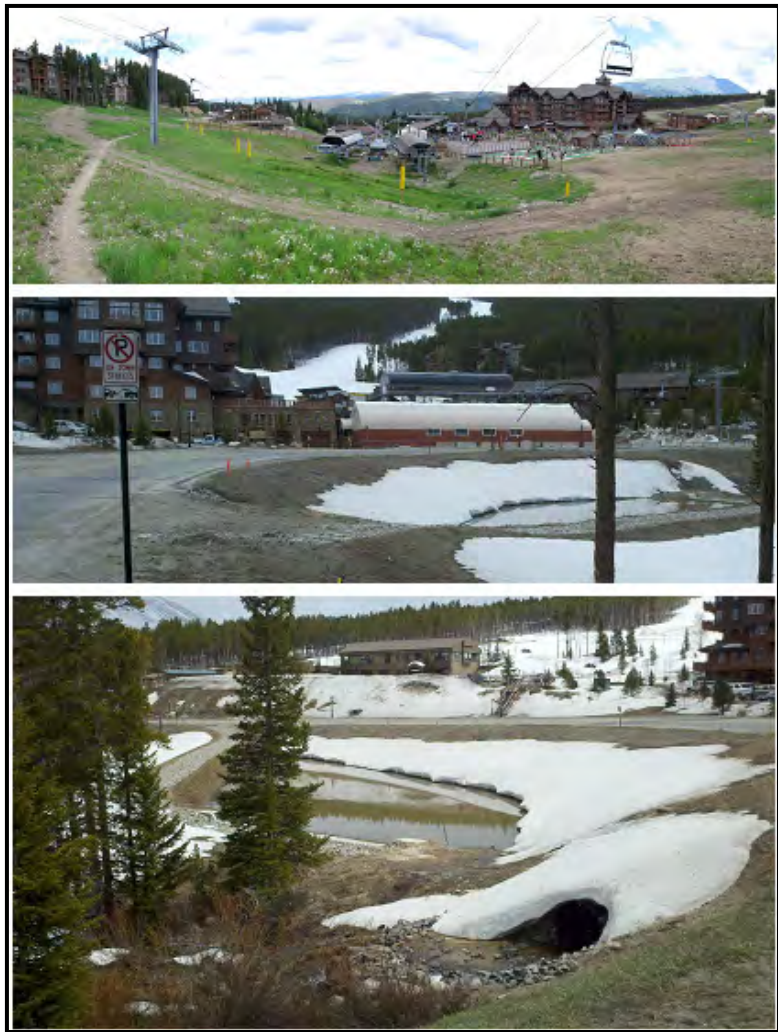
Photo 4. Part of the Peak 7 Base area drainage system, this infiltration trench carries collected storm water from south to north. Here at the south end there is a concrete spillway which apparently used to function as a level spreader before the trench was extended northwards in 2009 or 2010.

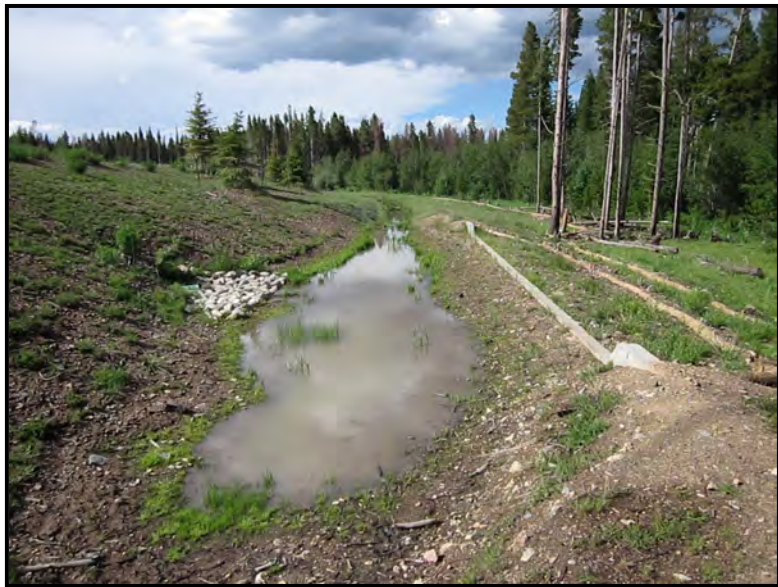
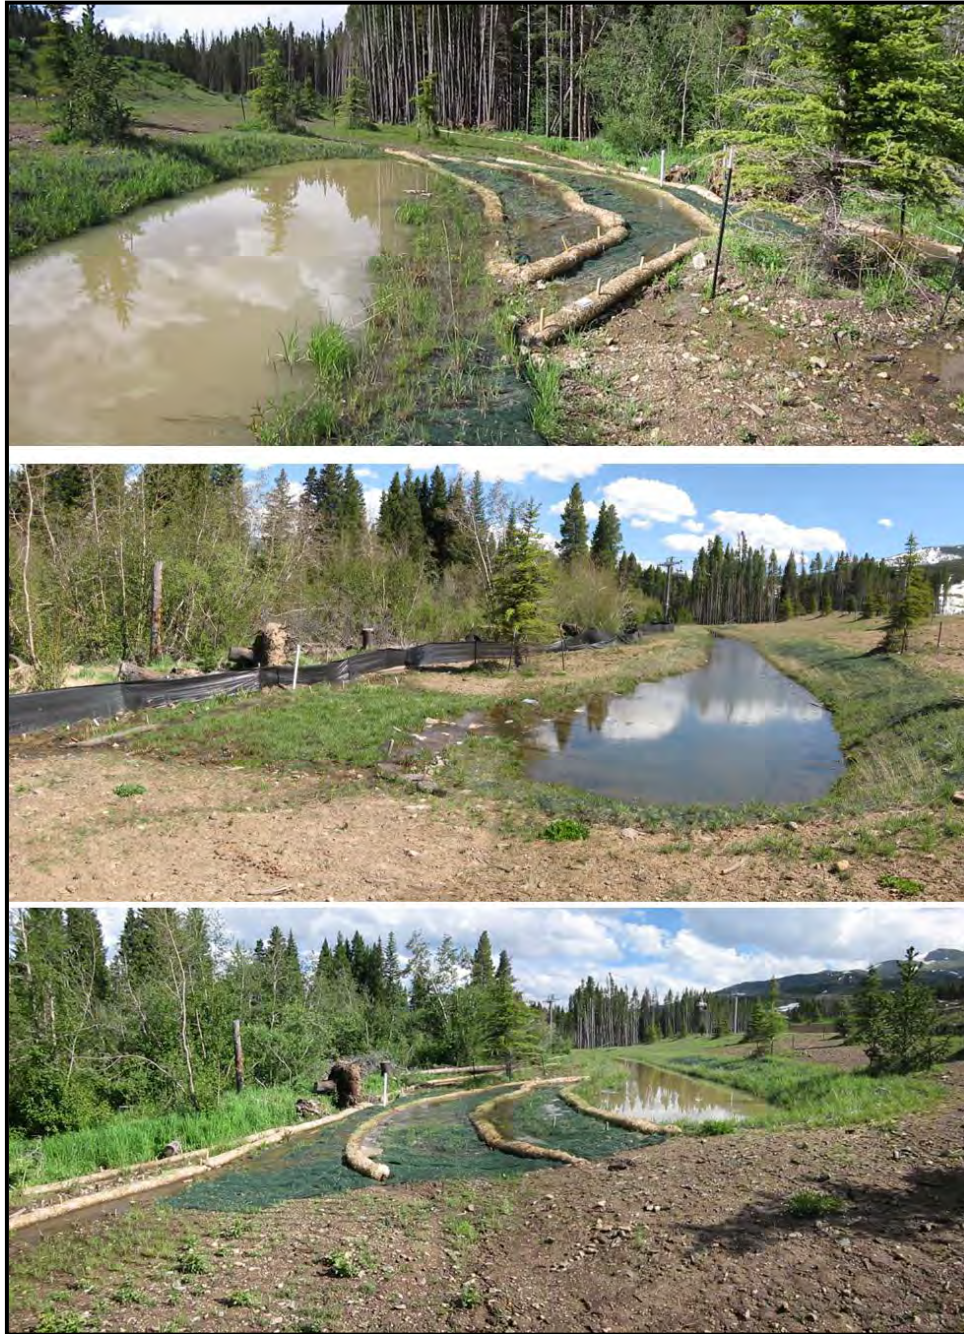
At the north end of the trench, surface water was seen flowing from the trench into the wetland throughout the summer. Temporary measures have been implemented at the end of this trench to dissipate the surface water and prevent channelization (Photo 5). These measures appear to have been effective during 2011 and so far the flows have not physically cut an identifiable channel. Nonetheless, the trench outlet has introduced a novel water source to the wetland below it. The source is surface water which is a shift from the natural condition which would have been wholly groundwater, and it is particularly concentrated in a narrow band at the top of the site. Further into the wetland, the surface flow dissipates and is lost in the complex microtopography. While negative effects were not observed in 2011, we caution that the system was newly implemented and impacts could develop in the future.

Photo 5. The new trench at the bottom of the Peak 7 drainage system is filled at its south end, and it spills at its north end (shown here). The upper photo is a view north of the outlet. The lower two show it looking south. The middle photo shows the outlet as it looked in May. The lower photo shows it in July, after a set of wattle check dams was installed.

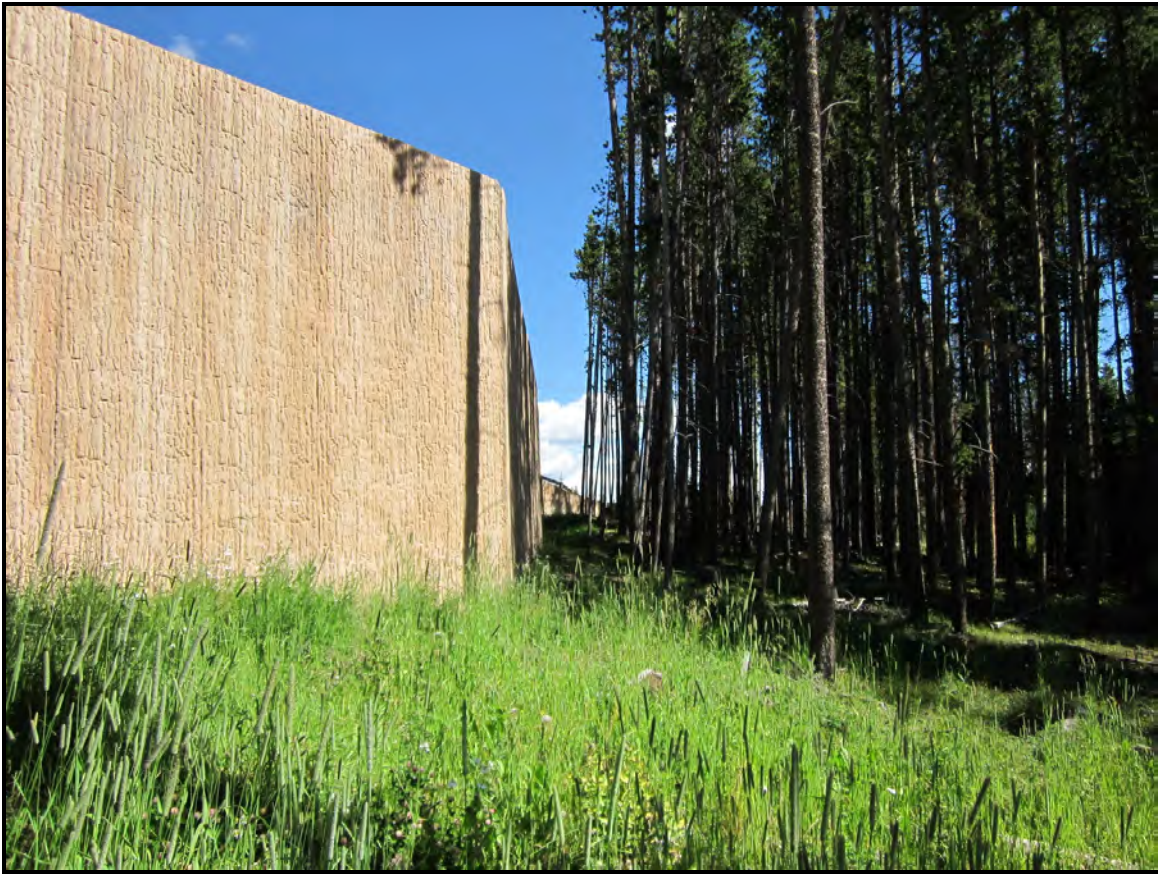
Photo 6. A concrete retaining wall constructed below Ski Hill Road and the Stables Lot in 2008 may influence local water distribution in addition to being a barrier to hydrologic connection and wildlife movement.

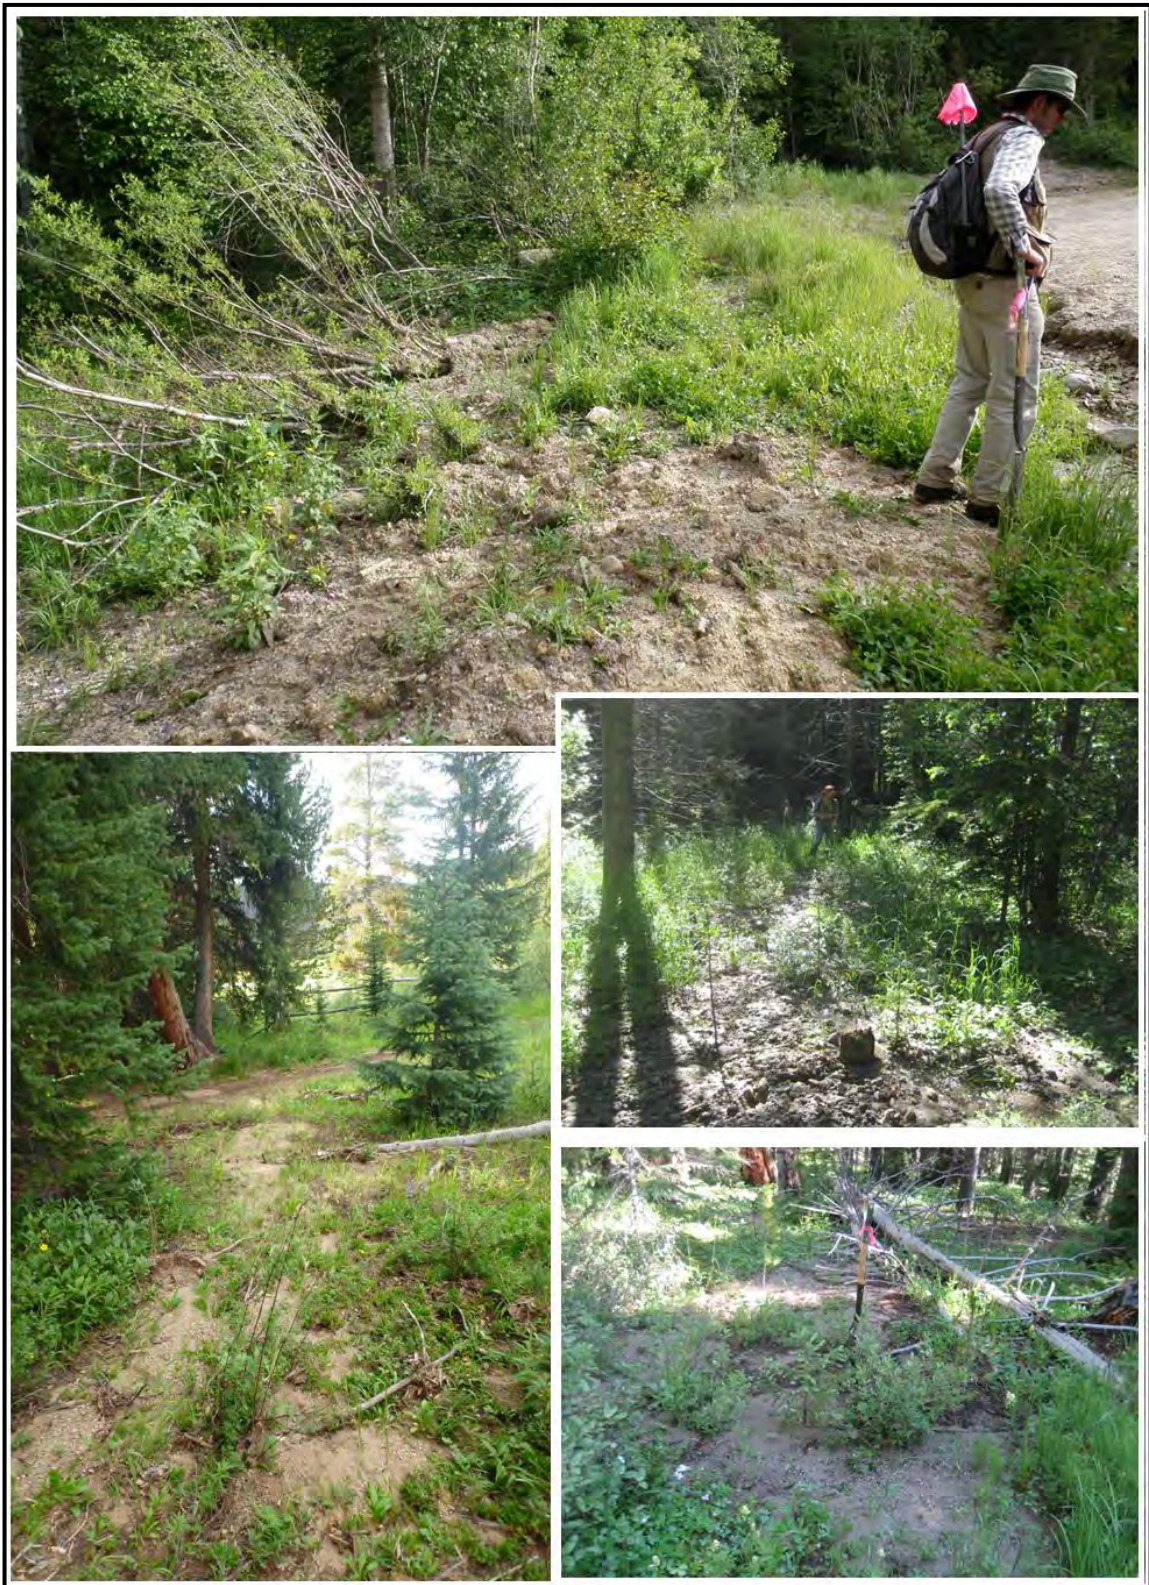
Photo 10. Sediment runoff from County Road 3 is a notable stressor on water/soil quality, geomorphology, and vegetation in the Peak 7 SS unit. Though fairly severe, the extent of this impact is quite limited.

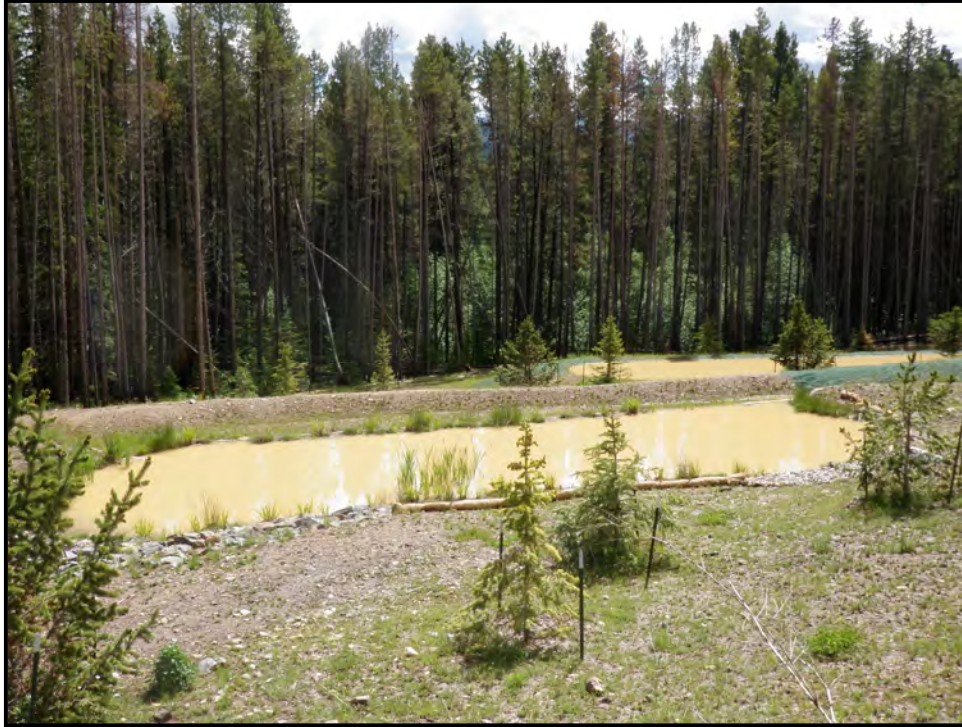
Photo 11. Water in detention ponds was often turbid long after storm events. Most of these ponds have surface water outlets to Peak 7 SS or Upper CG wetlands. While some of the suspended sediments did settle out in ponds, outflows to CGP were regularly high in turbidity. Water quality stressors of this type tended to be limited to the wetlands at the upper edge of these units.

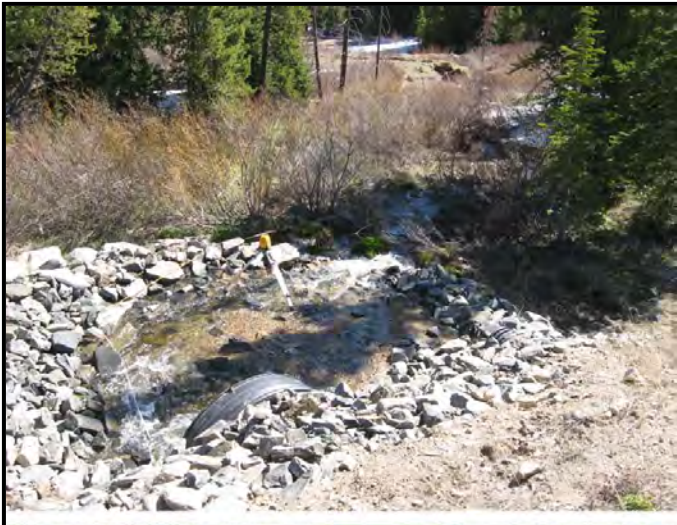
Photo 14. Boreas Creek enters Upper CG through this new 48" culvert. Water and sediment discharge from the Peak 8 watershed are concentrated by drainage systems above to this single channel. These photos show the culvert and the rock diversion structure below it. The upper photo is from early June. The lower photo is from early August. The rock structure has eroded, an indication of high stream power associated with this channel.

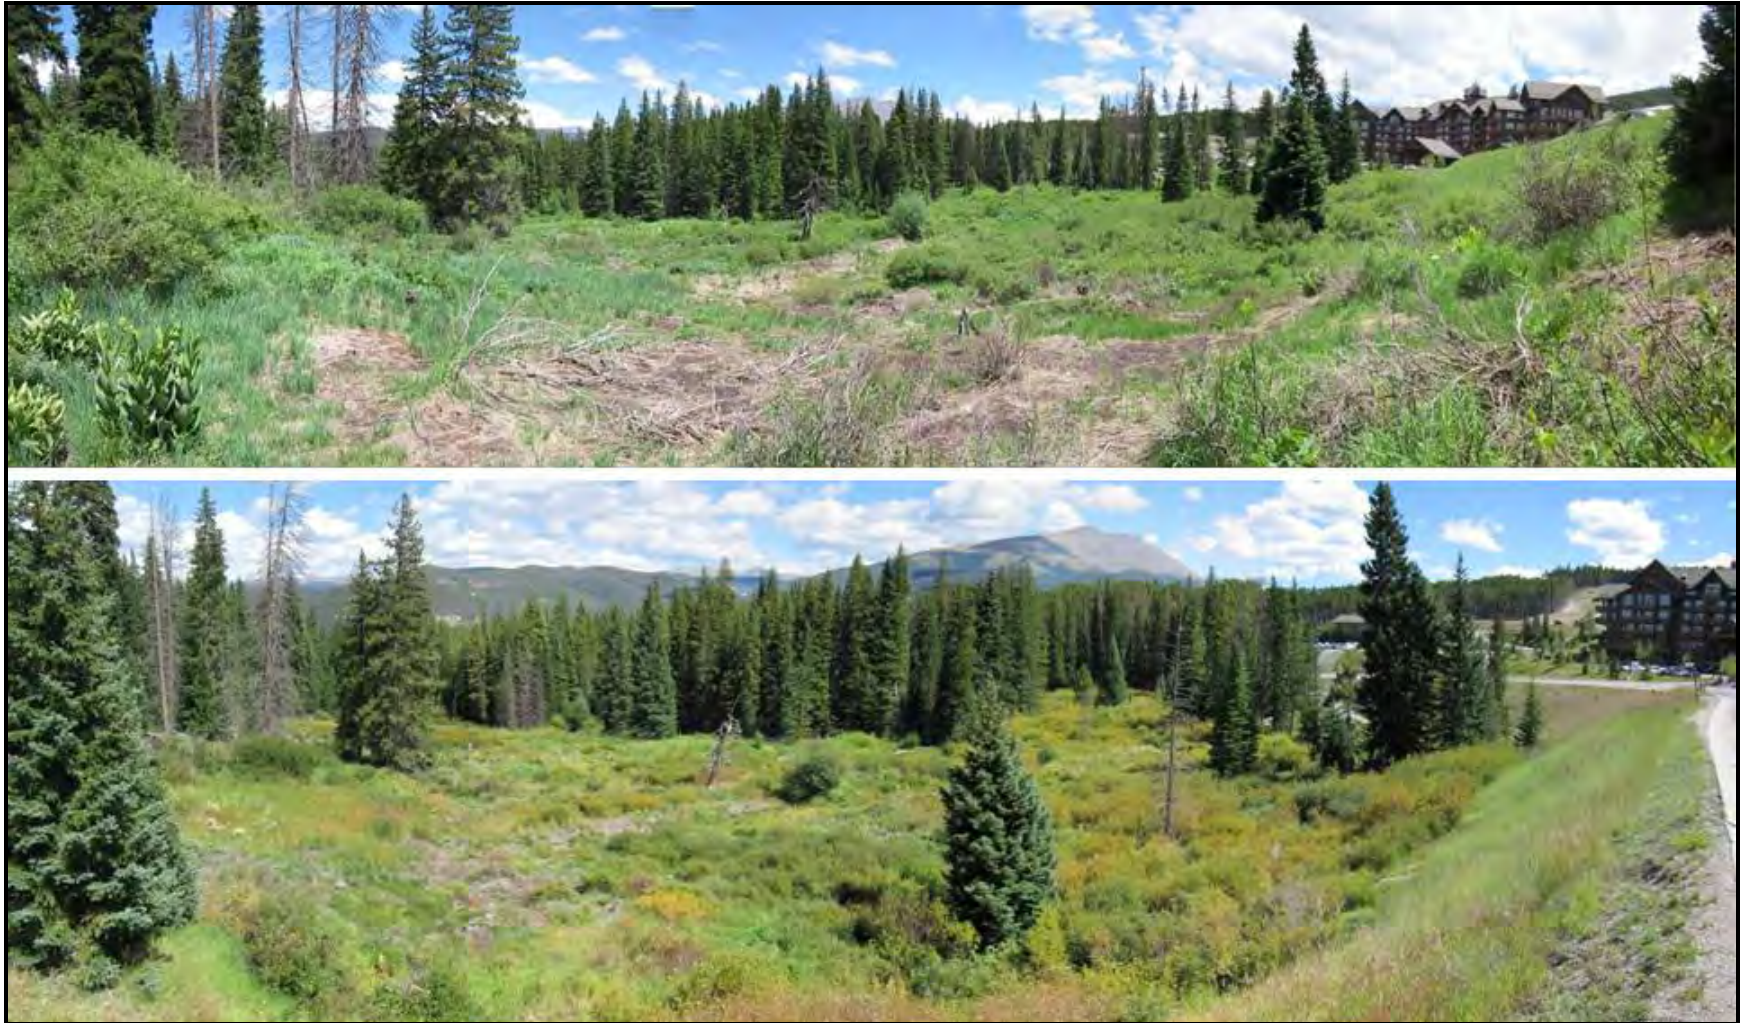
Photo 16. Two views of the dried portion of Upper CG in 2011. The upper photo is from June, and the lower one from September. In 2005, the area in the foreground was filled with beaver ponds. Wetland habitat has significantly receded since then.

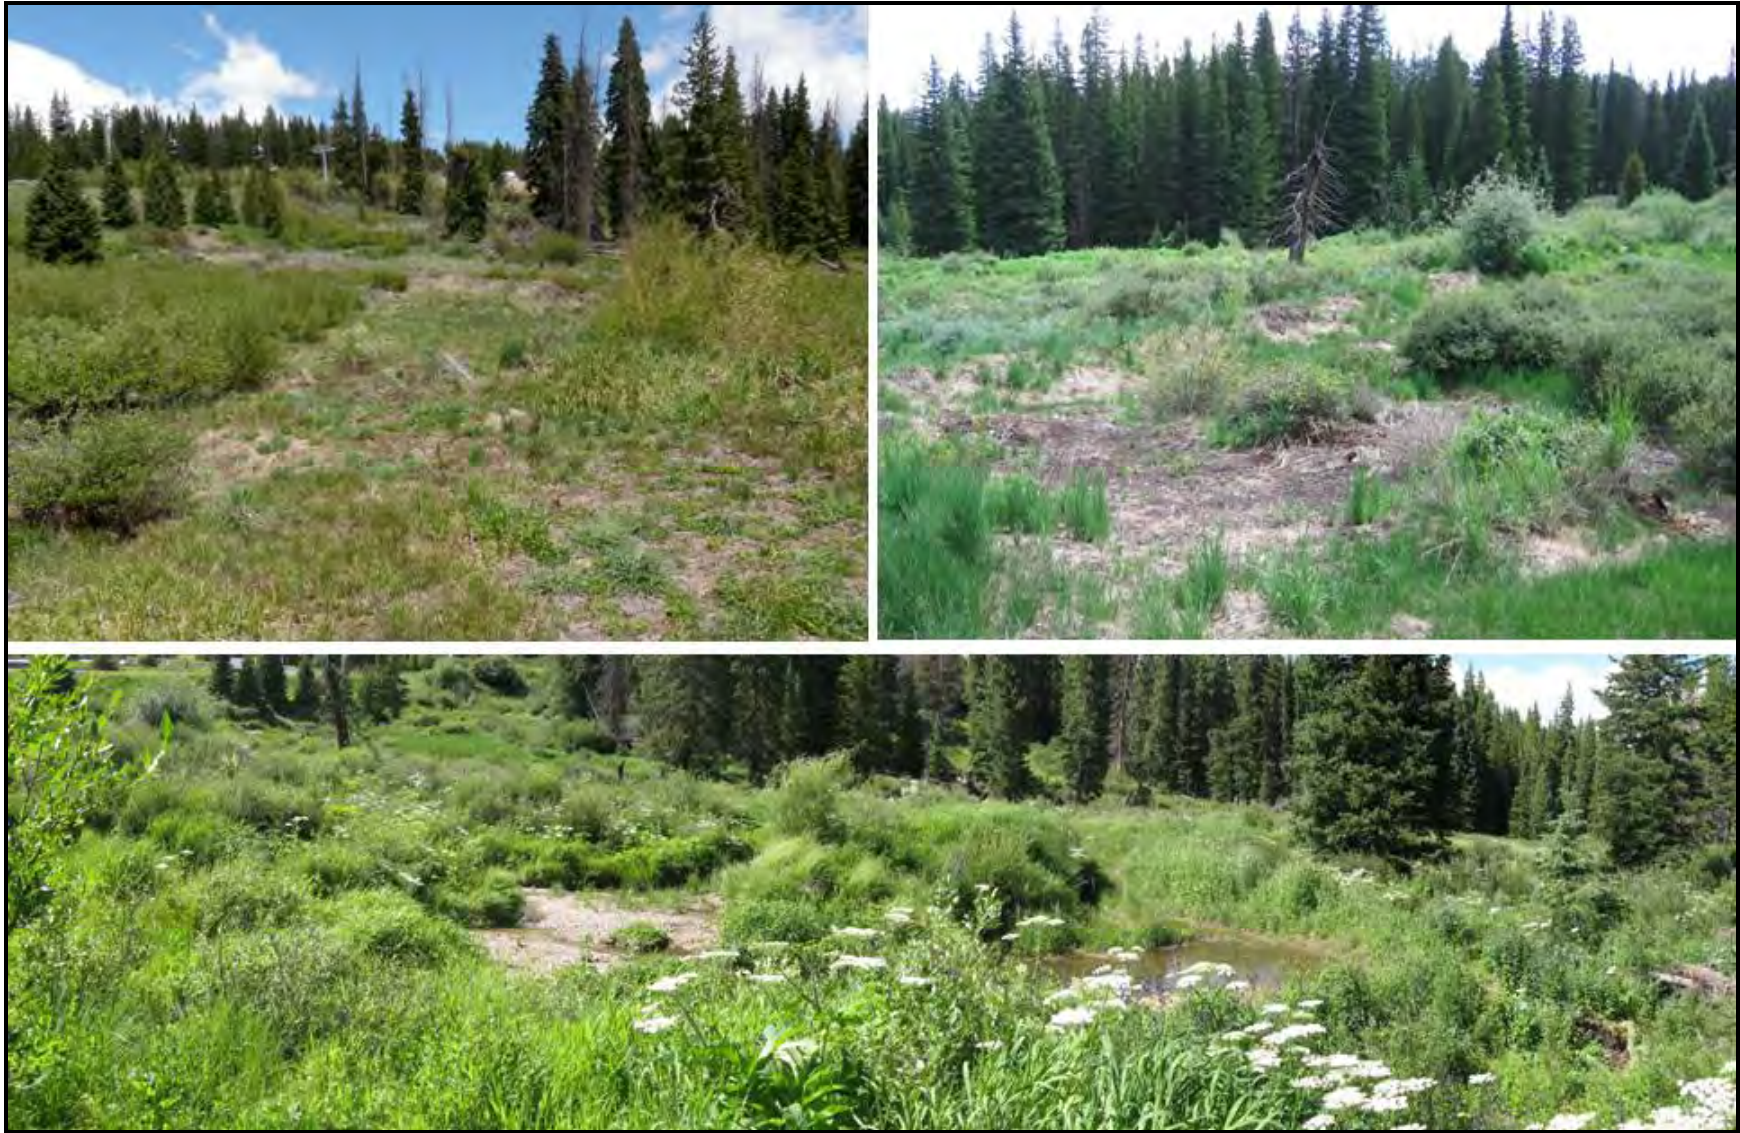
Photo 17. Photos of several dewatered and dried beaver ponds in Upper CG.

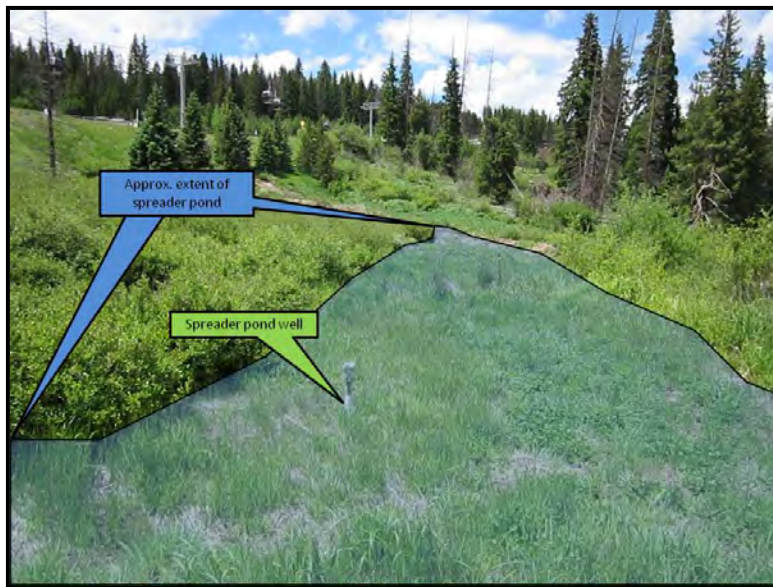
Photo 18. Obviously, the Spreader Pond is now no longer a pond. For reference, the approximate extent of the former pond is shaded in this photo. This photo also shows the location of our data-logging well on what used to be the bed of the pond. Data from this well indicates that this location may now be dried to the point that it no longer has wetland hydrology. Note that this pond had become entirely filled with sediment before its recent breach, raising the elevation of the bed.
