A Comprehensive Assessment of Wetland Condition in Cucumber Gulch Preserve, Breckenridge, Colorado.

Report Submitted to the Town of Breckenridge, CO

10/31/11

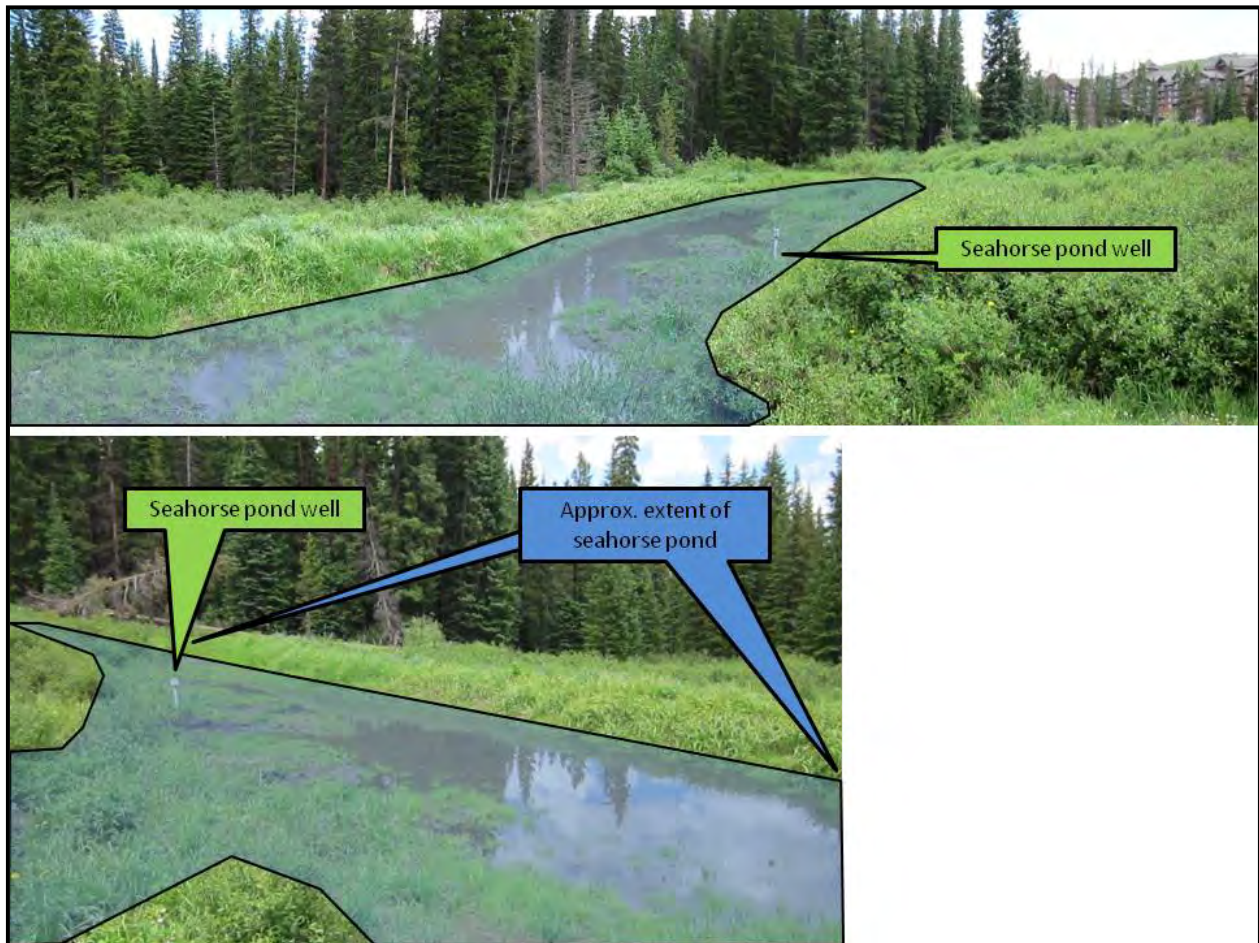
Photo 19. These two photos are of the Seahorse Pond (from alternate angles) which is about 40 m down-valley from the spreader pond. The approximate extent of the former pond is shaded. The Seahorse Pond was dry early in the 2011 season, but was partially filled for about 4 weeks in July (the photos show the pond in its partially filled condition) before it dried again. The location of the monitoring well within the bed is shown. Located off the main Boreas Creek channel, this pond has not yet become fully filled with sediment, so when overbank flows from Boreas Creek divert into the area in front of the dam (as happened in July, 2011), there is still volume (depth) for a smaller pond to form.

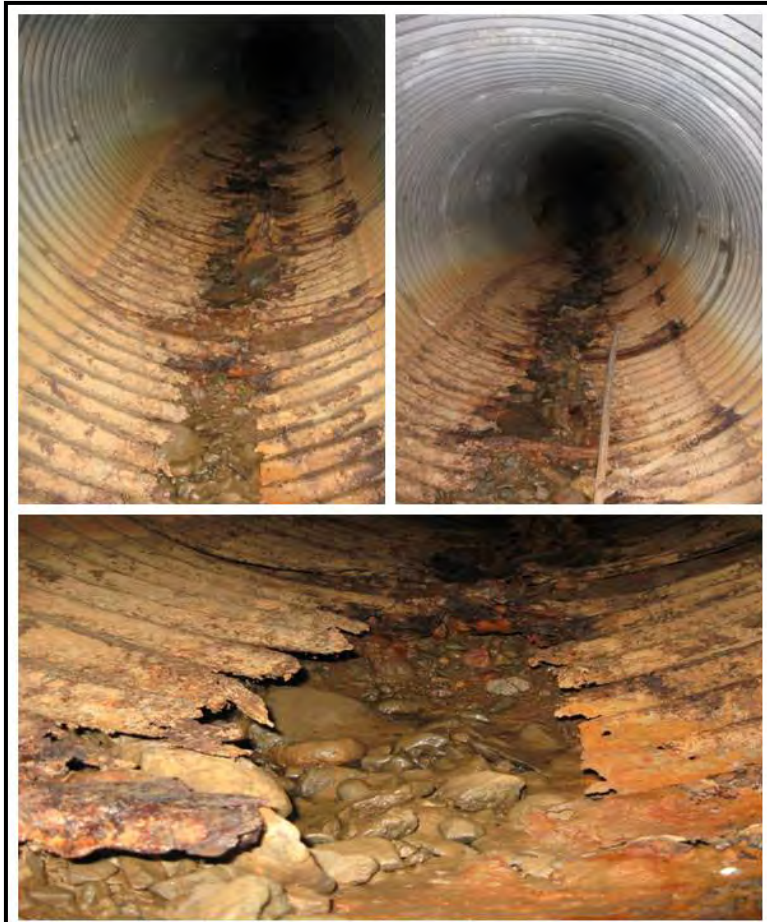
Photo 20. Photos from within the old Boreas Creek culvert (underneath Ski Hill Road) show that the bottom of this old pipe had completely rusted through. Some portion of Boreas Creek flows probably used to drain out of the pipe and into the ground while this old culvert was in use. A new culvert was installed recently, so any incidental spreading action of this old pipe is now no longer in play.

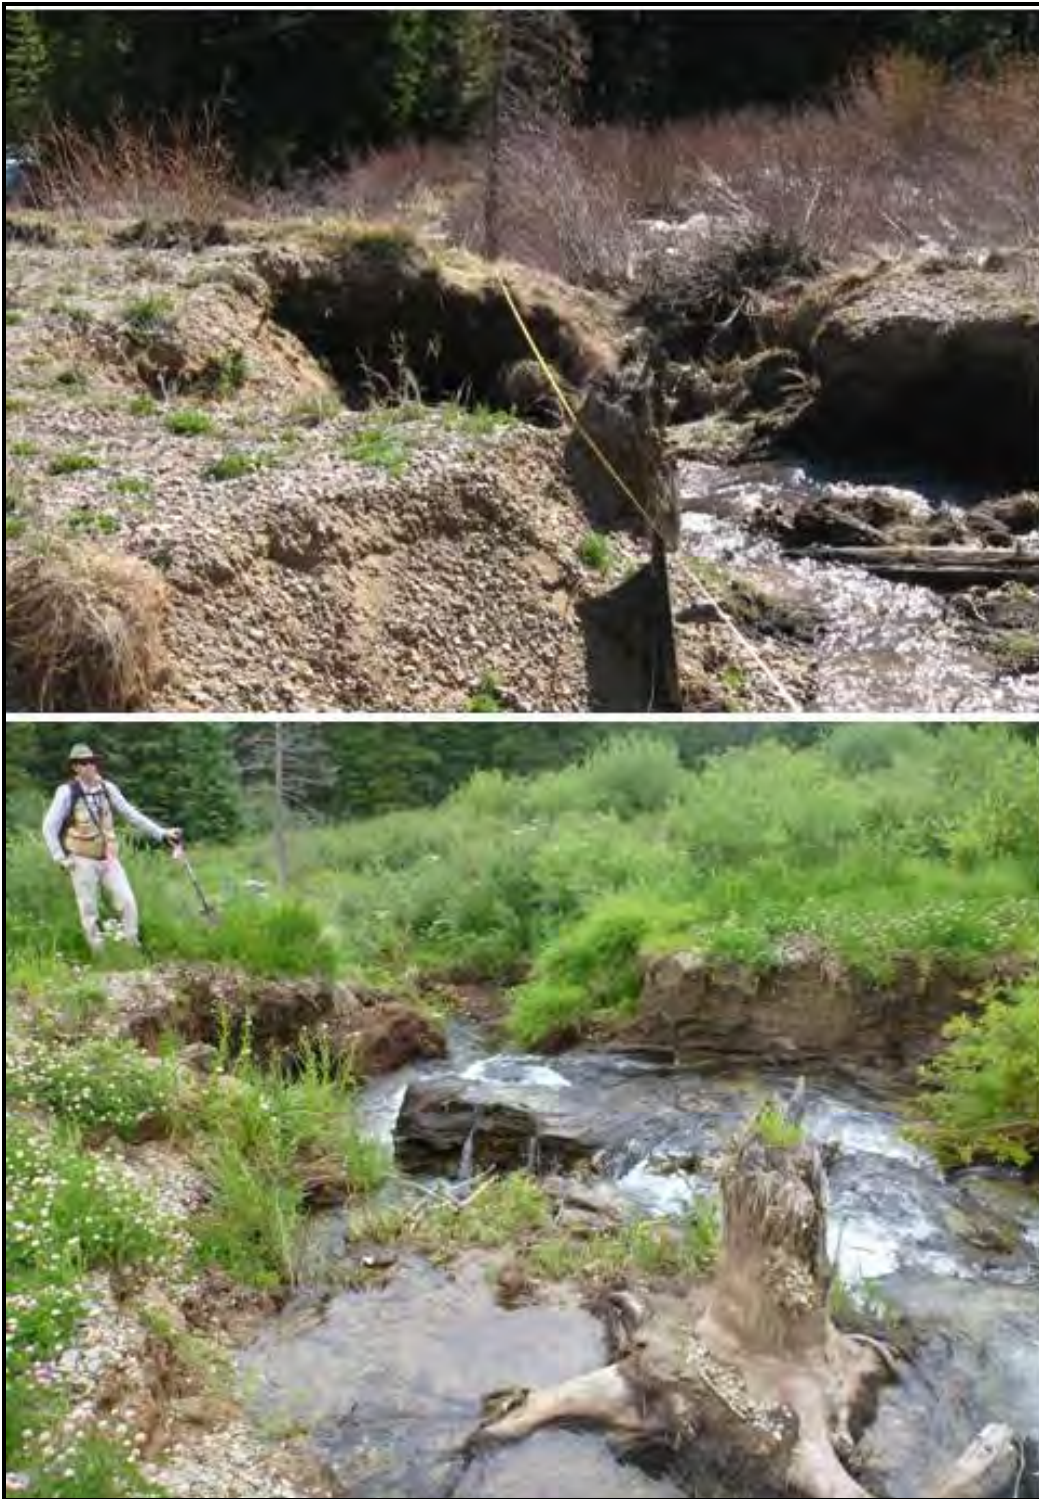
Photo 18. These photos show a view of the spreader pond dam taken from a point upstream (within the historic bed of the pond) in early June (upper photo) and mid-July (lower) of 2011. The dam had clearly begun to breach prior to this season, but the job was finished during July of 2011. Prior to this, the dam had functioned by impounding water and diverting much of the flow northward (left) to outlets on that side of the pond. Now, water flows directly through this area in one single, larger channel. Notice that the volume of the pond (in front of the dam) is completely filled with allochthonous sediment. In the upper photo notice the black piece of sediment fence at the bottom middle of the picture which is buried in sediment. The creek is now down-cutting through this sediment and even further down into ancient sediments that were below the level of the bottom of the pond.

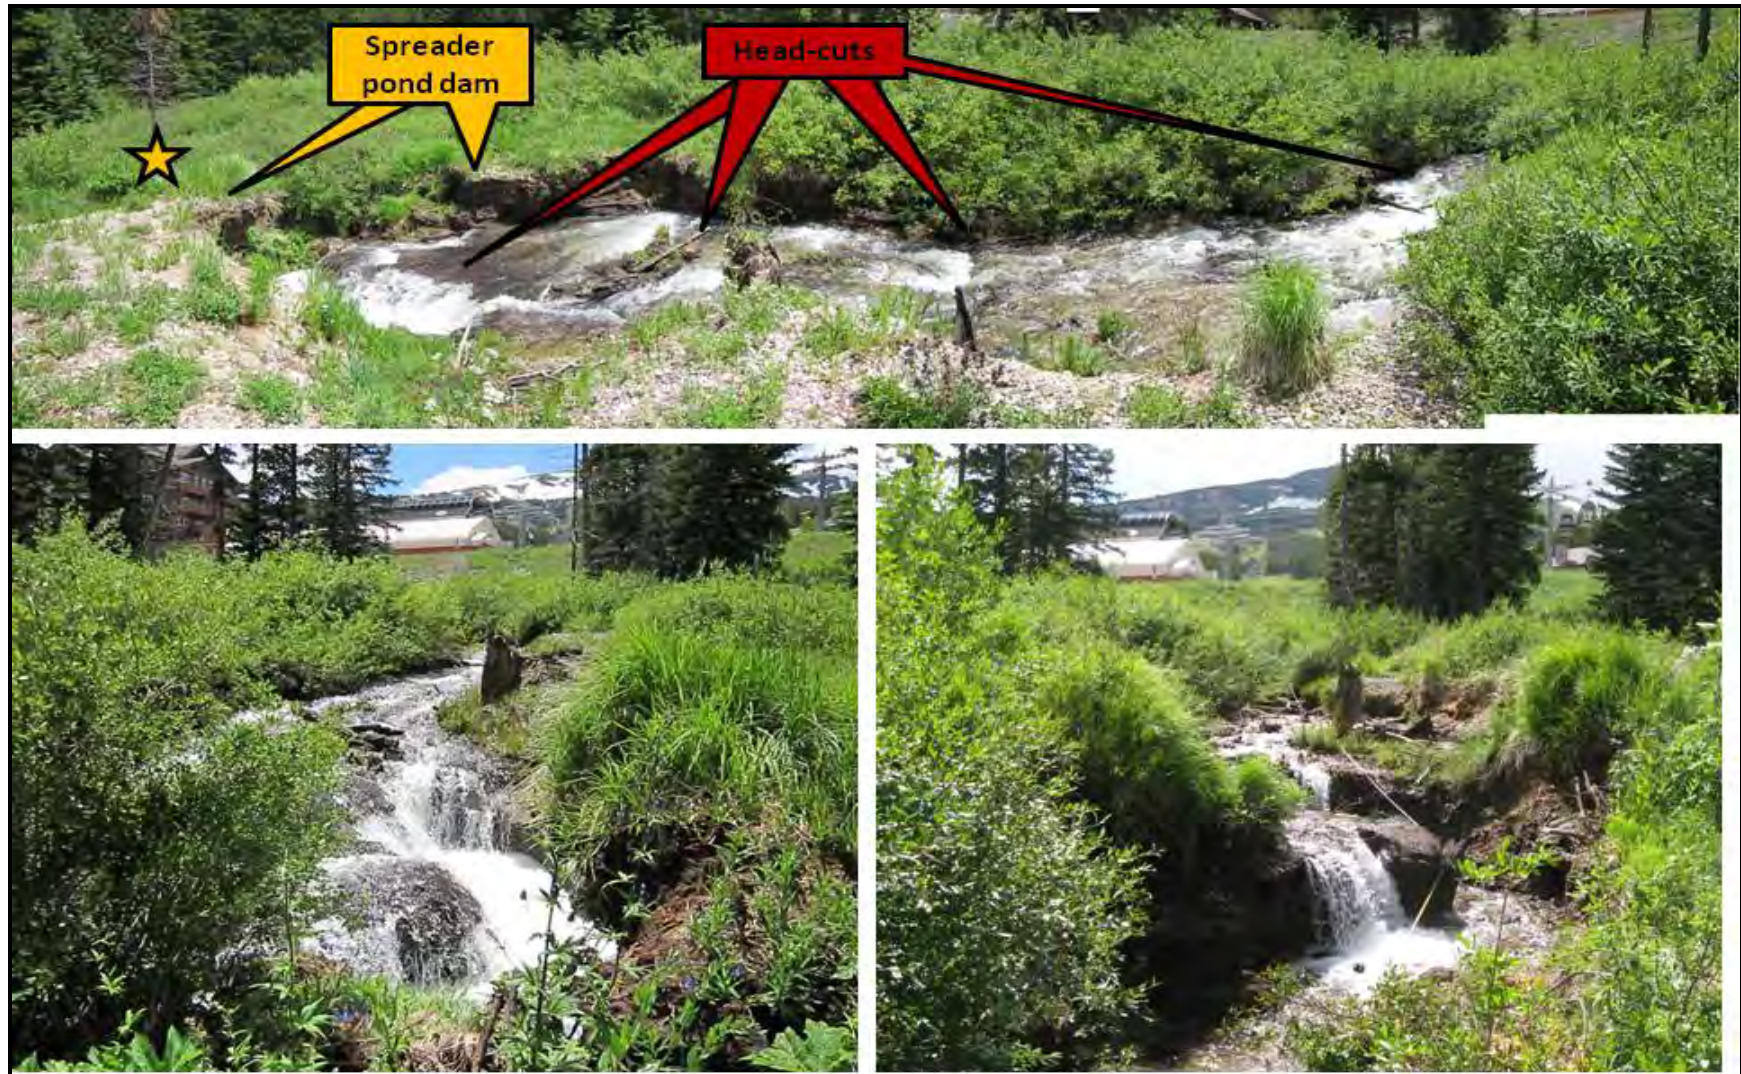
Photo 19. These photos illustrate the process of degradation (down-cutting) on Boreas Creek through the region of the old spreader pond. The upper photo (from early July, 2011) shows the channel lengthwise where it runs through what used to be the spreader pond. The location of the dam breach and several active head-cuts are shown. The lower photos are taken from just downstream of the dam breach (location marked by a star) looking upstream. The left photo was taken in early July, and the right photo in early August, 2011 showing the advancement of channel incision.

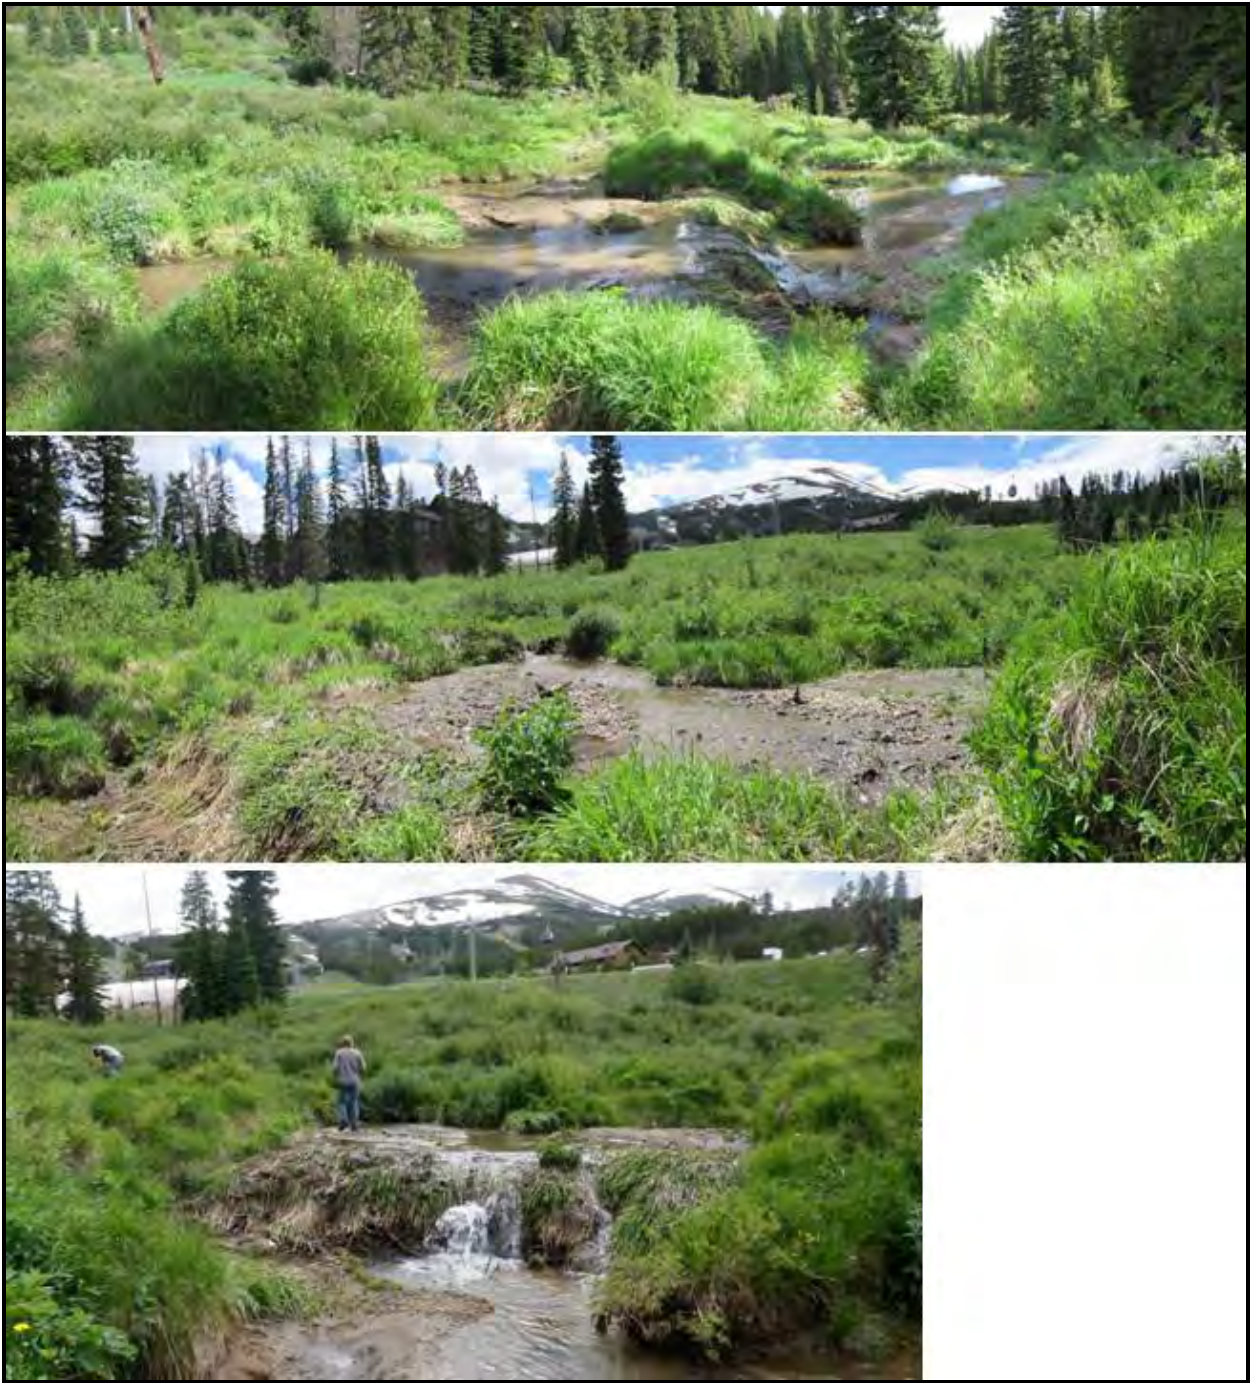
Photo 20. These photos show ponds in Upper CG that have been filled completely by sediment. The sediment that accumulated has reached the elevation of the top of the beaver dams that had previously created ponds. That is, the volume of each pond is completely filled, so they can no longer function as ponds even if water source is restored.

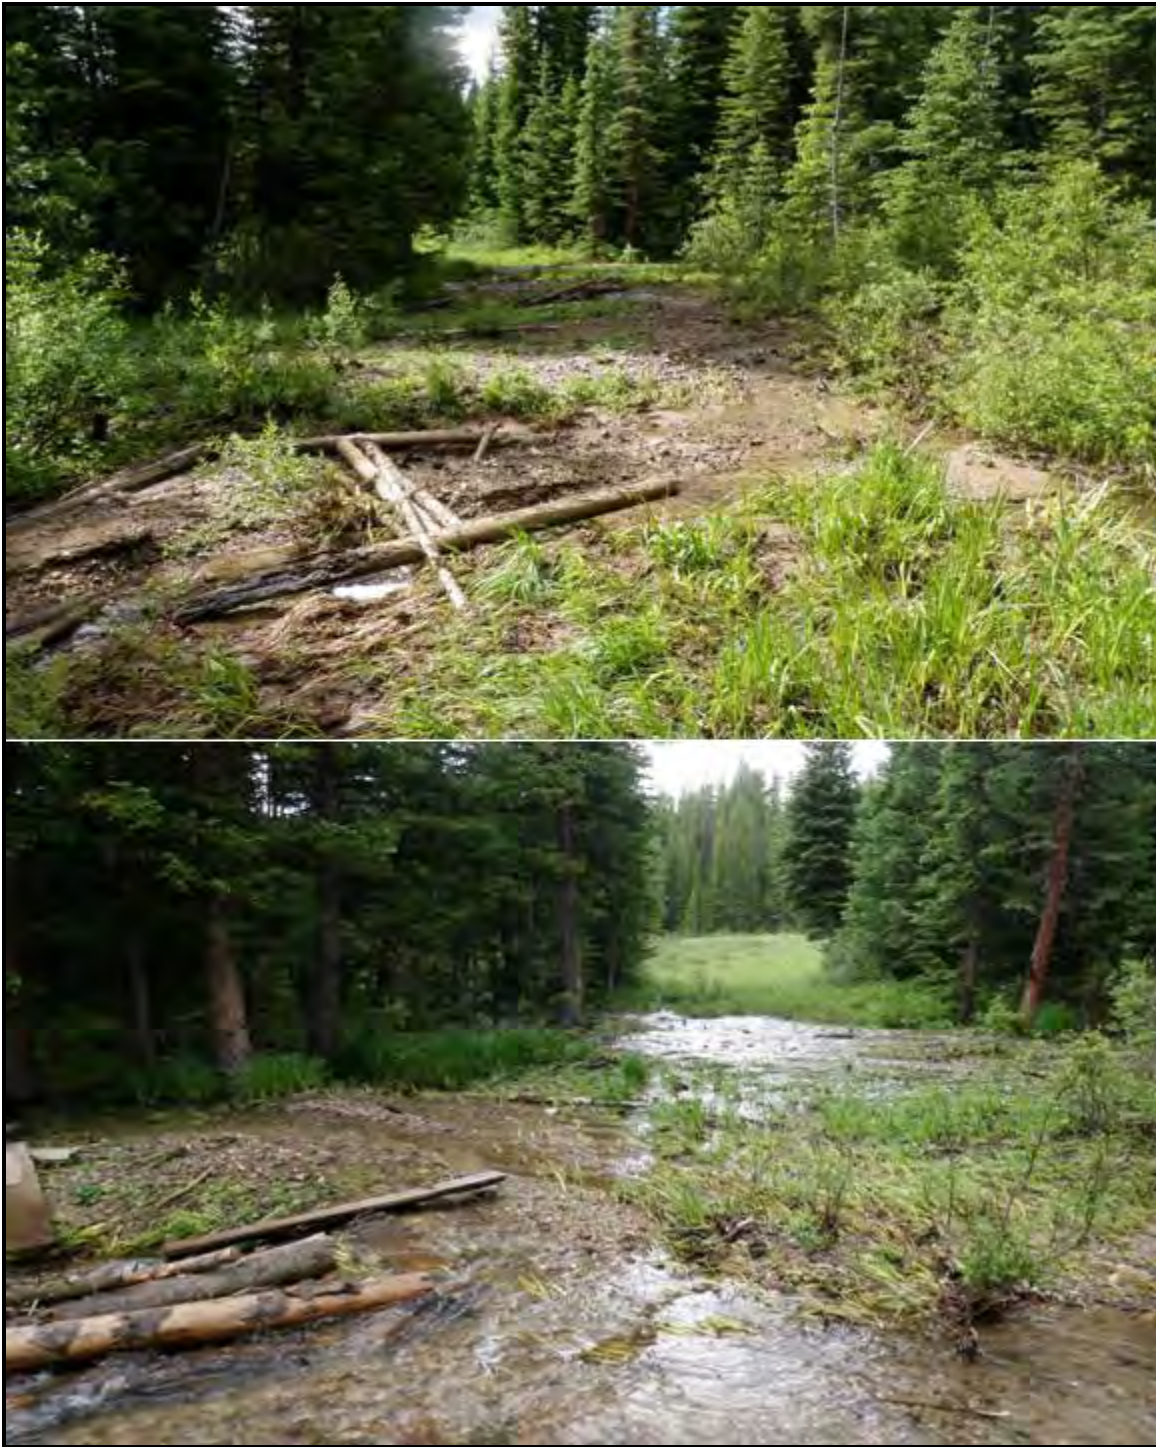
Photo 21. Large volumes of sediment were deposited along segments of the Boreas Creek channel in Upper CG during 2011. The logs and lumber in these photos are debris from a destroyed bridge. The logs used to span a much narrower creek channel which is now buried somewhere under this dome of deposited sediment. The channel in this area is now wide and braided. Sediment deposition of this type impacts geomorphology and water distribution.

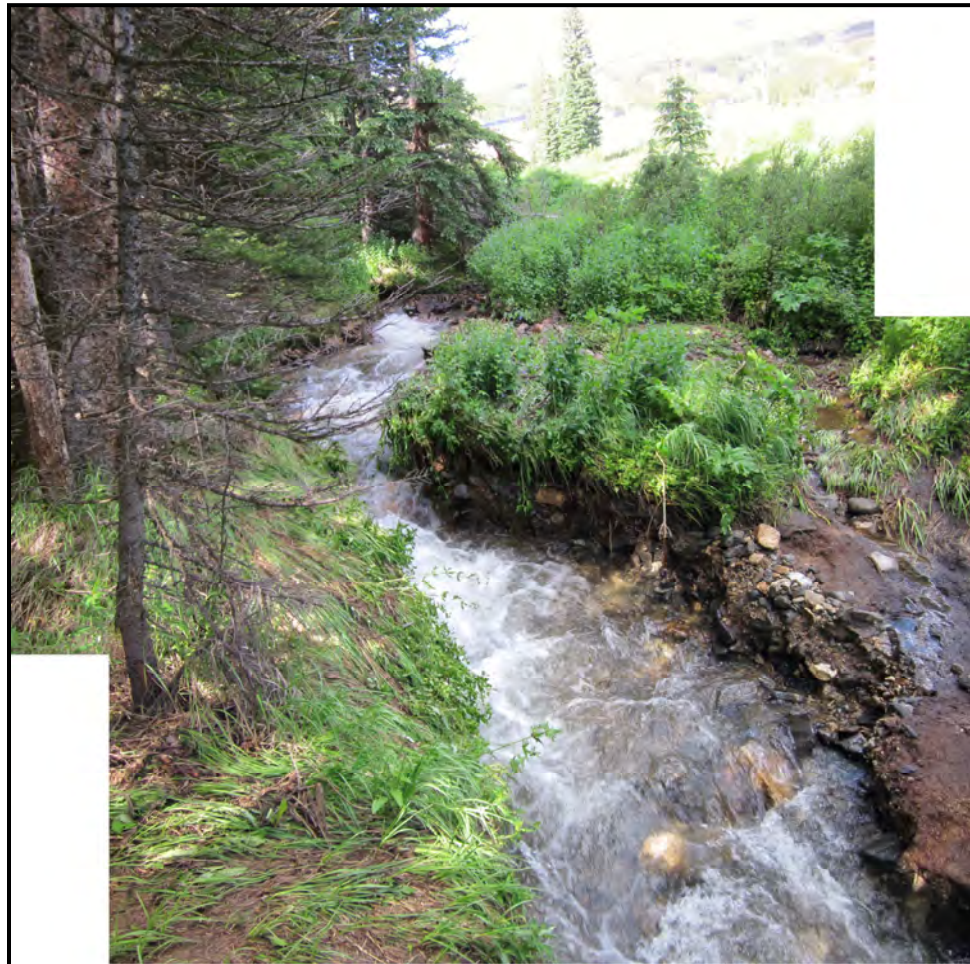
Photo 23. Channel incision occurred on segments of on Boreas Creek throughout the length of Upper CG in 2011. This photo shows a segment about 600 ft. downstream of the culvert which down-cut about 1.0-1.5 ft.

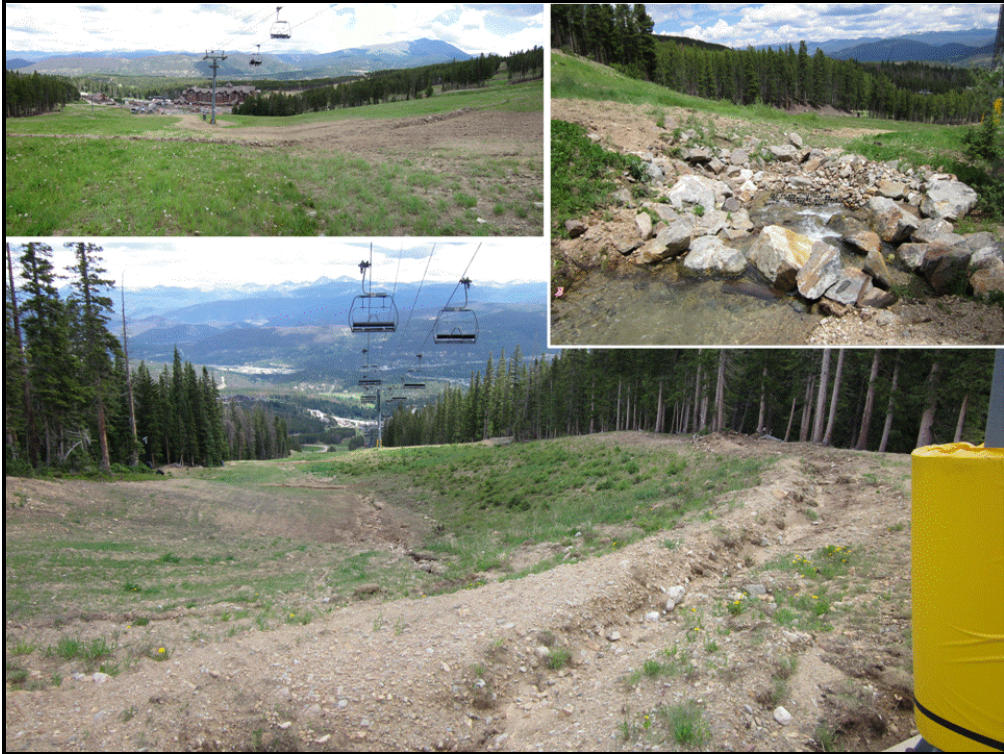
Photo 258. Additional observations on the artificially managed hydrology and sediment regime in the CGP source watershed are shown. Accelerated erosion and efficient sediment transport in the watershed have consequences in receiving areas such as CGP.

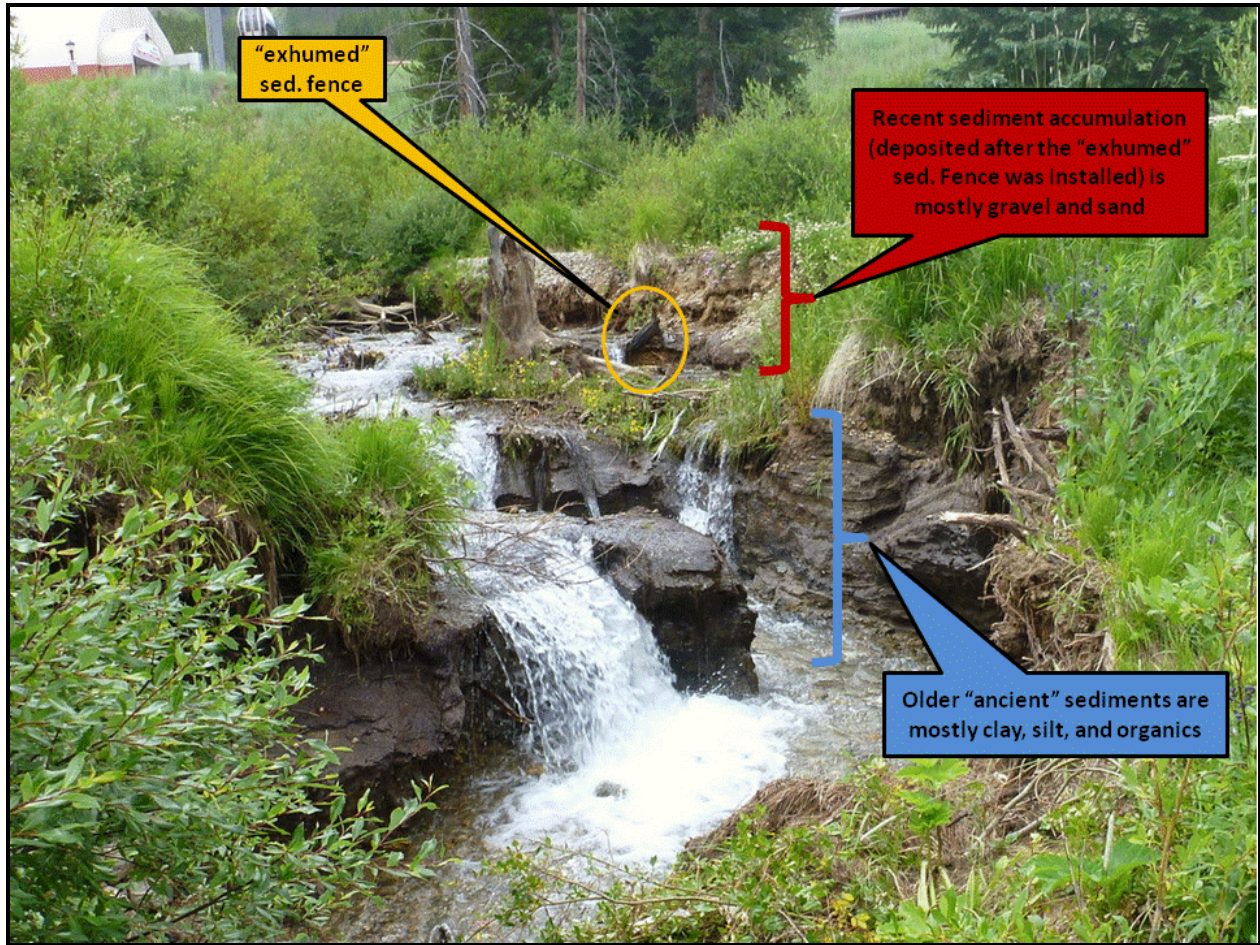
Photo 269: The down-cutting channel on Boreas Creek yields key information about the sediment profile and history of sedimentation in Upper CG. This photo is taken from just downstream of the Spreader Pond dam, looking upstream.

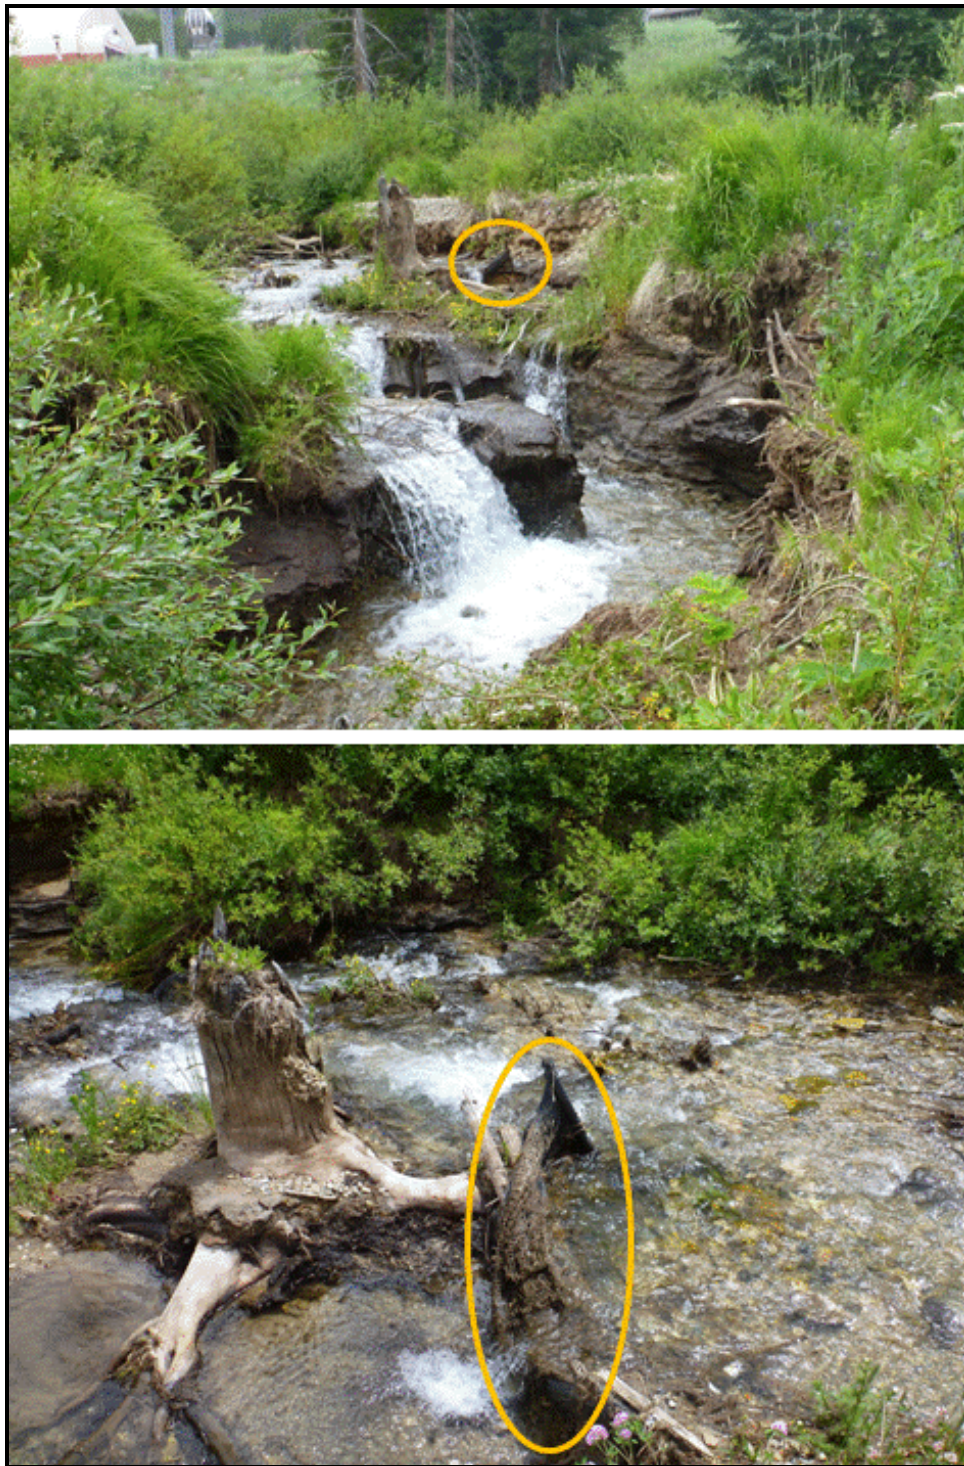
Photo 27. This photo gives a clearer view of the "exhumed" sediment fence (circled) within the enlarging Boreas Creek channel. The base of the fence and the base of the adjacent tree stump indicate the elevation of the streambed at the time the fence was installed. Since the time that fence was installed up to the time the dam broke, about three ft. of coarse sediment had filled the pond, effectively raising the ground surface by that height. Now, the creek is cutting through these sediments, and deeper, leaving the new ground surface "high and dry."

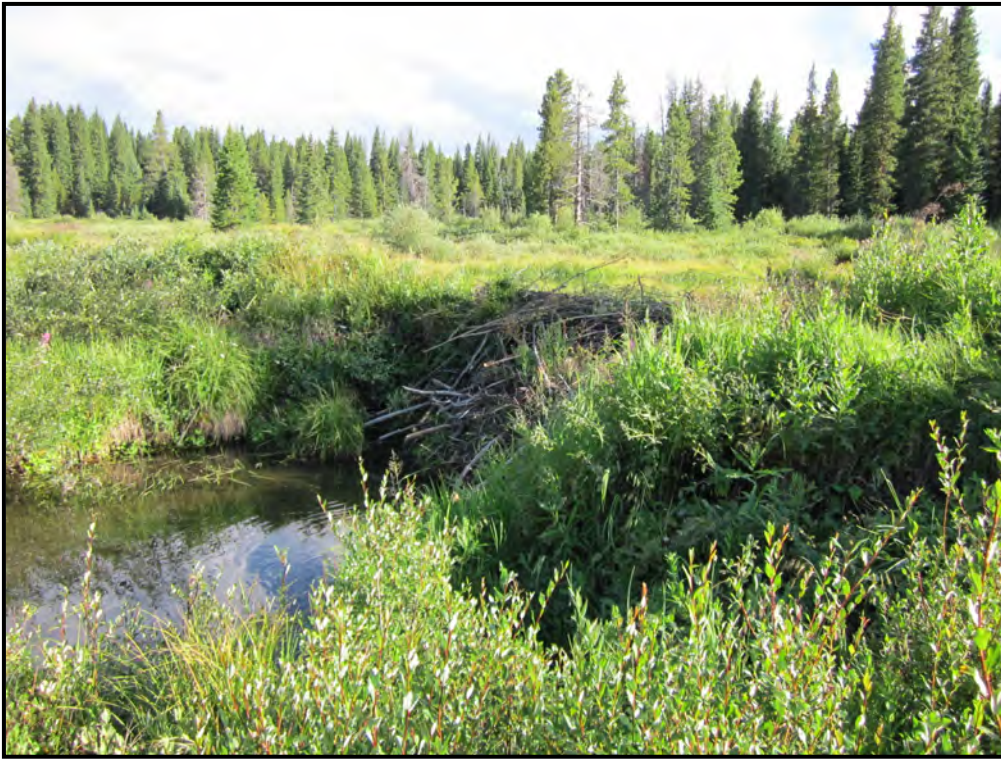
Photo 33. This dam breach (in Lower CG) was repaired by beavers during the 2011 season. Notice that the building materials consist of nothing larger than willow stems.

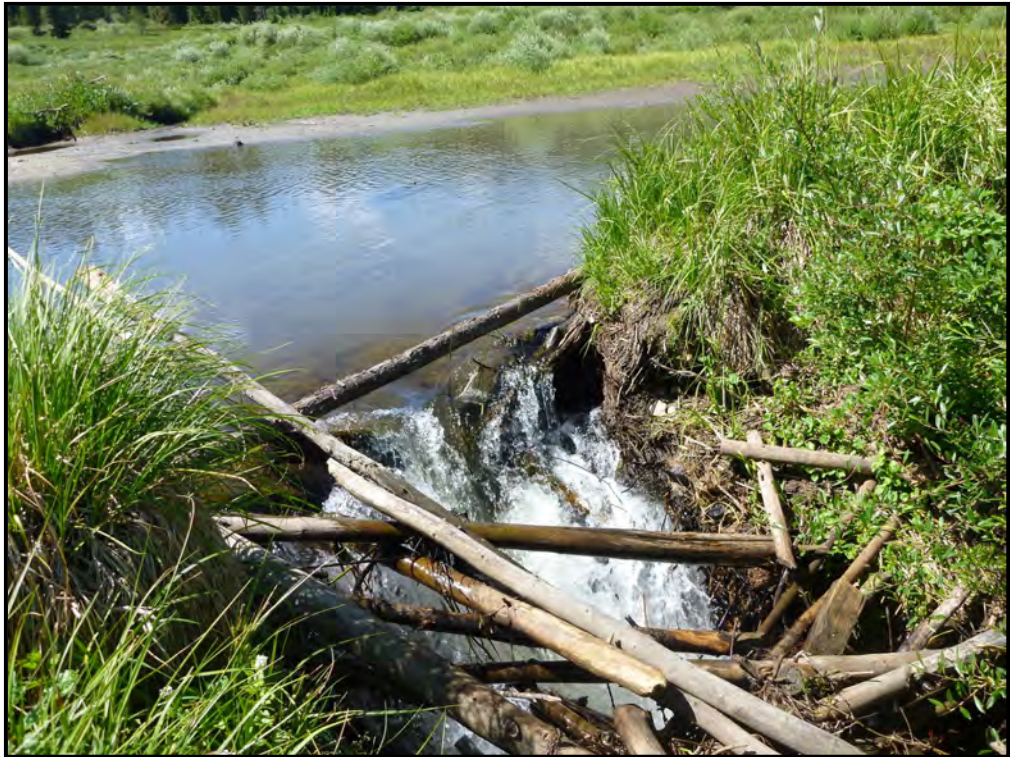
Photo 34. In addition to some repaired dams, we also observed many dams which were not being maintained by beavers including this one. Notches in the dam like this, if not repaired, concentrate flows and scouring energy which will eventually cut through the dam altogether, draining the pond. Note that the logs are debris from an upstream broken bridge that were carried here in high flows, not material placed by beavers.

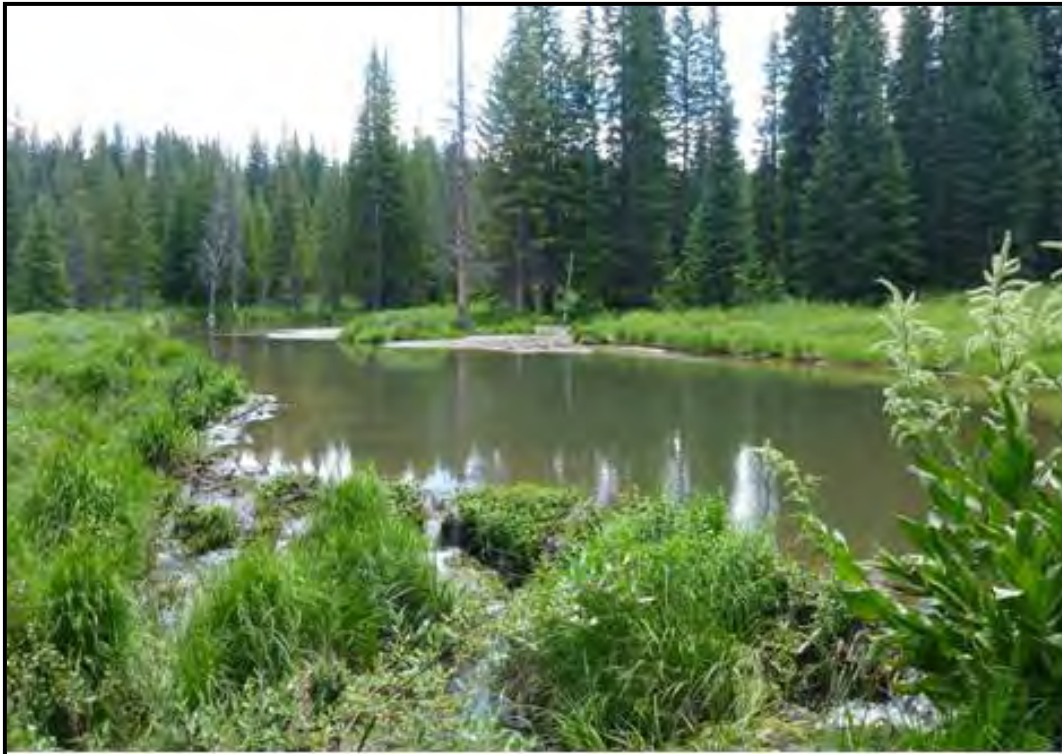
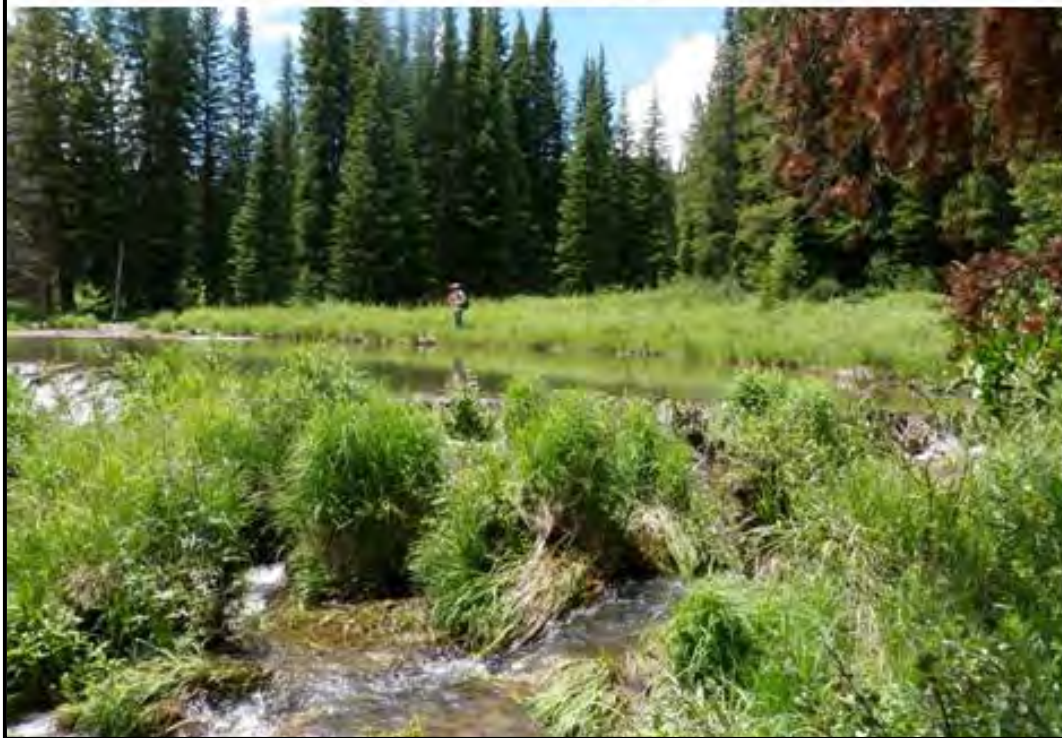
Photo 28. These photos of the Reset Pond show how it functions by distributing outflow across the dam into numerous distributary channels below. If this dam fails, the distribution function will be compromised.

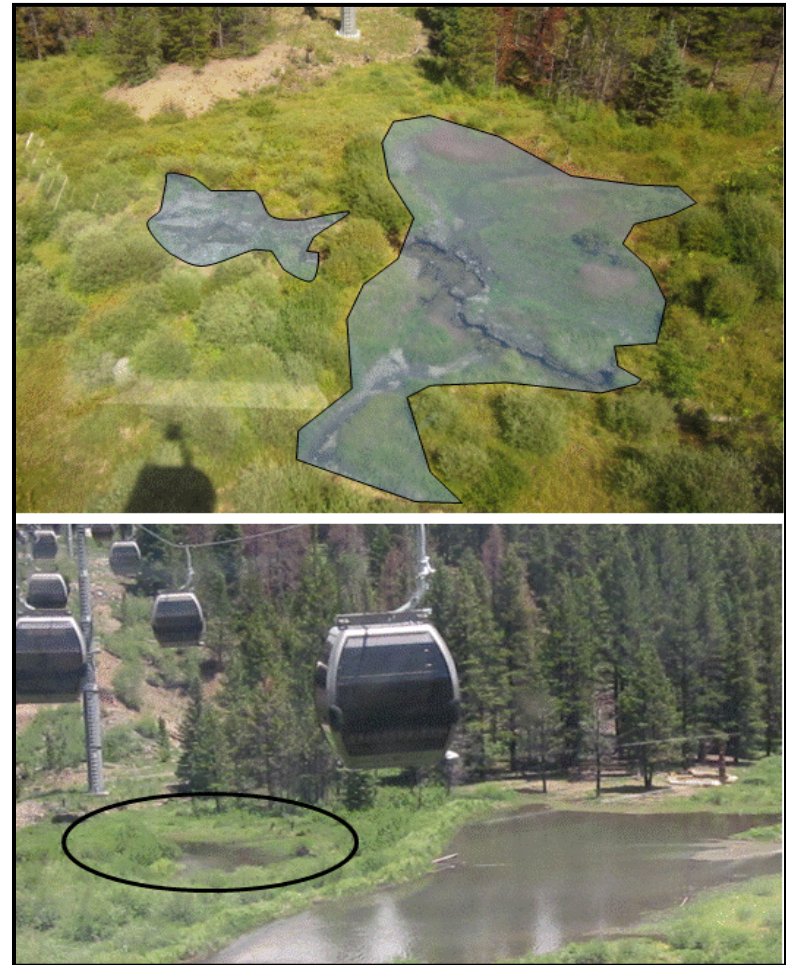
Photo 30. The upper photo (from September) shows two adjacent ponds which dried during 2011. The approximate extent of the ponds is shaded as if they were filled. One can see where a channel has cut through sediments in the old bed. The lower photo shows these ponds still full in early July, before their dams breached.

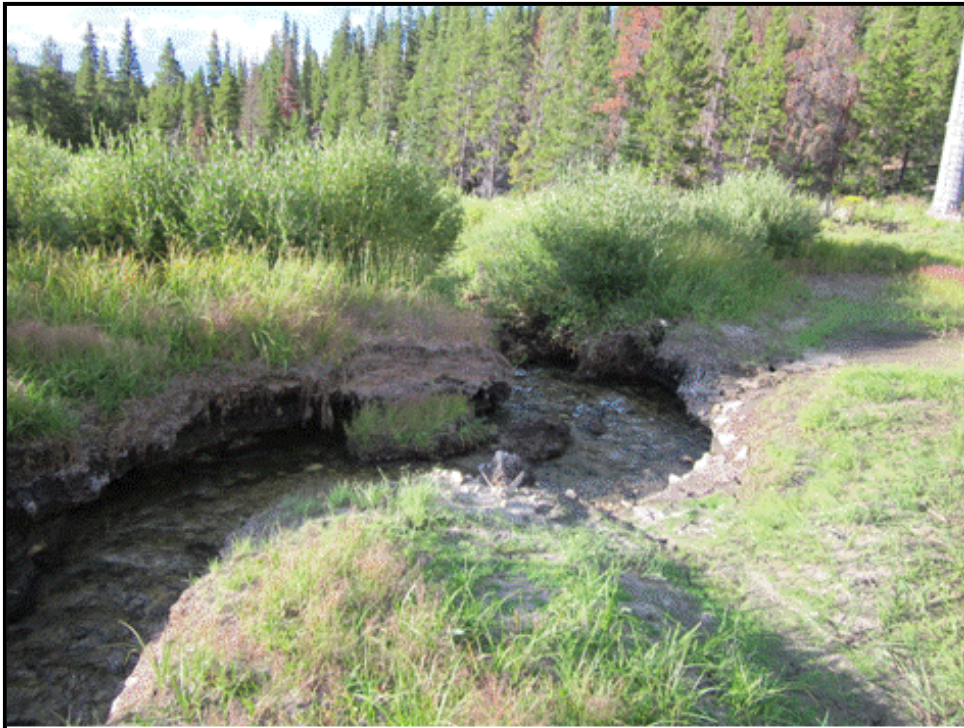
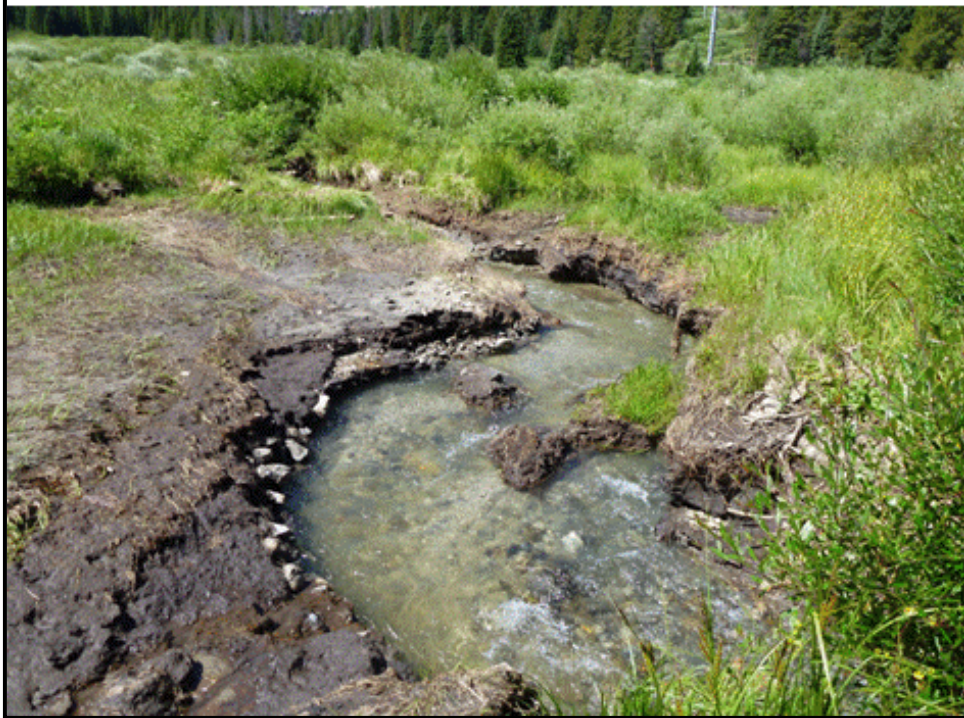
Photo 31. Two views of a new channel cutting through pond sediments and a breached dam in Lower CG are shown here. This channel is in the bed of the dried pond shown in Photo 34.
