TOWN OF BRECKENRIDGE
OPEN SPACE ADVISORY COMMISSION
Monday, January 21, 2013
150 Ski Hill Road

Open Space and Trails**2012 Cucumber Gulch Wetland Monitoring Report**

A report of baseline conditions and initial indications
of success for wetlands restoration

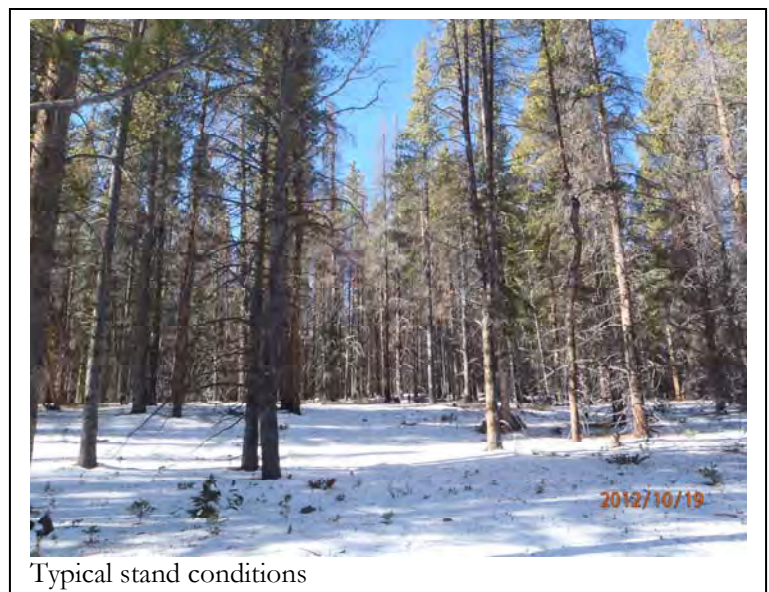
As much of the area around Breckenridge was historically logged during the mining era, subsequent lodgepole pine regeneration has produced fairly homogenous lodgepole pine stands across the valley. Average diameter breast height (dbh) of trees is 5 to 10 inches. Understory regeneration of seedling conifers in these lodgepole pine stands in general is marginal and patchy. Understory conifer species (where they do occur) generally consists of lodgepole pine, Engelmann spruce, or subalpine fir. Grasses and forb composition in the understory is dependant upon the individual stand location (slope and aspect). For instance, stands on hillsides where drainage is more rapid and sites are drier, understory cover and composition is more limited. Stands located on benches and on shallow slopes where topography is fairly

Typical stand conditions

Based on these factors, removal of MPB-killed lodgepole pine, and salvage of recently blown-down trees would be appropriate treatment. Additionally, removal of taller lodgepole pine and ground scarification would help improve stand diversity. Taller lodgepole pines are recommended for removal as they would likely blow-down if the stand is opened more than 30%, and they were left standing. Any spruce or subalpine fir trees should be retained.

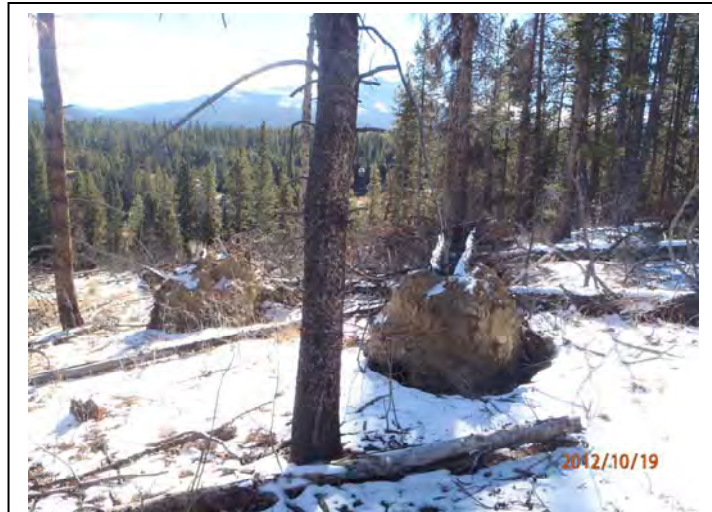
Recently blown-down trees at eastern edge of unit should be assessed for removal, or some trees may also be left for small mammal and subnivean habitats

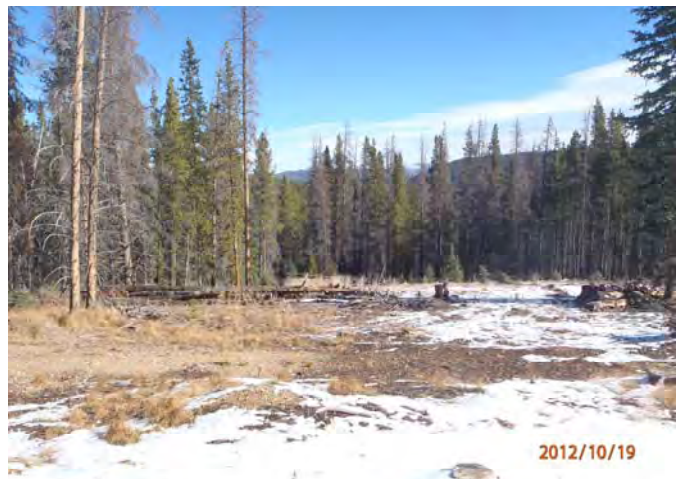
The site already has a recently used log-landing area, which should be used again, scarified and reclaimed using a native grass seed mix.
