TOWN OF BRECKENRIDGE  
*OPEN SPACE ADVISORY COMMISSION*  
Monday, February 17, 2014  
2<sup>nd</sup> floor, Stephen C. West Ice Arena  
189 Boreas Pass Road

**Memorandum**

**2013 Wetlands Monitoring in Upper Cucumber Gulch Preserve  
Breckenridge, CO:  
Restoration performance monitoring**

## CHANNEL RESTORATION IN UPPER CUCUMBER GULCH

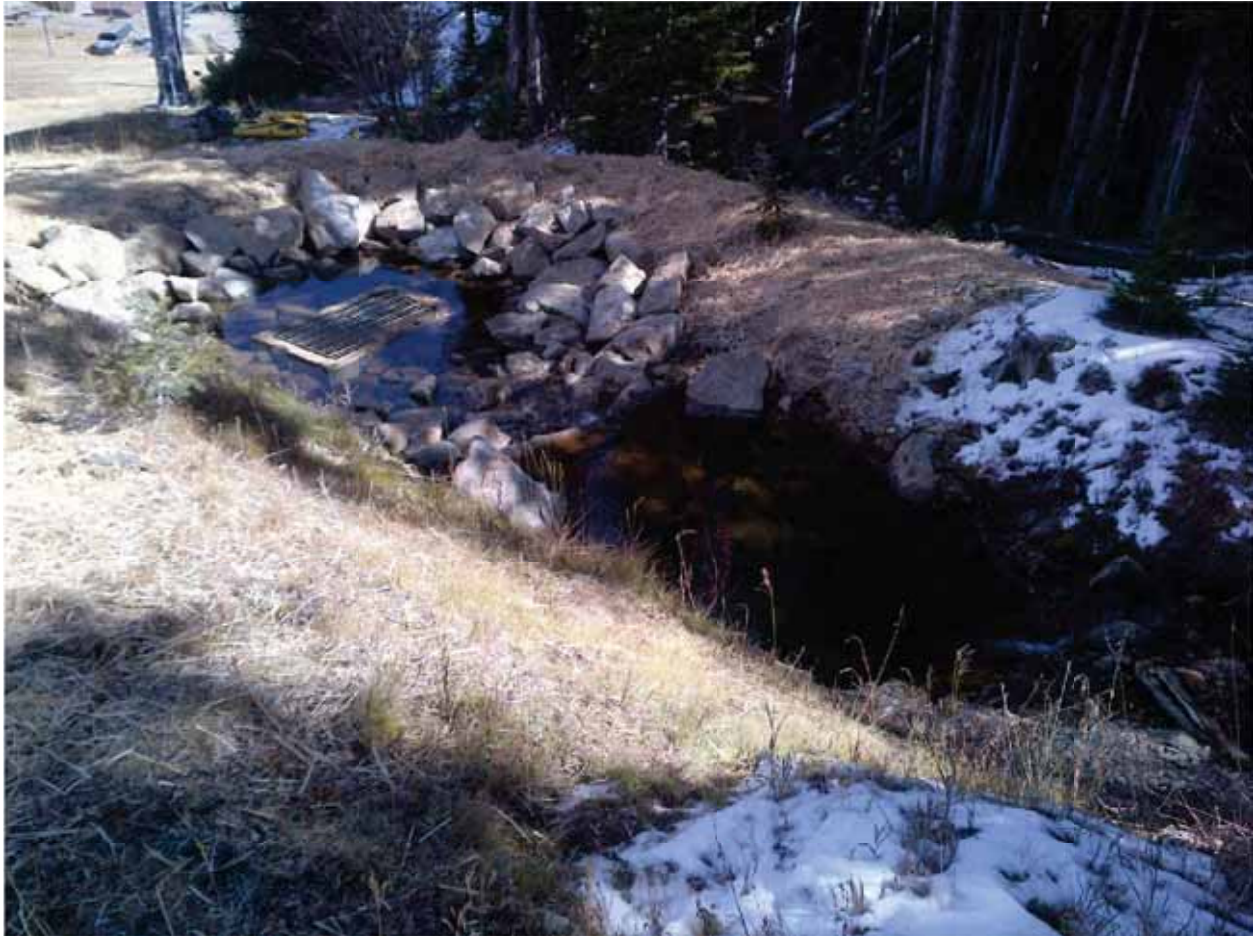
**Photo C1.** *This photo shows one of the intakes to the Boreas Creek culvert on the ski area within the contributing watershed. The sediment retention pond upstream of the grated intake was constructed in 2013 in an effort to reduce the volume of sediment transferred from the ski area to Cucumber Gulch through Boreas Creek. The volume of the retention pond is approximately 3 CY. The pond did not appear to capture a measureable amount of sediment in 2013.*

No additional on-site remedial actions appear necessary at this time. Off-site, non-regulatory remedial actions are being taken within the contributing watershed. Our 2011 report specifically identified high levels of allochthonous sediment as a primary stressor to CGP wetlands. This sediment originates on the Peak 8 portion of the Breckenridge Ski Area and other developments upstream of CGP, and is carried to the site via Boreas Creek. We specifically recommended application of sediment BMPs on the ski area to decrease sediment stress to the wetland habitats in Cucumber Gulch. Monitoring these efforts in the contributing watershed is beyond the scope of this report, but the Town has reported that some efforts in this realm were being made in 2012, including a new small retention pond at one of the Boreas Creek culvert inlet structures (see Photo C1).

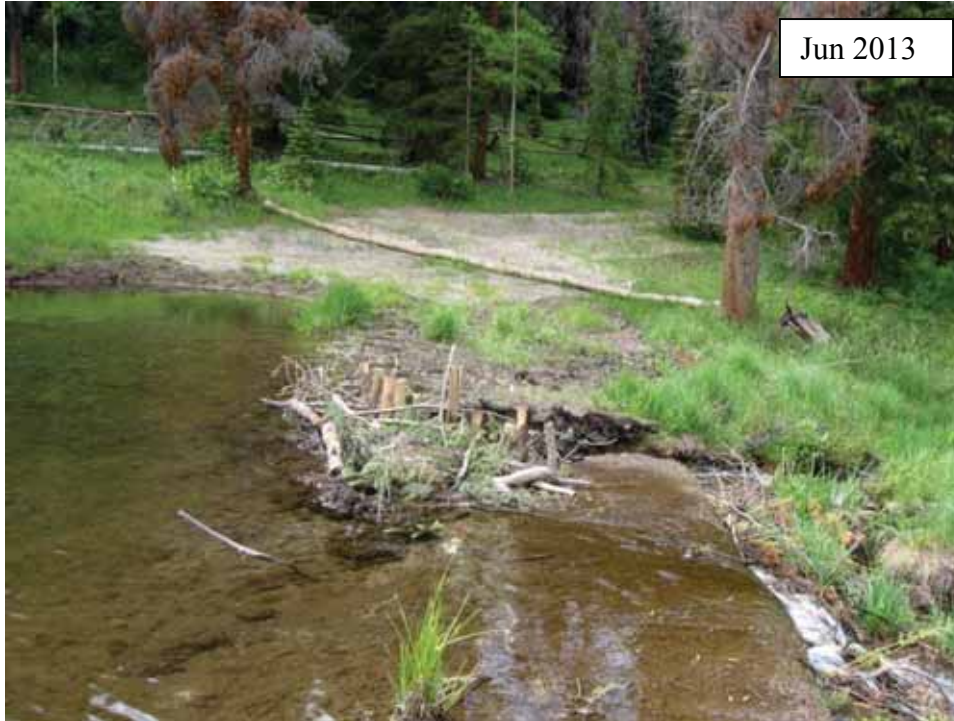
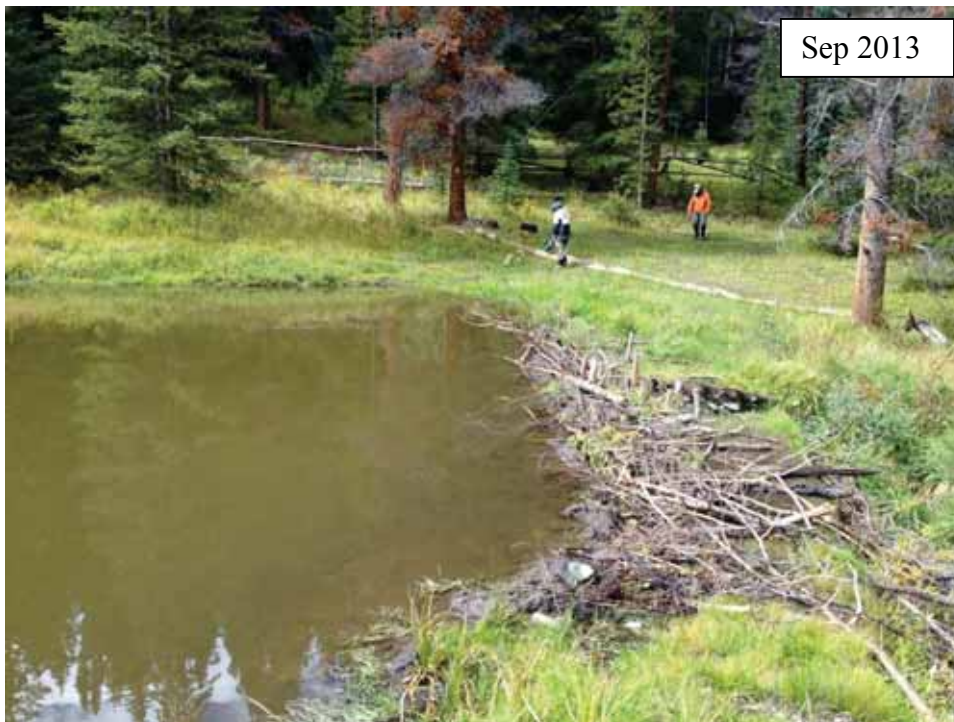
**Photo C2.** *In June of 2013, a channel began to cut around the repaired plug in the reset pond dam. Town staff arrested the breach with a structure composed of brush packed against vertical poles driven into the ground (upper photo). This temporary structure was meant to mimic a beaver dam and was intended to prevent water from concentrating in the eroding channel until such time that beavers reoccupied the pond, which occurred later that season (lower photo).*

During runoff in 2013, a channel cut began eroding through the newly repaired reset pond dam. Town staff acted quickly to plug the breach with a temporary structure made of brush seated against wooden poles that were driven into the ground (see Photo C2). By mid-August, a pair of juvenile beavers had moved into the reset pond and began working the dam, including the section repaired by the Town, and the dam is now a continuous structure across this section that held through the 2013 season.

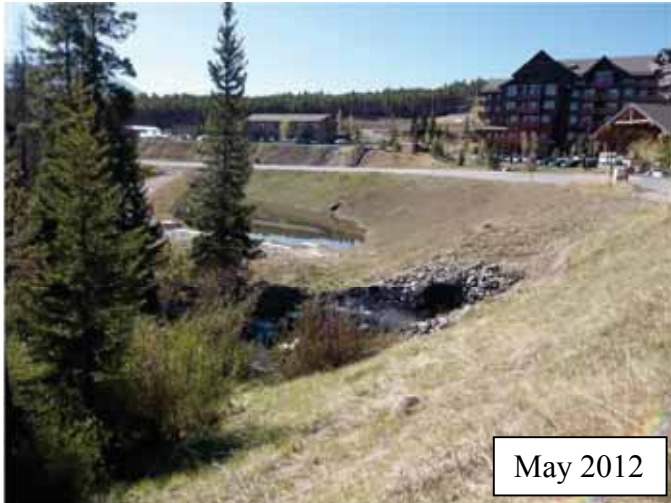
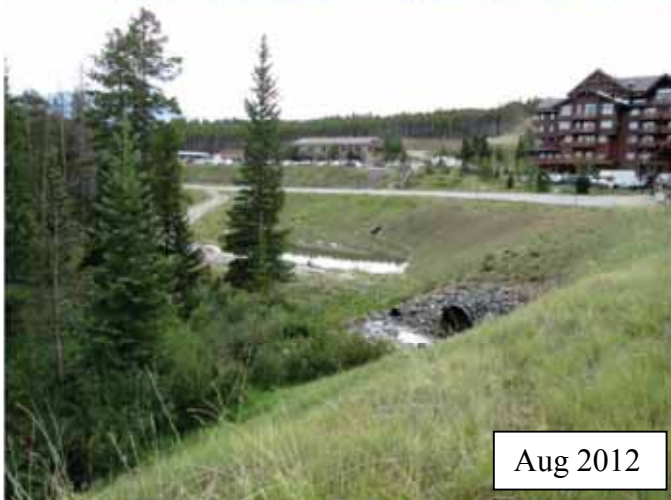
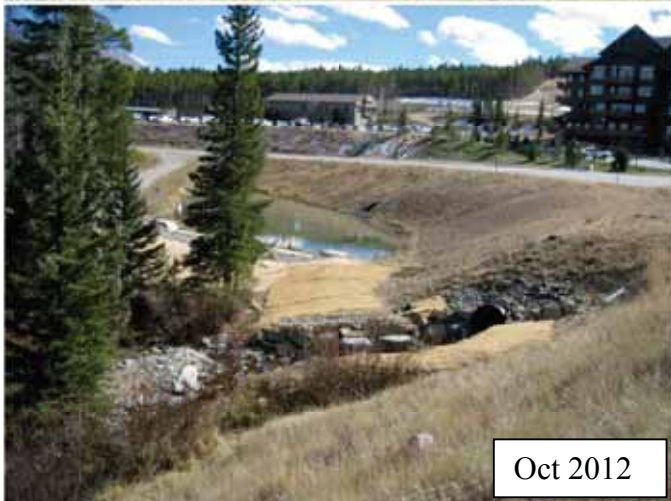
**Photo C4b.** *Photopoint 2b, 2013. The restoration project included reconstruction of the culvert outlet structure and revegetation. The construction in the lower photo is for drainage from a new parking lot and hotel building. It is unrelated to the project.*

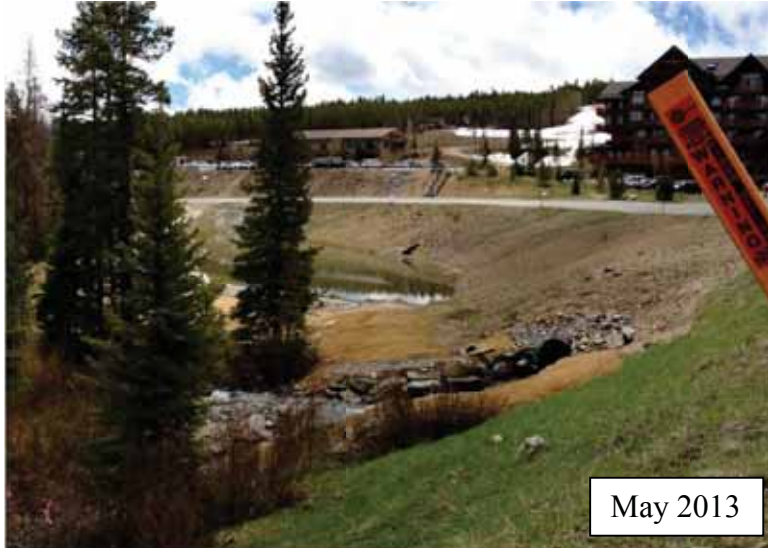
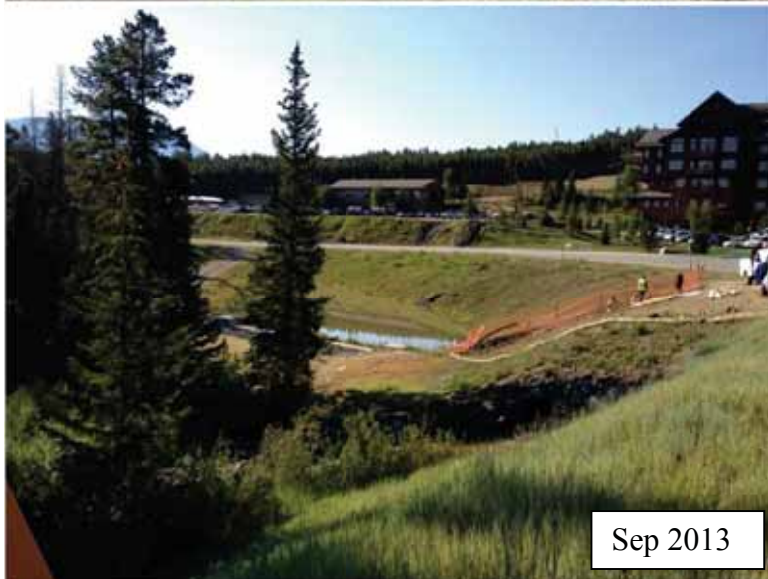
**Photo C5a.** *Photopoint 3a, 2012. The photos show the development of treatments at the head of the Upper CG project area including reconstruction of the culvert outlet structure, a lateral distributary channel, and revegetation.*

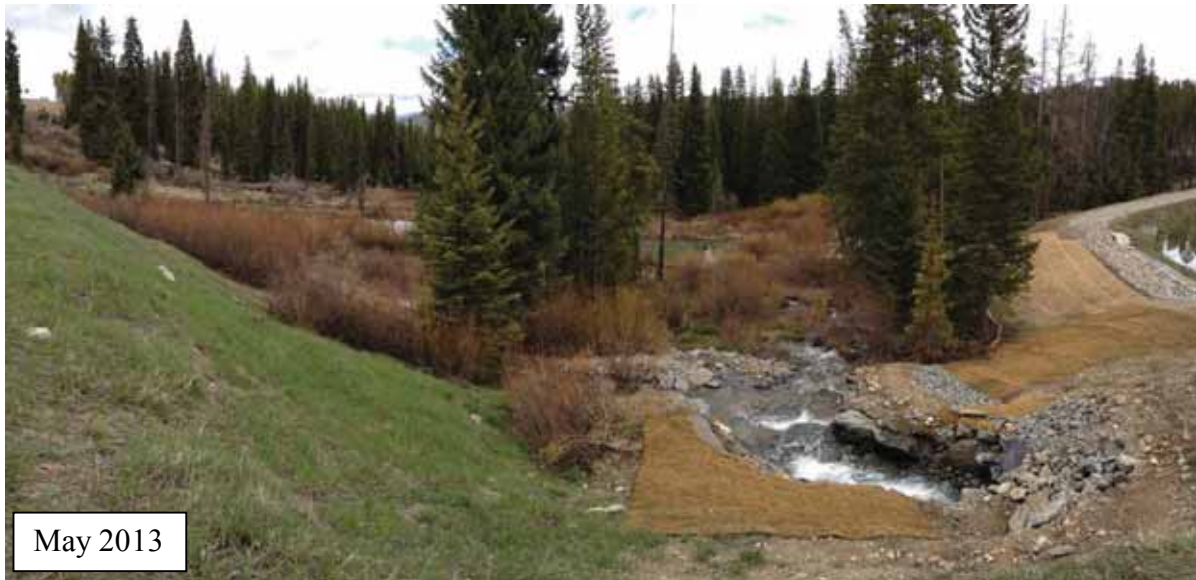
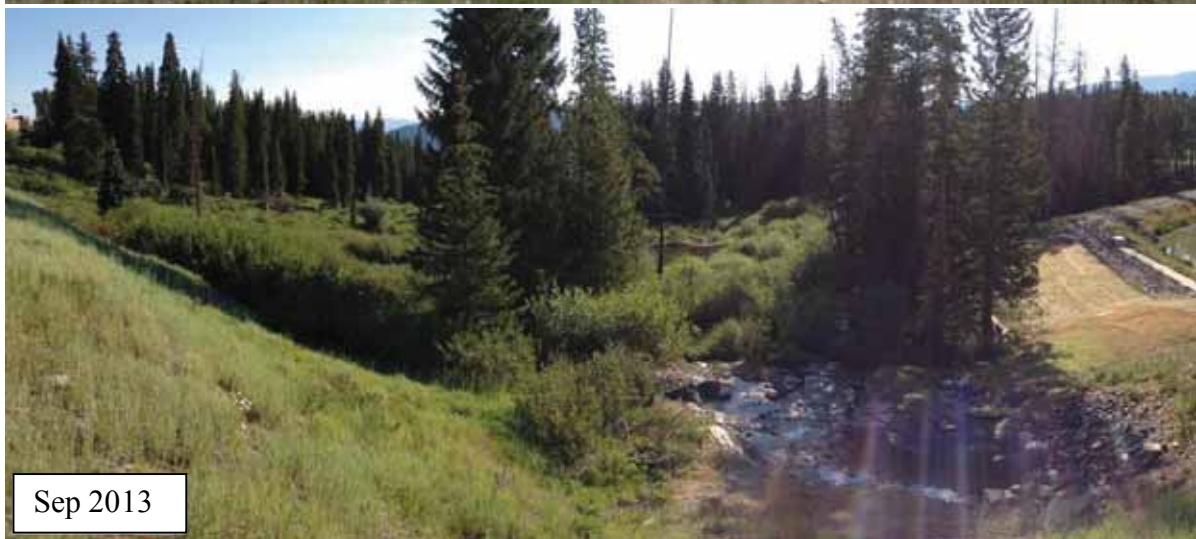
**Photo C6a.** *Photopoint 3b, 2012. A closer view of the Boreas Creek culvert outlet.*

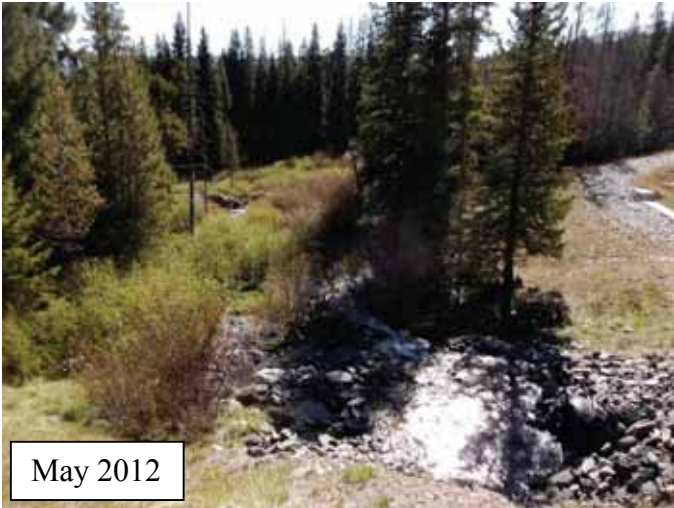
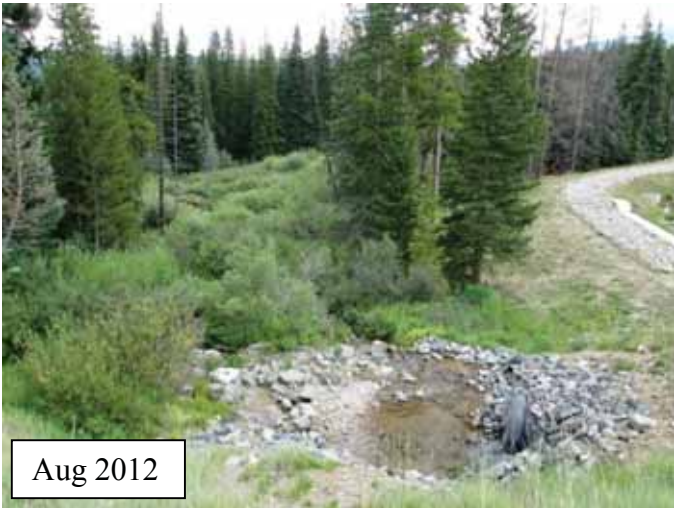
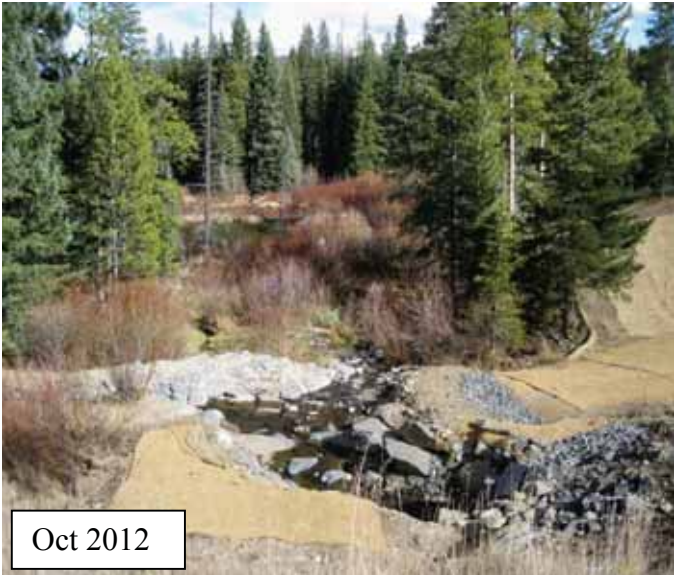
**Photo C6b.** *Photopoint 3b, 2013. The Boreas Creek culvert outlet. The flows seen in the photo from May are typical of snowmelt runoff. The low in the September photo shows runoff from a small thunderstorm. Note the severe turbidity.*

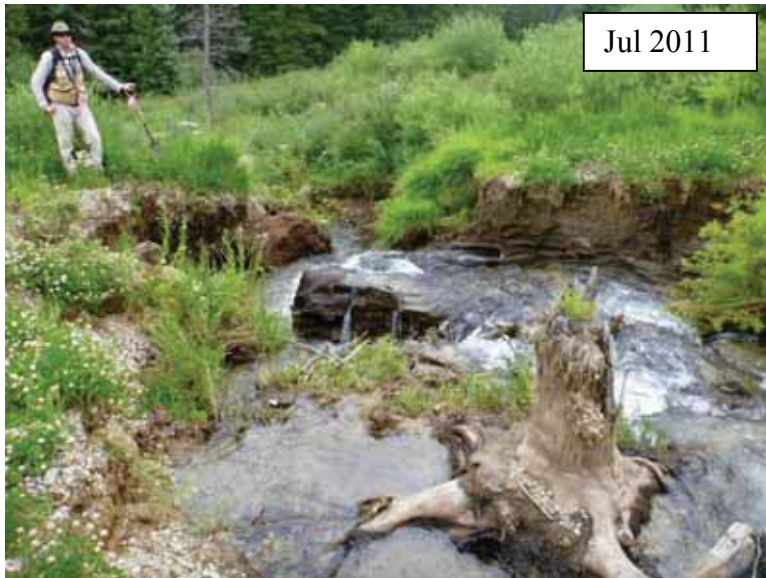
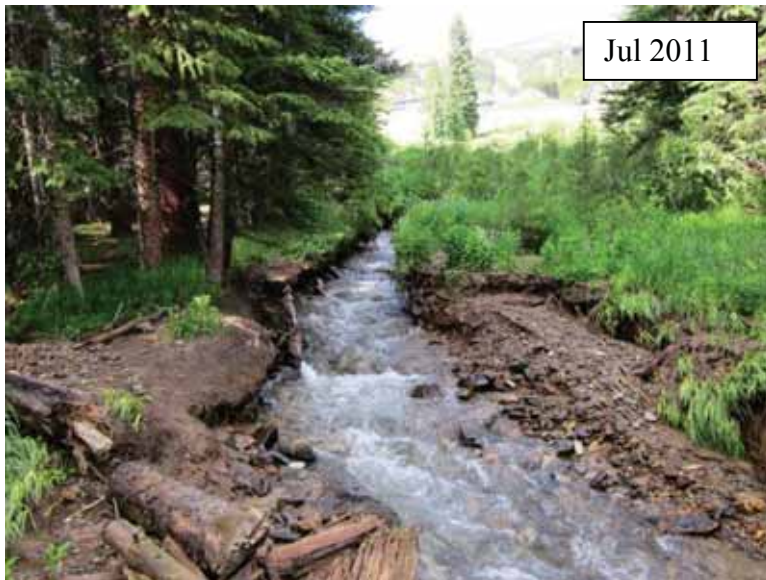
**Photo C8.** One of the treatments aimed at improving water source and distribution was construction of a lateral distribution channel that draws water from just downstream of the Boreas Creek culvert to spread it northward along the toe of the road fill at the head of Upper CG. The upper photo and the lower right photo shows the alignment of the new channel (shown in green) and the main channel of Boreas Creek (shown in blue) just after construction in October, 2012. The lower right photo shows a segment of the new channel in August, 2013.

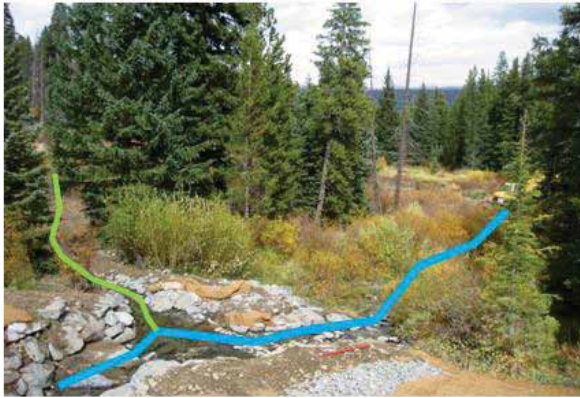
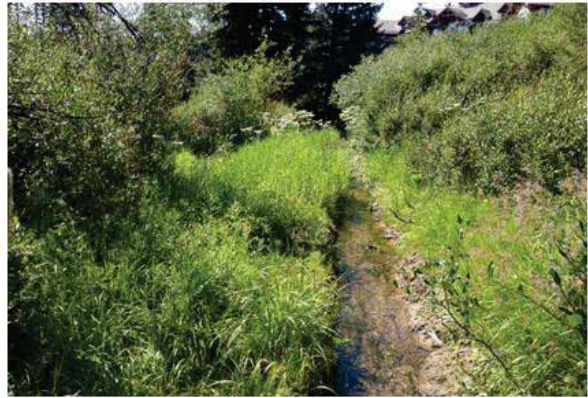
**Photo C9a.** *Photopoint 1, 2012. The restored pond in the foreground is the spreader pond. Prior to restoration (upper two photos) water entering Upper CG was confined to the south edge of the wetland within the incised Boreas Creek channel, leaving the bulk of the wetland area in the foreground high and dry. When full, (lower photo) this pond distributes water laterally across the wetland area, feeding distributary channels and maintaining high water table.*

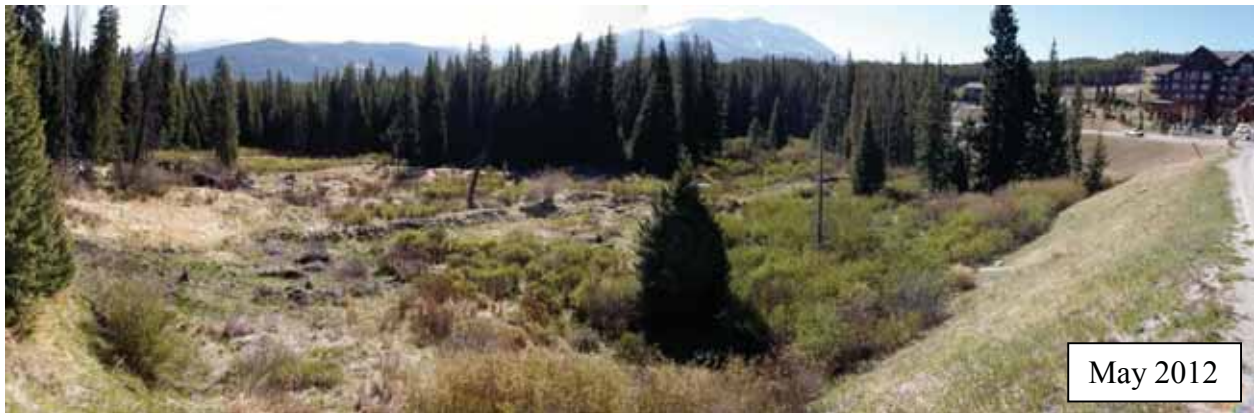
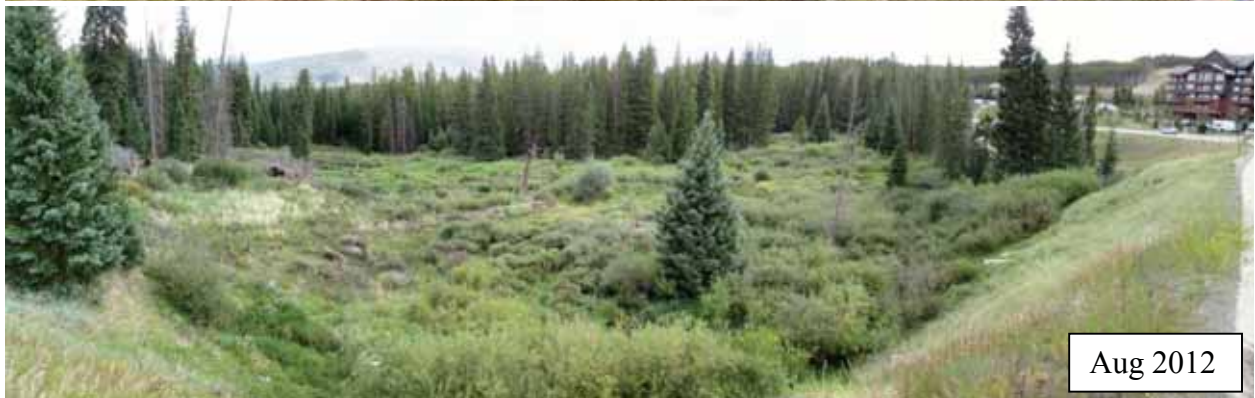
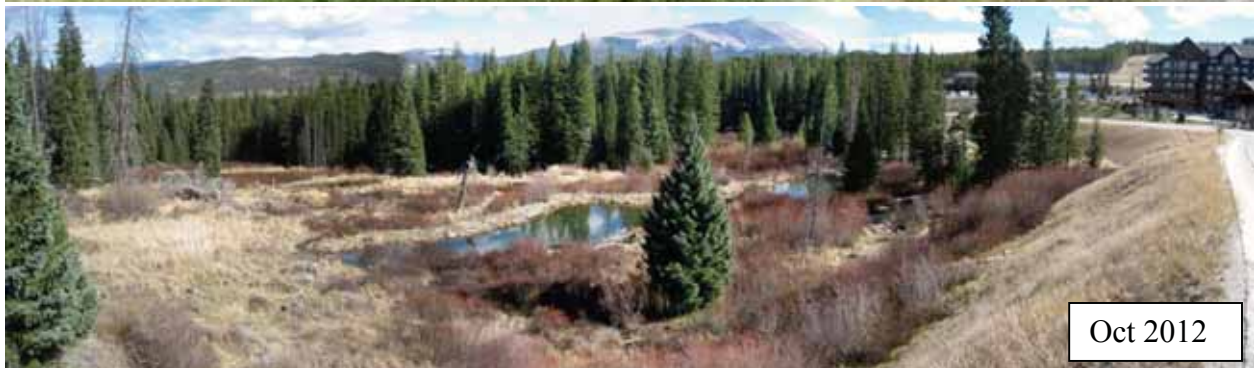
**Photo C9b.** *Photopoint 1, 2013. The photos show how the spreader pond consists of two cells, with the northeast cell on the right and the southwest cell on the left. The northeast cell was built to function as a sediment retention pond, and in the lower photo which was taken just after a thunderstorm, one can see how turbid that cell is compared to the southwest cell. The photo from September was also taken after beavers had moved in and completed the dam. Beavers effectively blocked the spillway channel that used to exit the pond on the west (left) end to raise the stage of water in the spreader pond by about 1 foot.*

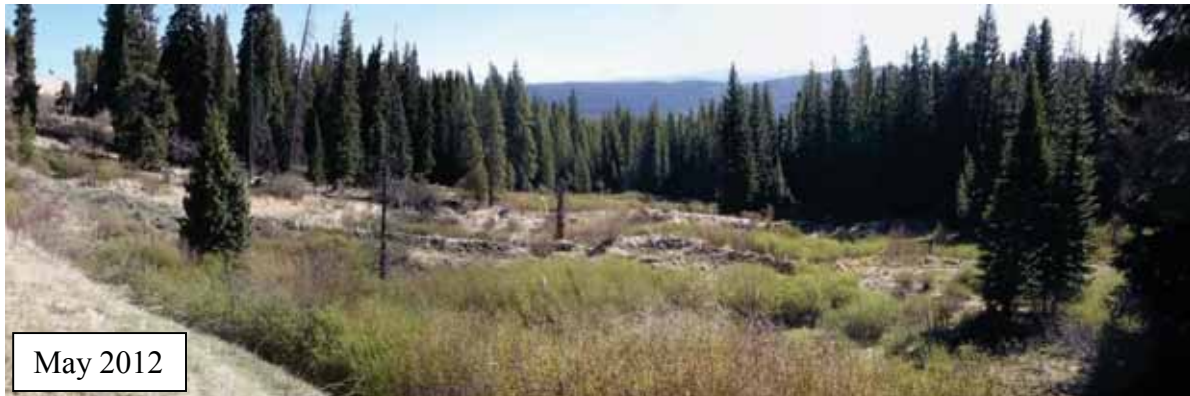
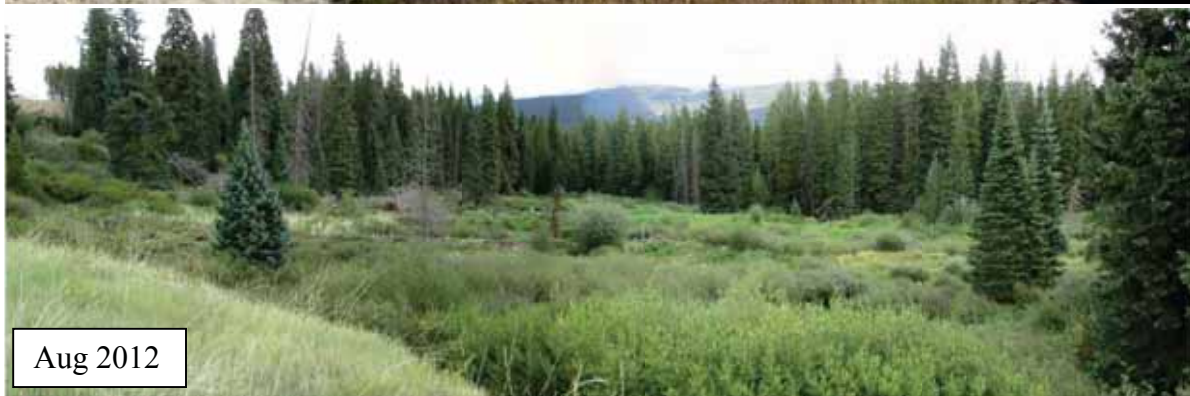
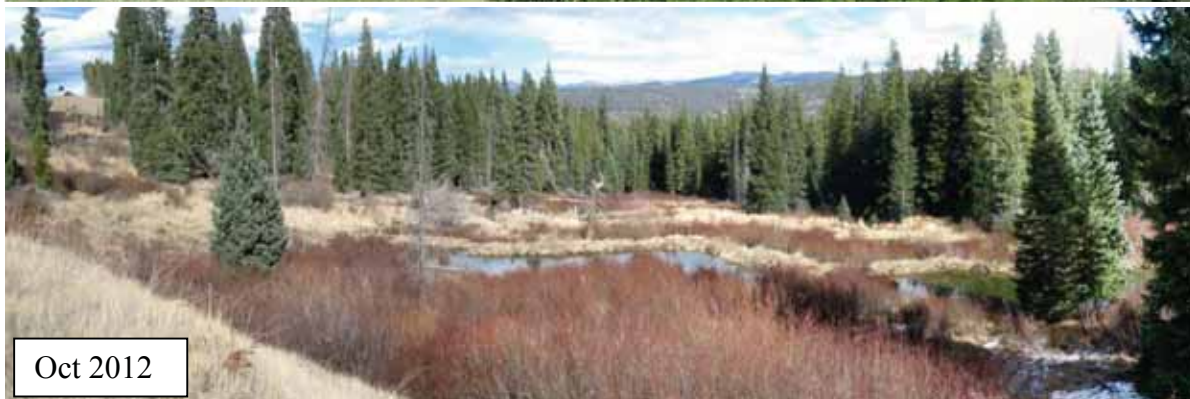
**Photo C10b.** *Photopoint 2a, 2013. The photos show the spreader pond restoration through 2013. In the lower photo from September, one can see how turbid the water in the northeast cell becomes after a thunderstorm which is indication of its intended function as a sediment retention pond. The stage of water in the ponds are higher in the lower photo as well, owing to beavers completing and elevating the pond dams.*

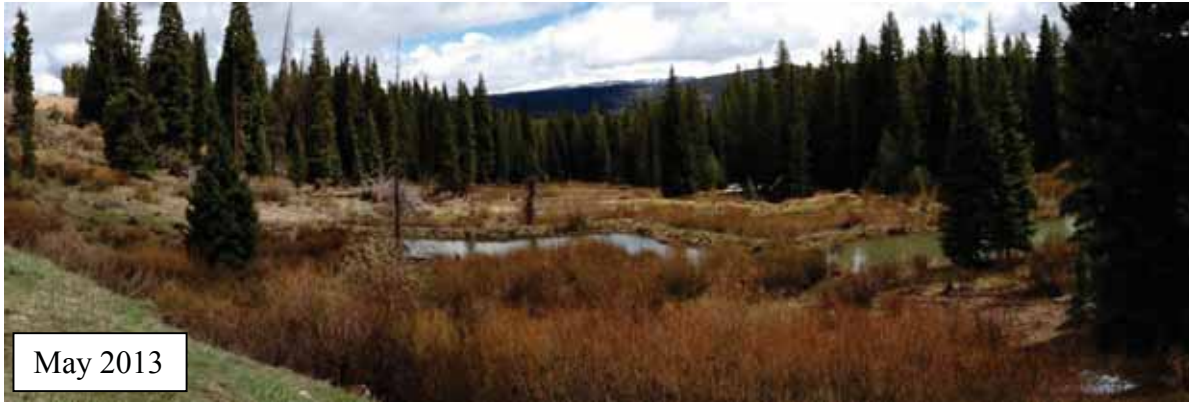
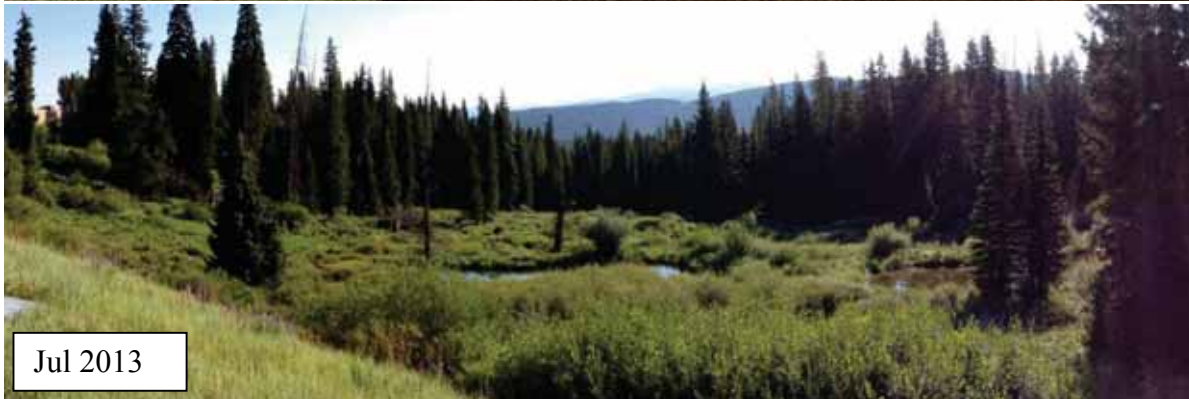
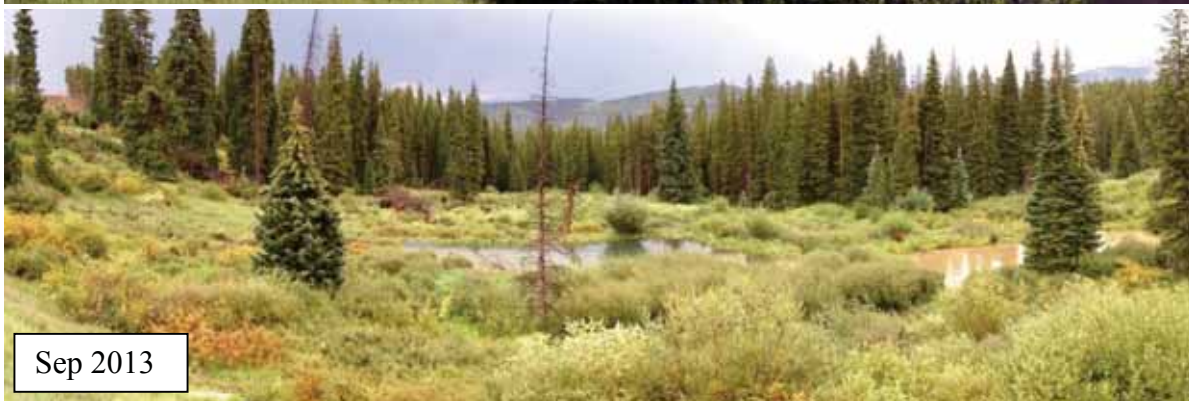
**Photo C11a.** *Photopoint 28, 2012. Spreader pond area seen from the west.*

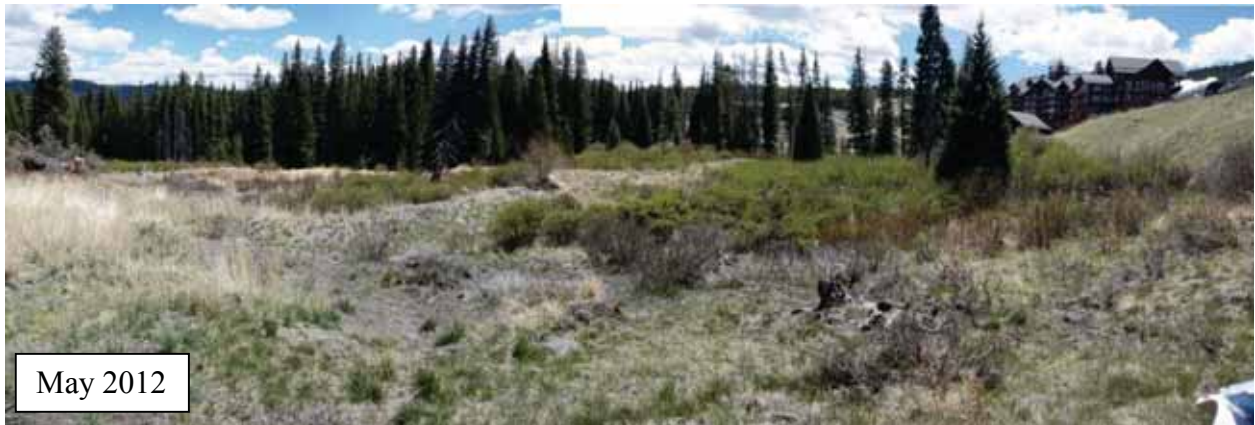
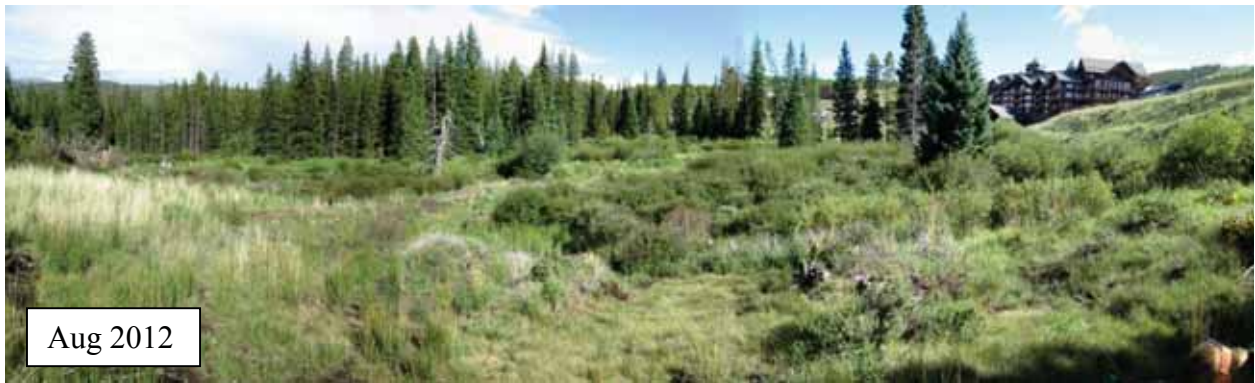
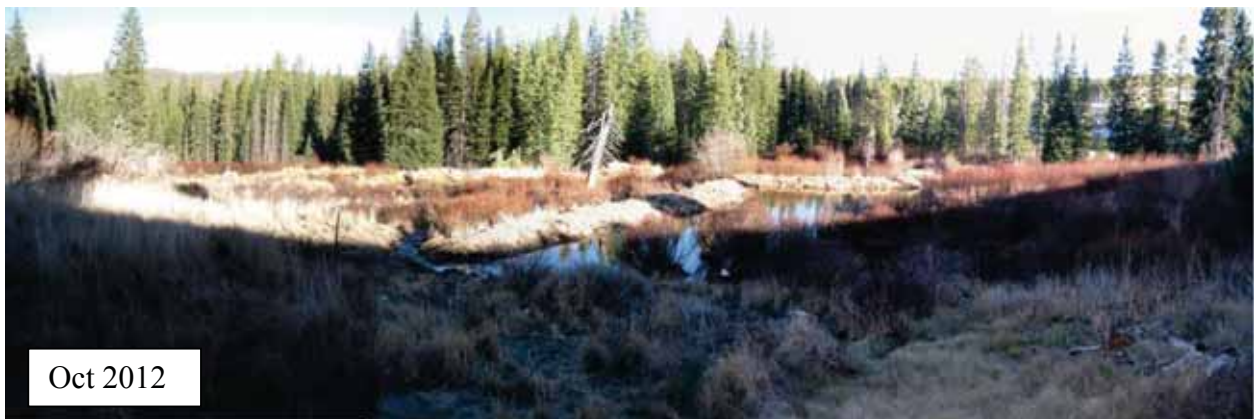
**Photo C11b.** *Photopoint 28, 2013. Spreader pond seen from the west side.*

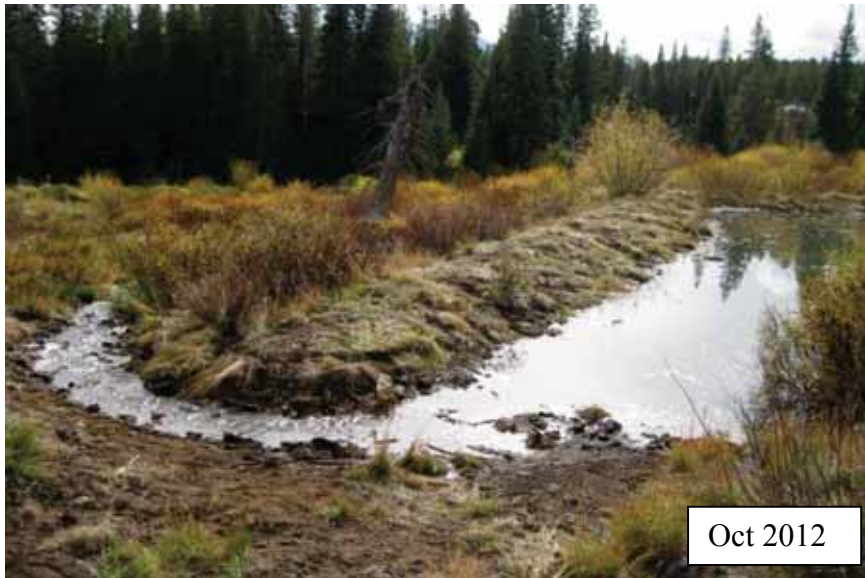
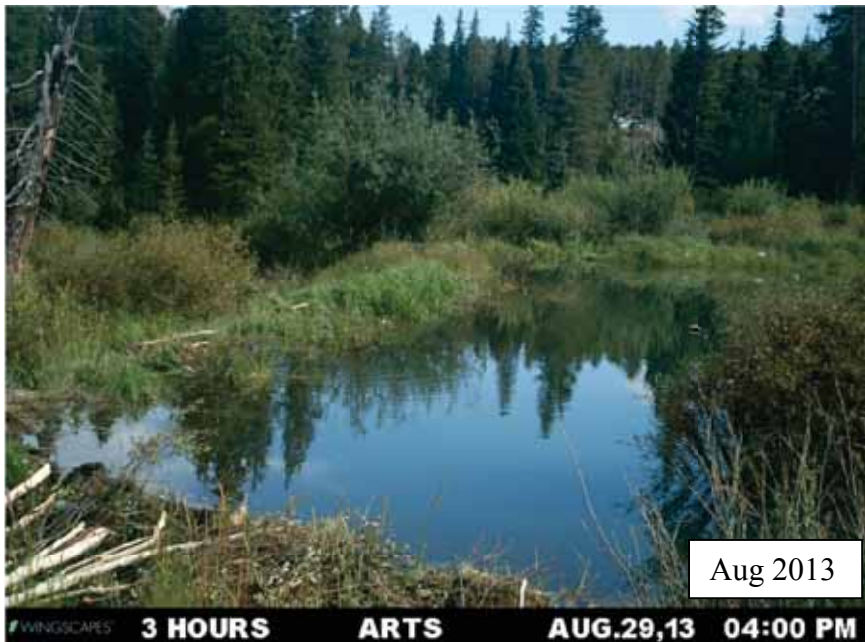
**Photo C13a.** *Photopoint 26, 2012 shows the lower portion of the Upper GC project area where ponds were restored during phase 1.*

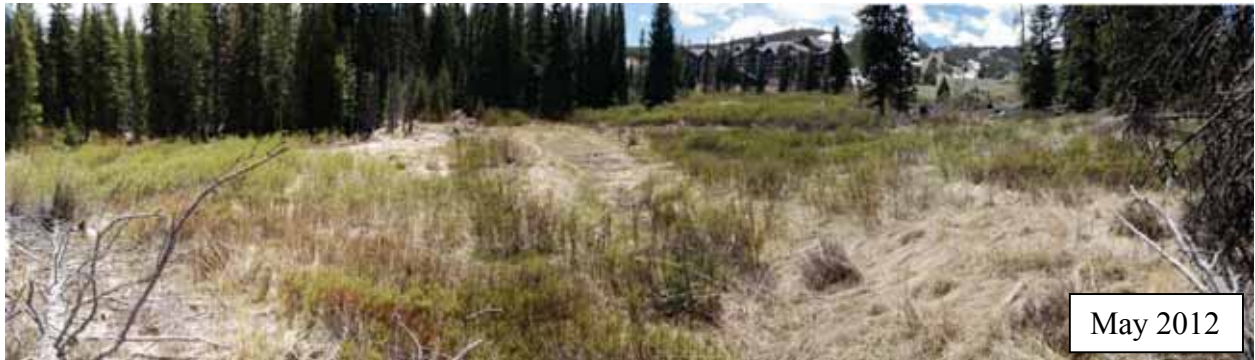
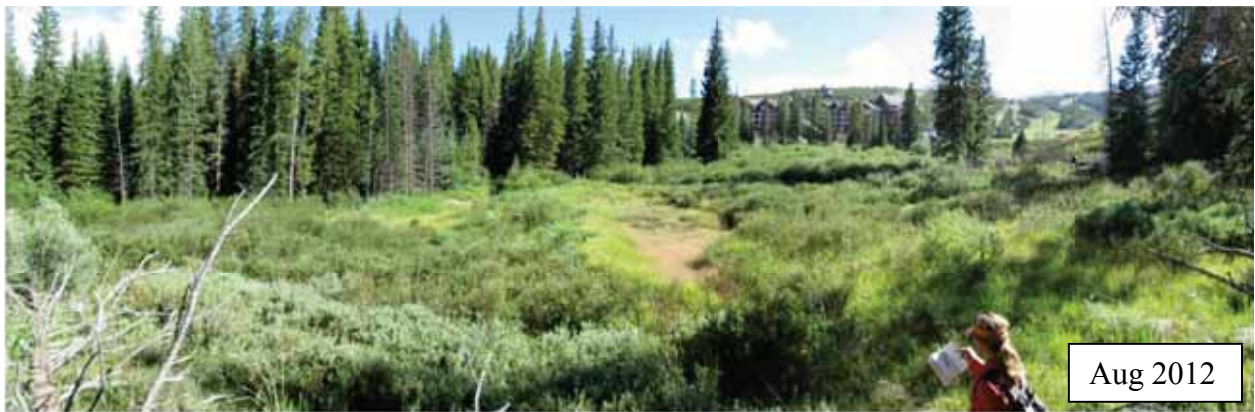
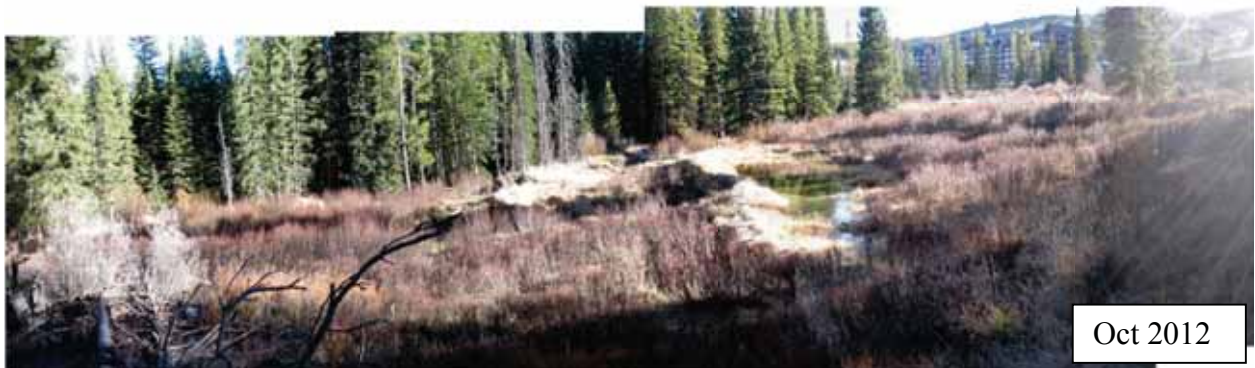
**Photo C13b.** *Photopoint 26, 2013. The stage of the ponds raised during 2013 after beavers reoccupied the area.*

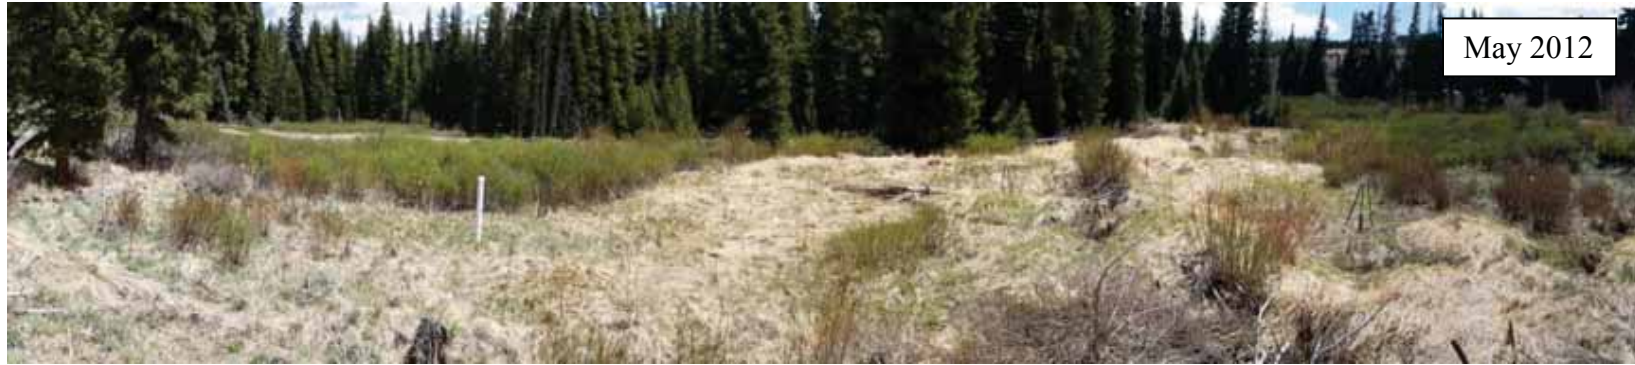
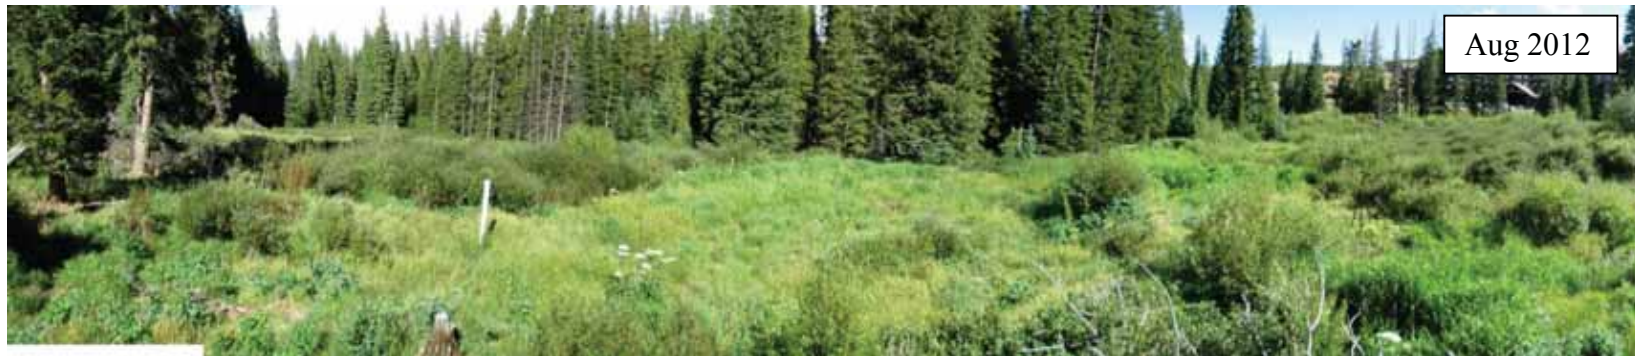
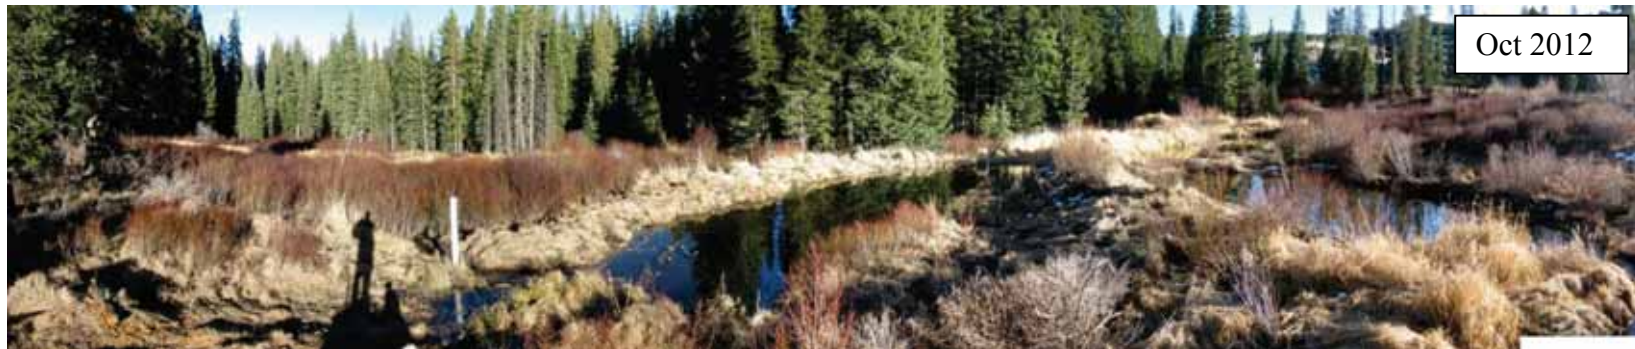
**Photo C14a.** *Photopoint 27a, 2012. The photos show pre-project condition followed by restoration of the ponds in the center of Upper CG.*

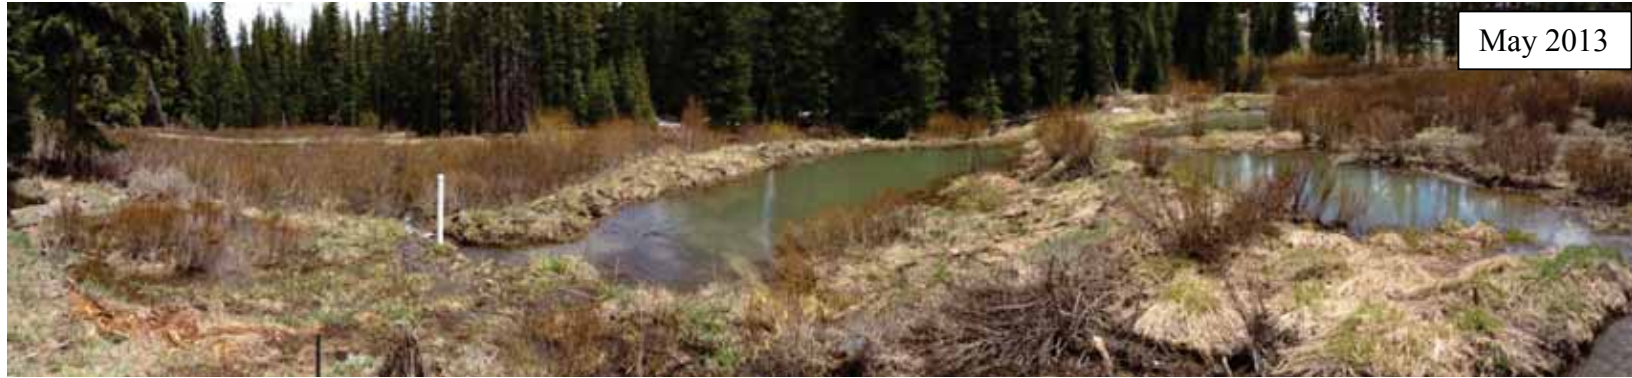
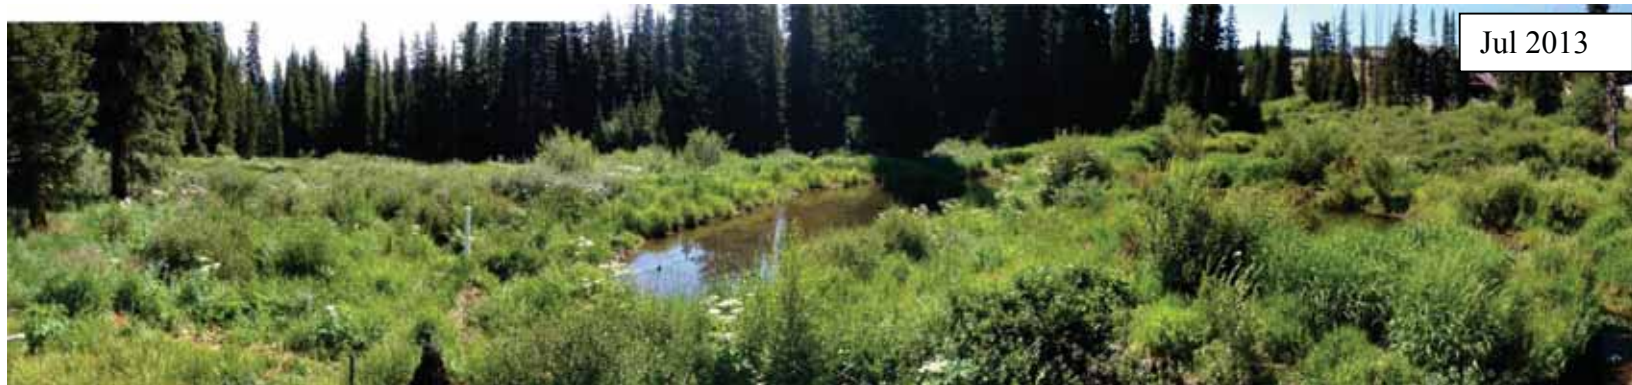
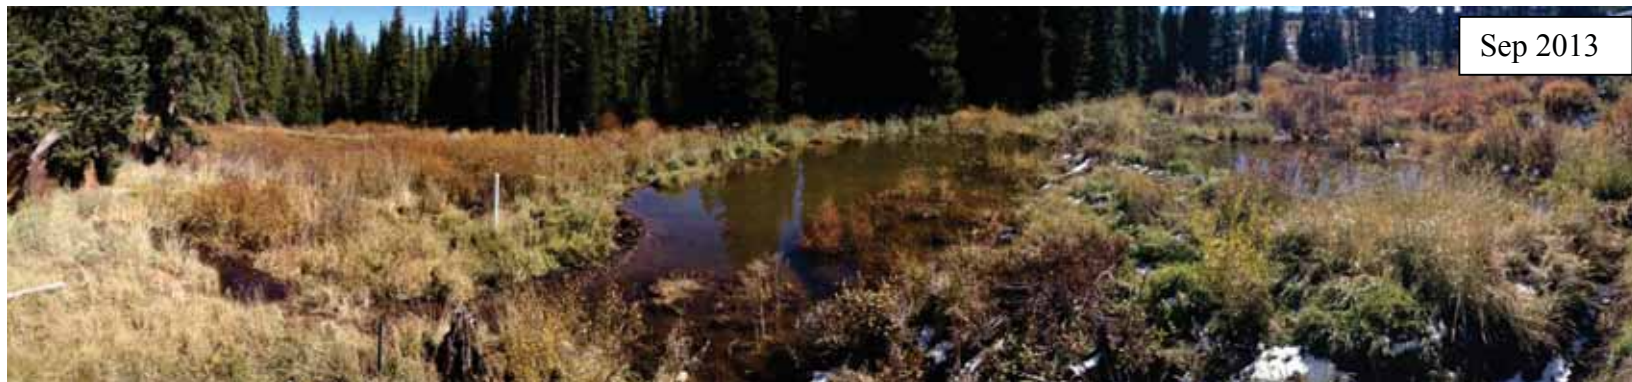
**Photo 14b.** *Photopoint 27a, 2013. In August, beavers reoccupied the area and began maintaining the dams, including plugging the spillway channel which raised the stage of the pond in the center of the photo by about 1 foot, which spread surface water laterally.*
