TOWN OF BRECKENRIDGE  
*OPEN SPACE ADVISORY COMMISSION*  
Monday, February 17, 2014  
2<sup>nd</sup> floor, Stephen C. West Ice Arena  
189 Boreas Pass Road

**Memorandum**

**2013 Wetlands Monitoring in Upper Cucumber Gulch Preserve  
Breckenridge, CO:  
Restoration performance monitoring**

## CHANNEL RESTORATION IN UPPER CUCUMBER GULCH

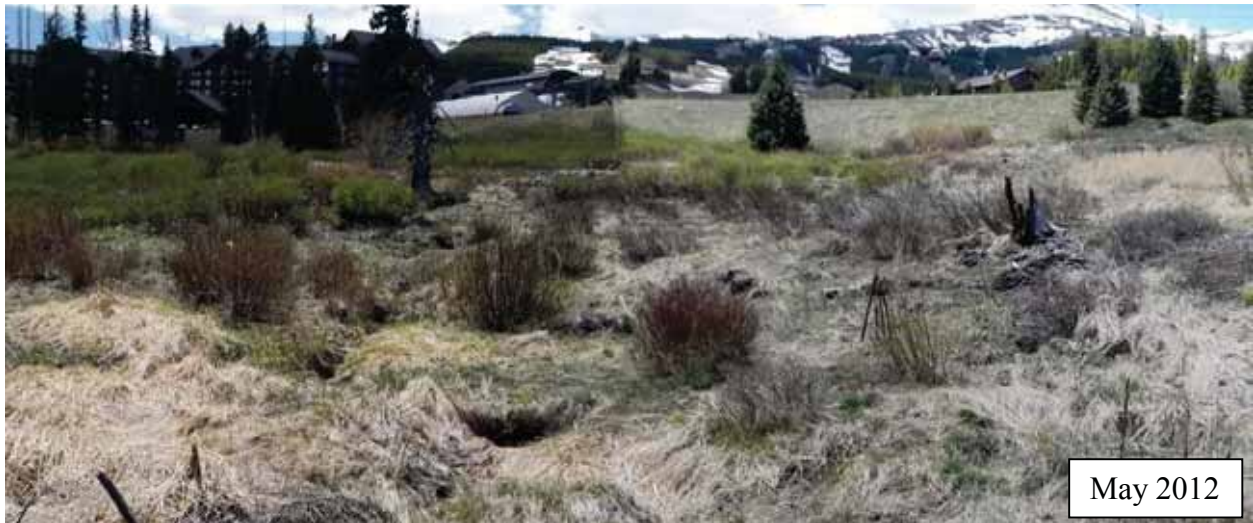
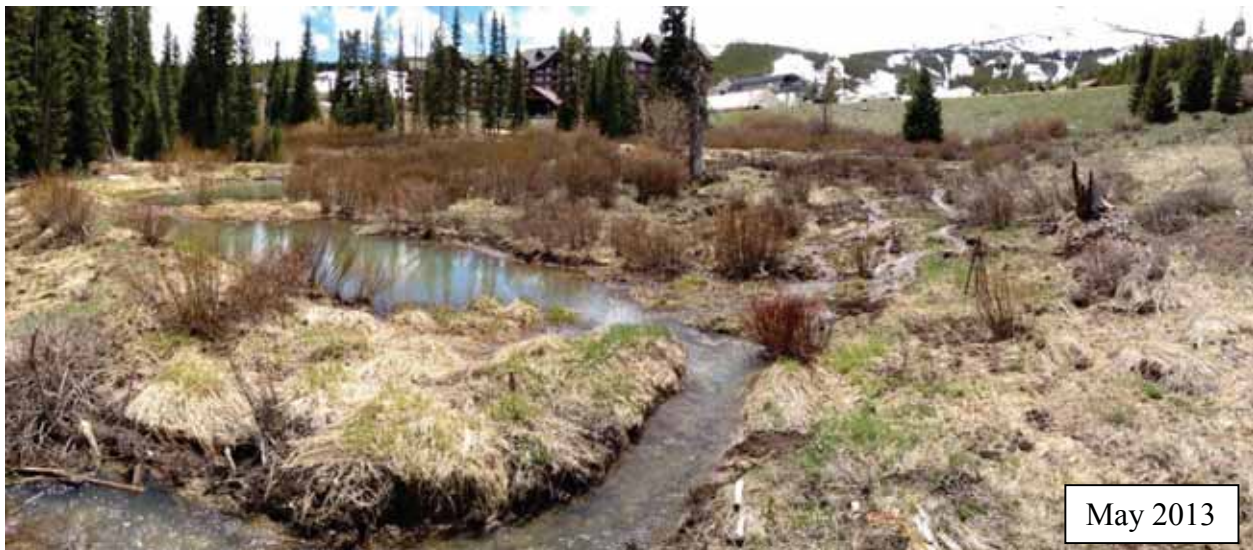
**Photo C15.** *Photopoint 27b, showing a comparison of 2012 to 2013 conditions in May. The photos document the restoration of pond habitat and water distribution channel in the central portion of Upper CG.*

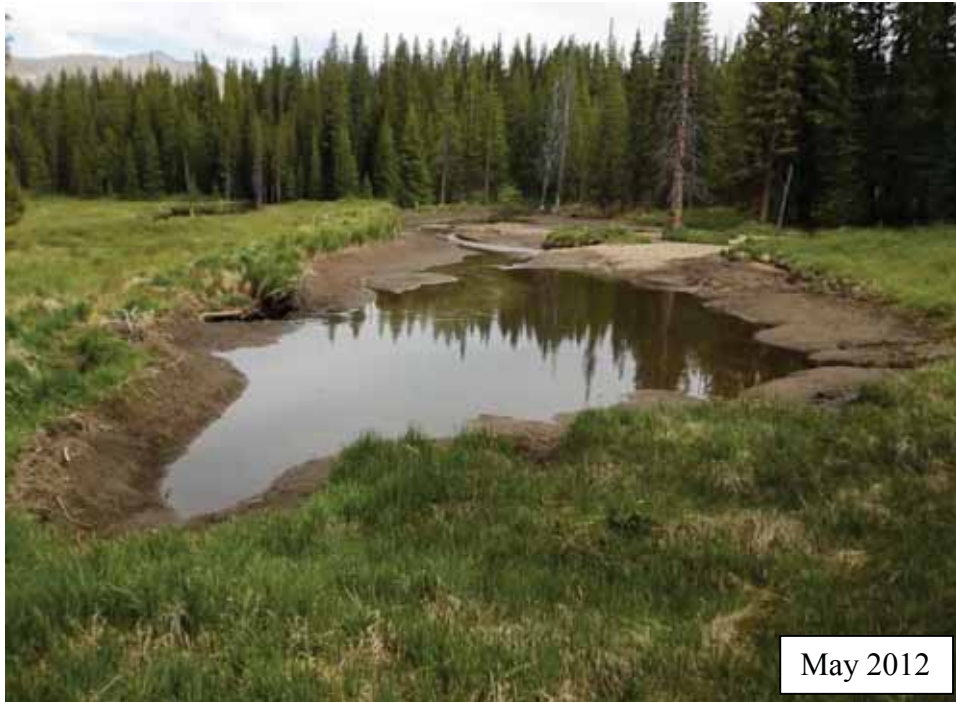
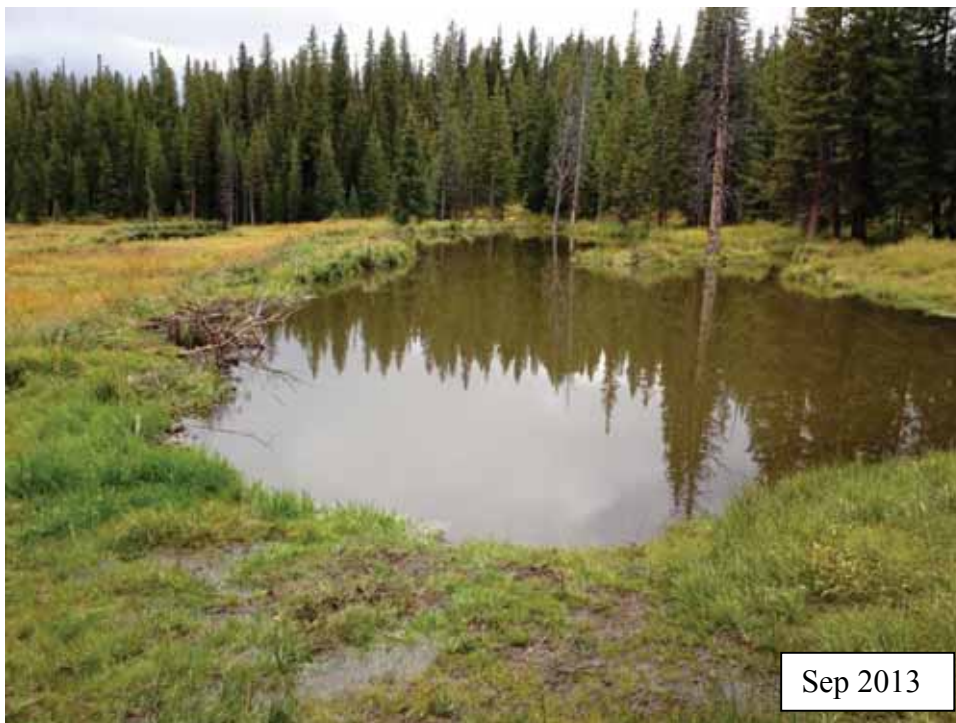
**Photo C16.** *Photopoint 21. The reset pond is where water flows from Upper to Lower CG. Prior to restoration in 2012 (upper photo) a breach in the dam captured all water outflow which lowered the water table and dried up the numerous distributary channels that normally feed wetland areas downstream and to the south. After restoration and re-occupation by beavers, the reset pond was again able to provide an elevated water table and active distributary channels.*

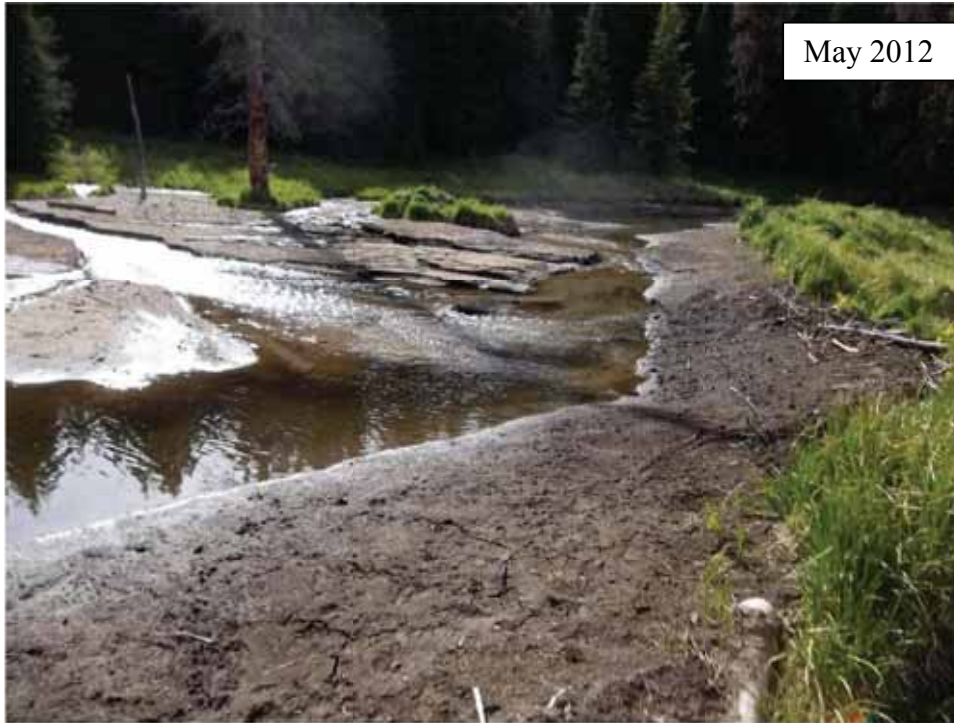
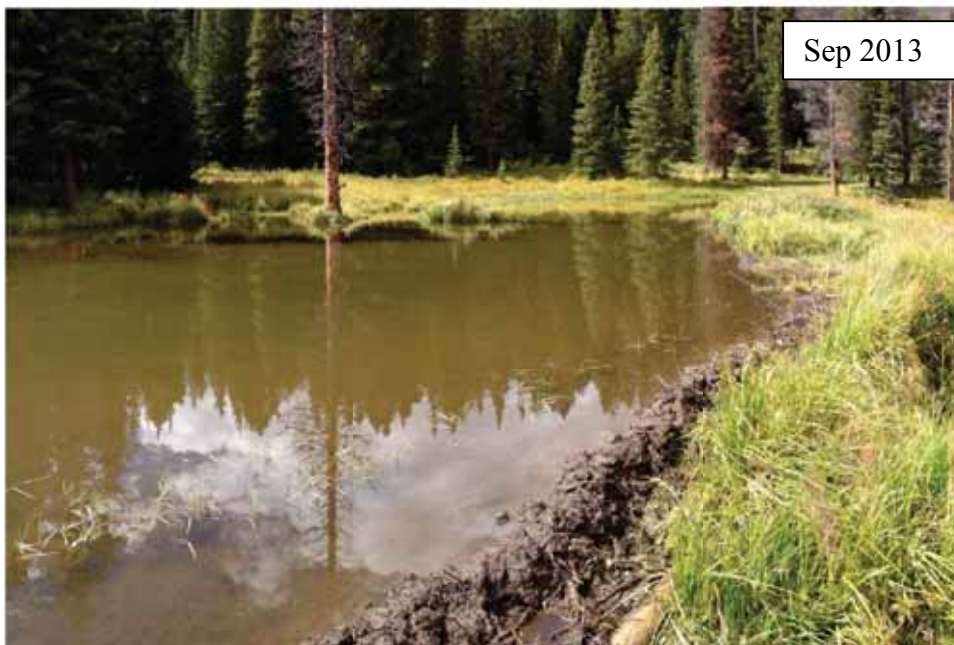
**Photo C17.** Another view of the reset pond before and after restoration treatments which were made to repair the dam and dredge sediments from the pond. In the lower photo, the mud sill along the dam was created by beavers that re-occupied an abandoned lodge in this pond which, prior to dredging, had lost connection with the pond due to accumulating sediments.

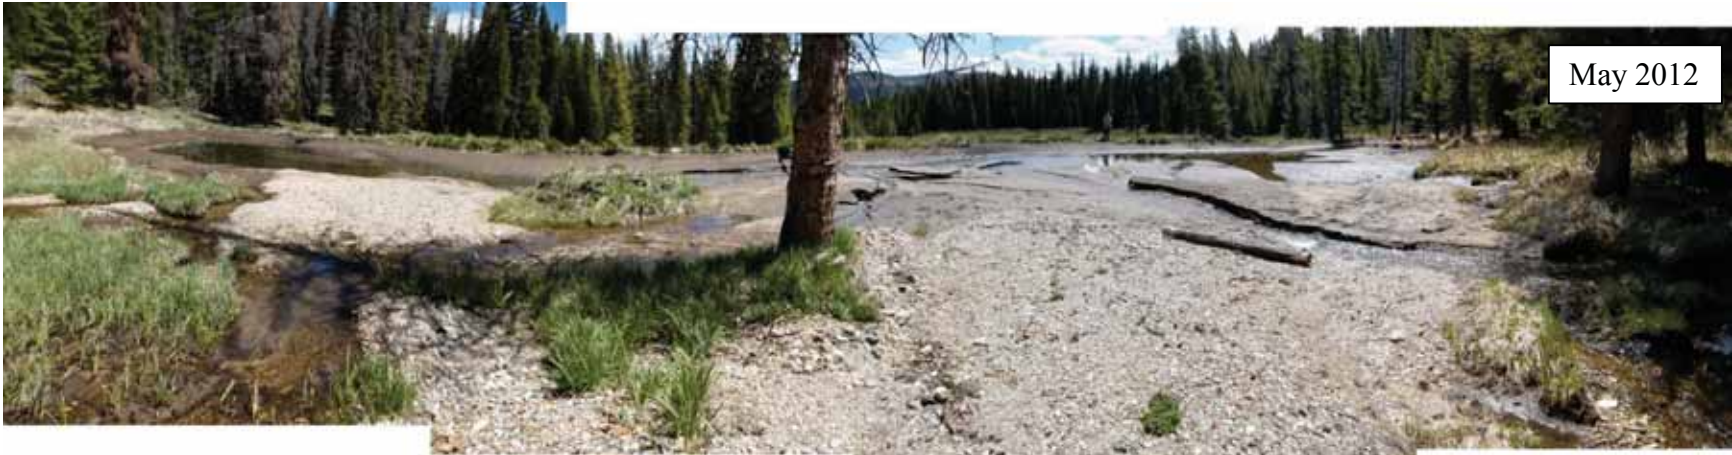
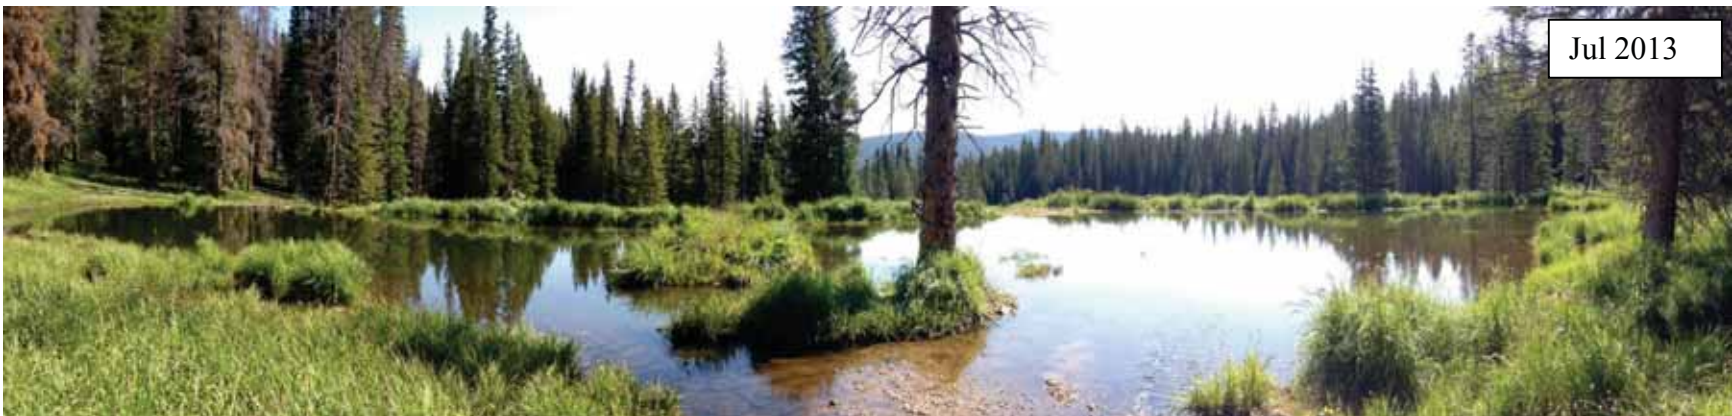
**Photo C18.** *Photopoint 22, before and after restoration of the reset pond. Dredging sediments restored depth to the pond and re-connected the abandoned beaver lodge (just left of the large dead tree) with aquatic habitat, making it habitable again by beavers.*

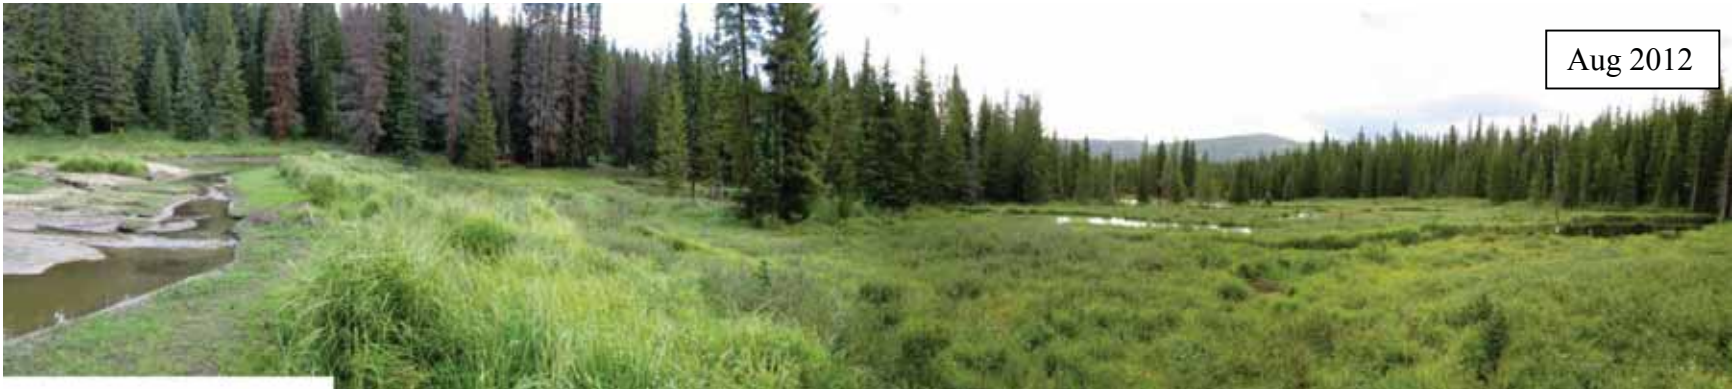
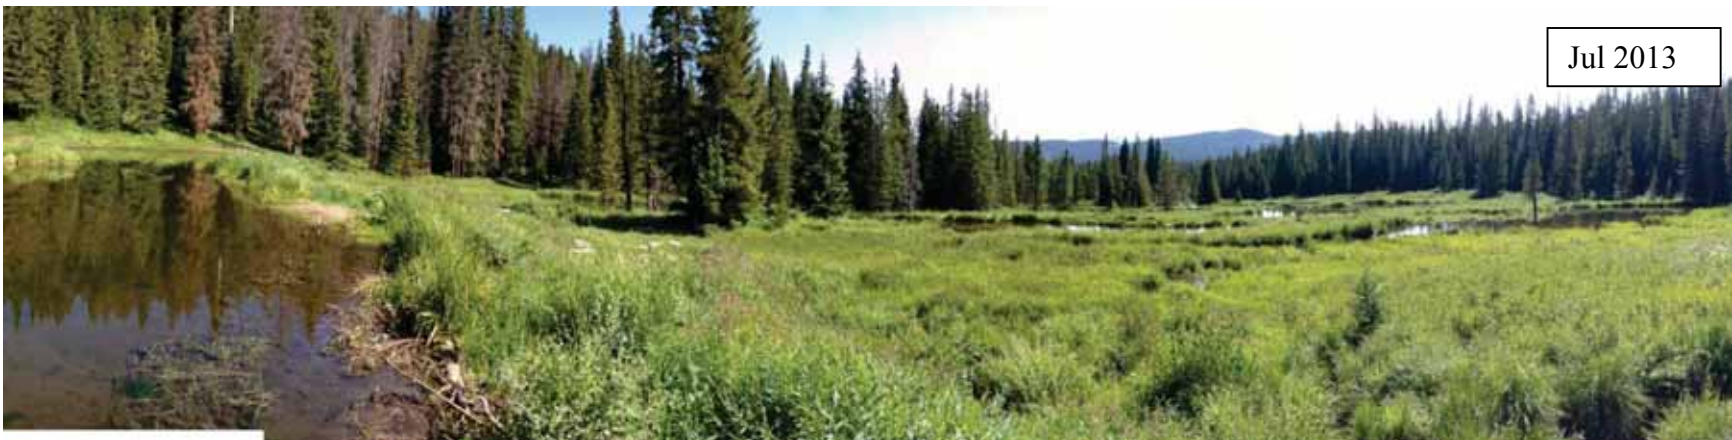
**Photo C19.** *Photopoint 23, before and after restoration of the reset pond. The full pond elevates the local water table, and it spills along the width of the dam crest supplying water to a system of distributary channels downstream of the dam. The channels are in the vegetation towards the right foreground of these photos, and they feed ponds in the right background.*

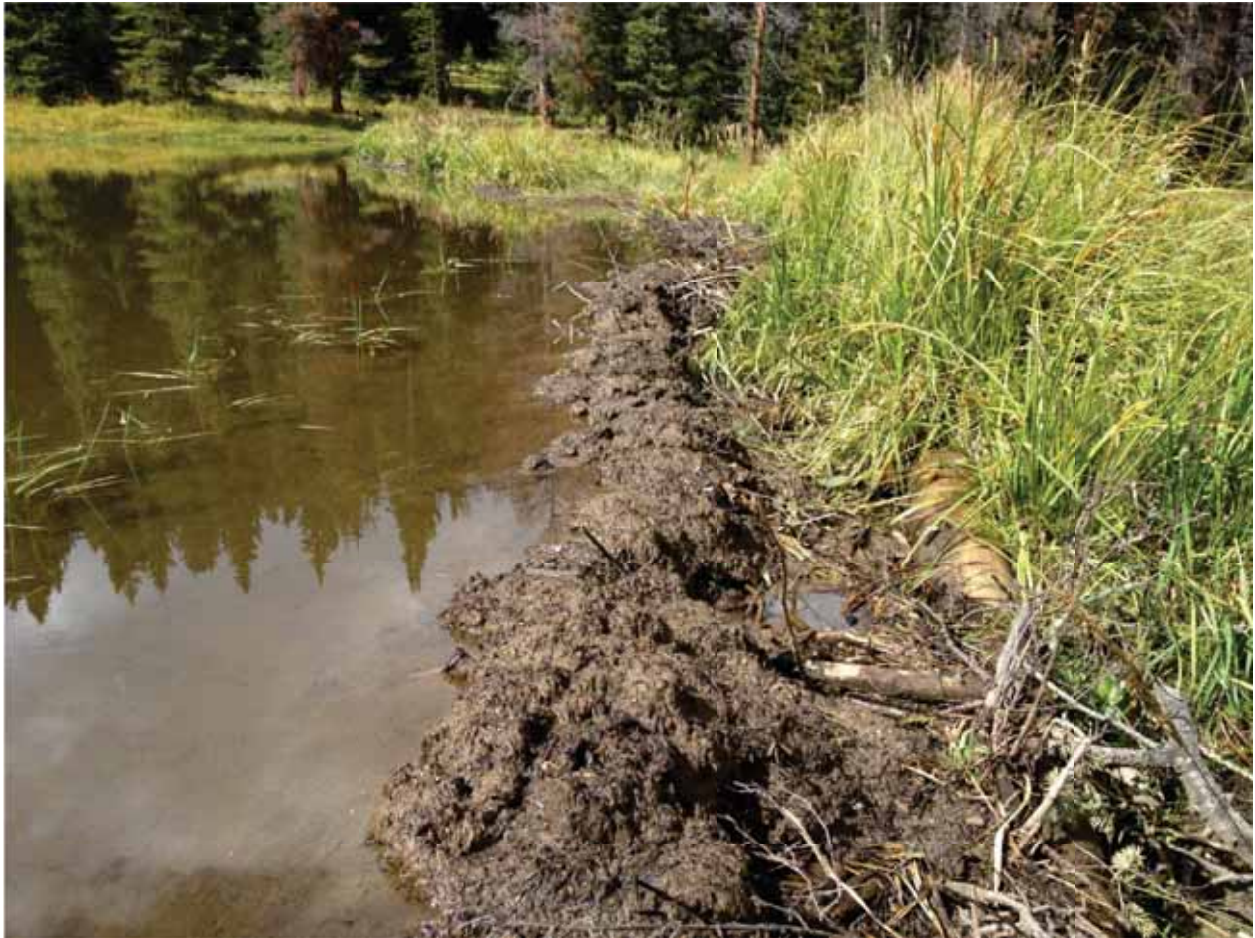
**Photo C20.** *A close up view showing beaver activity on the dam of the reset pond.*

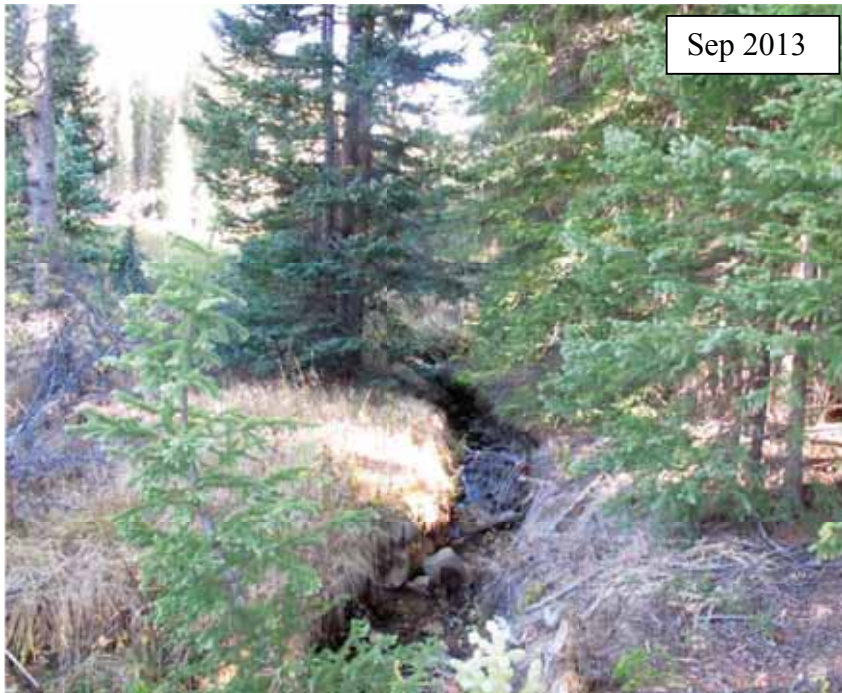
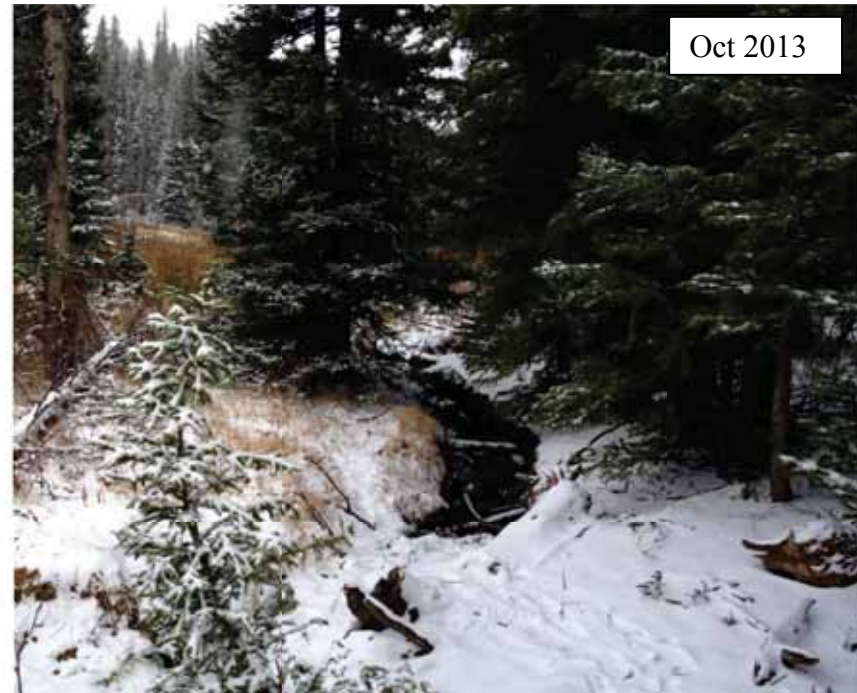
**Photo C21.** *This segment of the Boreas Creek channel was partially filled with cobble and woody debris to reduce channel volume and bank height during phase 3 work in September 2013.*

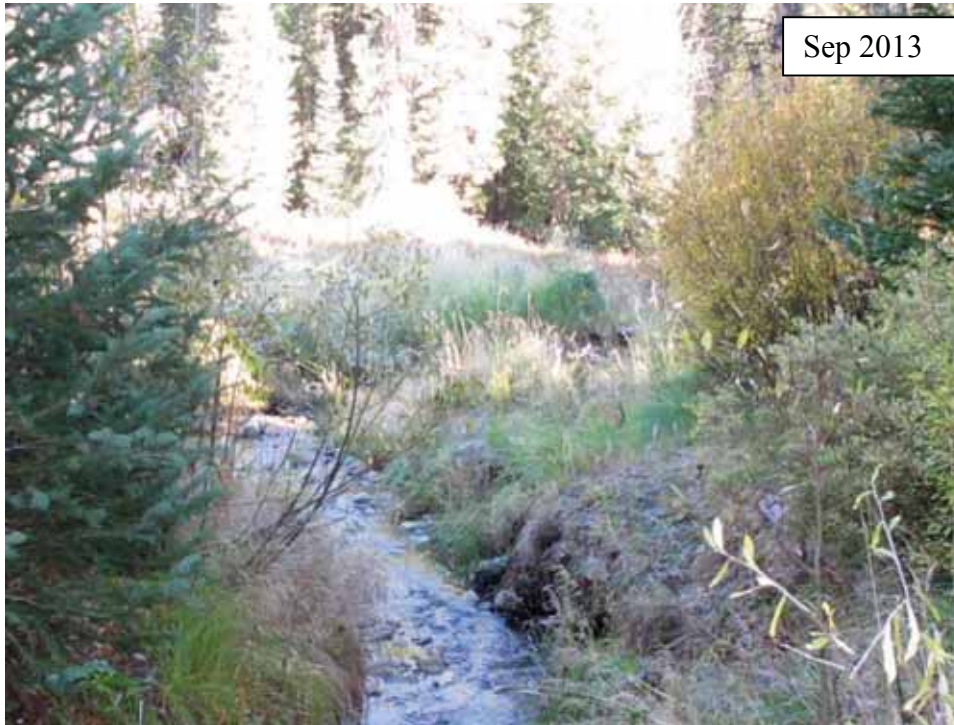
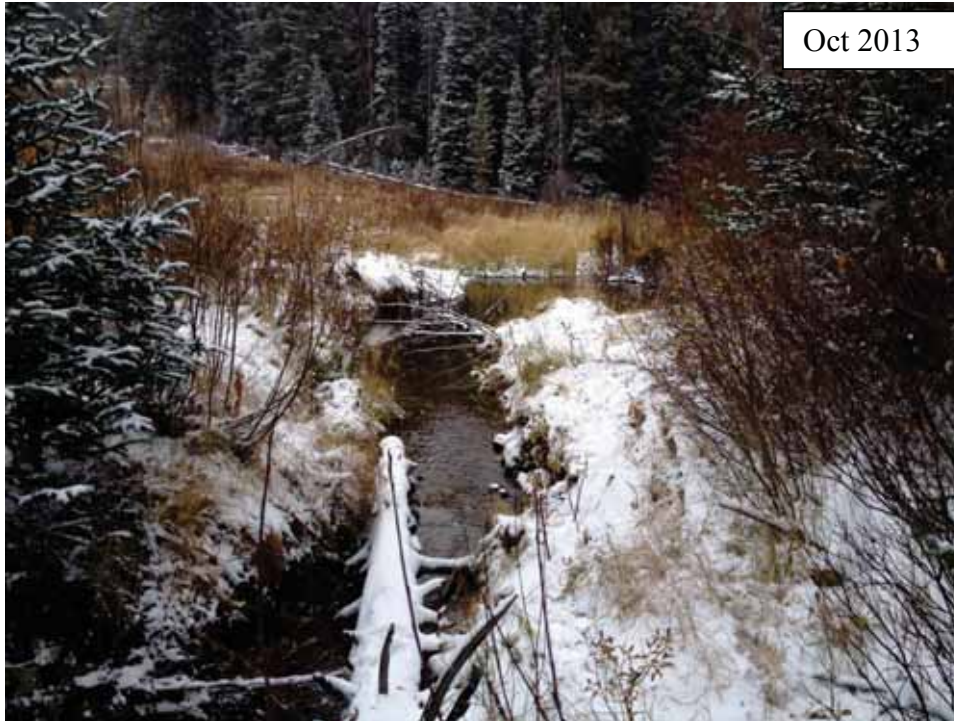
**Photo C22.** *An old breached dam was repaired on the downstream end of the Boreas Creek channel that is visible in these photos to create a pond. Large woody debris was also placed in the channel.*

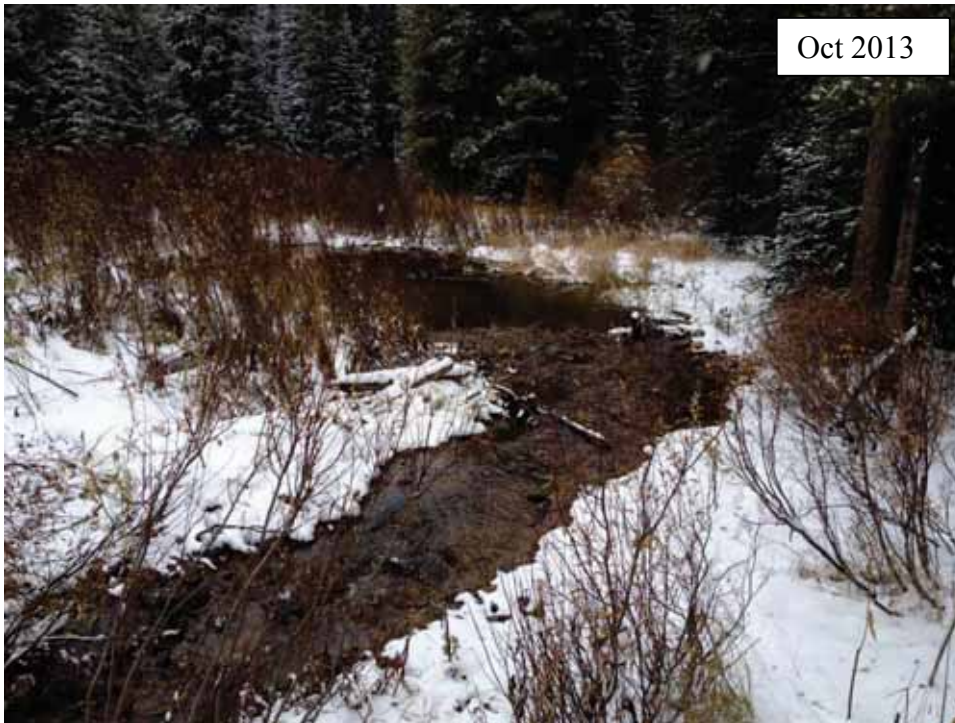
**Photo C23.** *Another old breached dam near the lower end of the project area was repaired to form this pond on the Boreas Creek channel.*

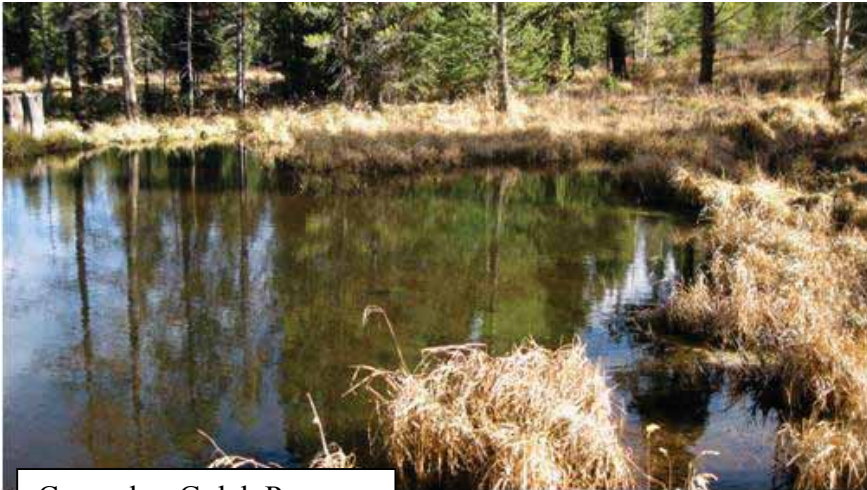
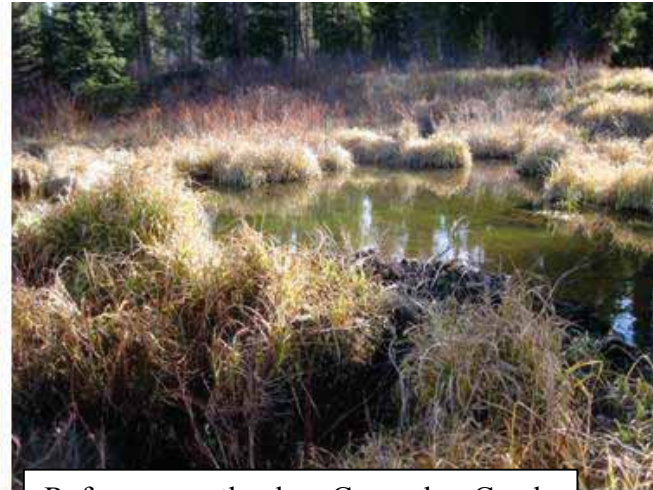
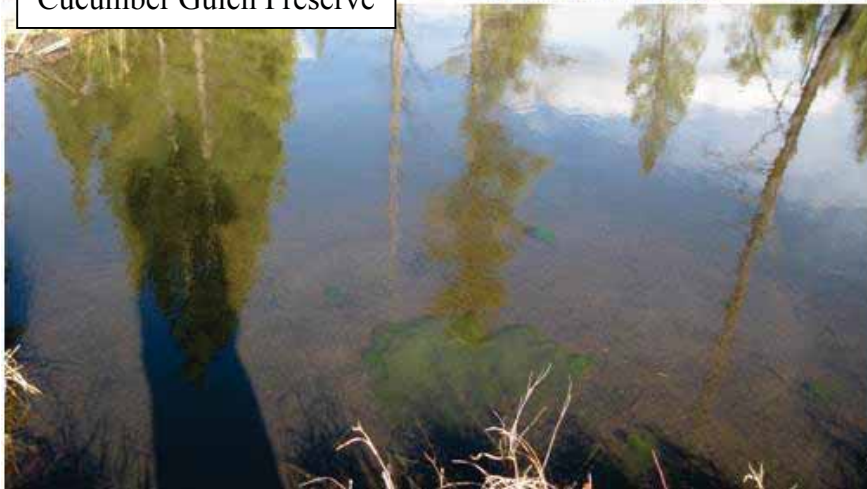
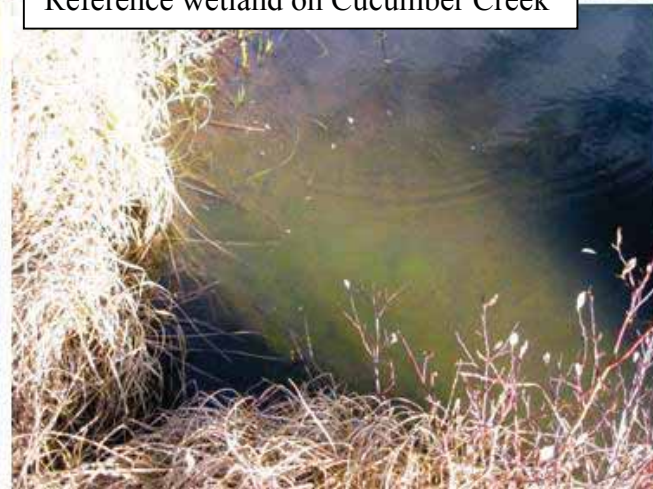
**Photo C24.** *These photos document algae blooms that were investigated in late summer 2012. The photos on the left are from CGP. Those on the right are from reference wetland on the neighboring Cucumber Creek drainage.*

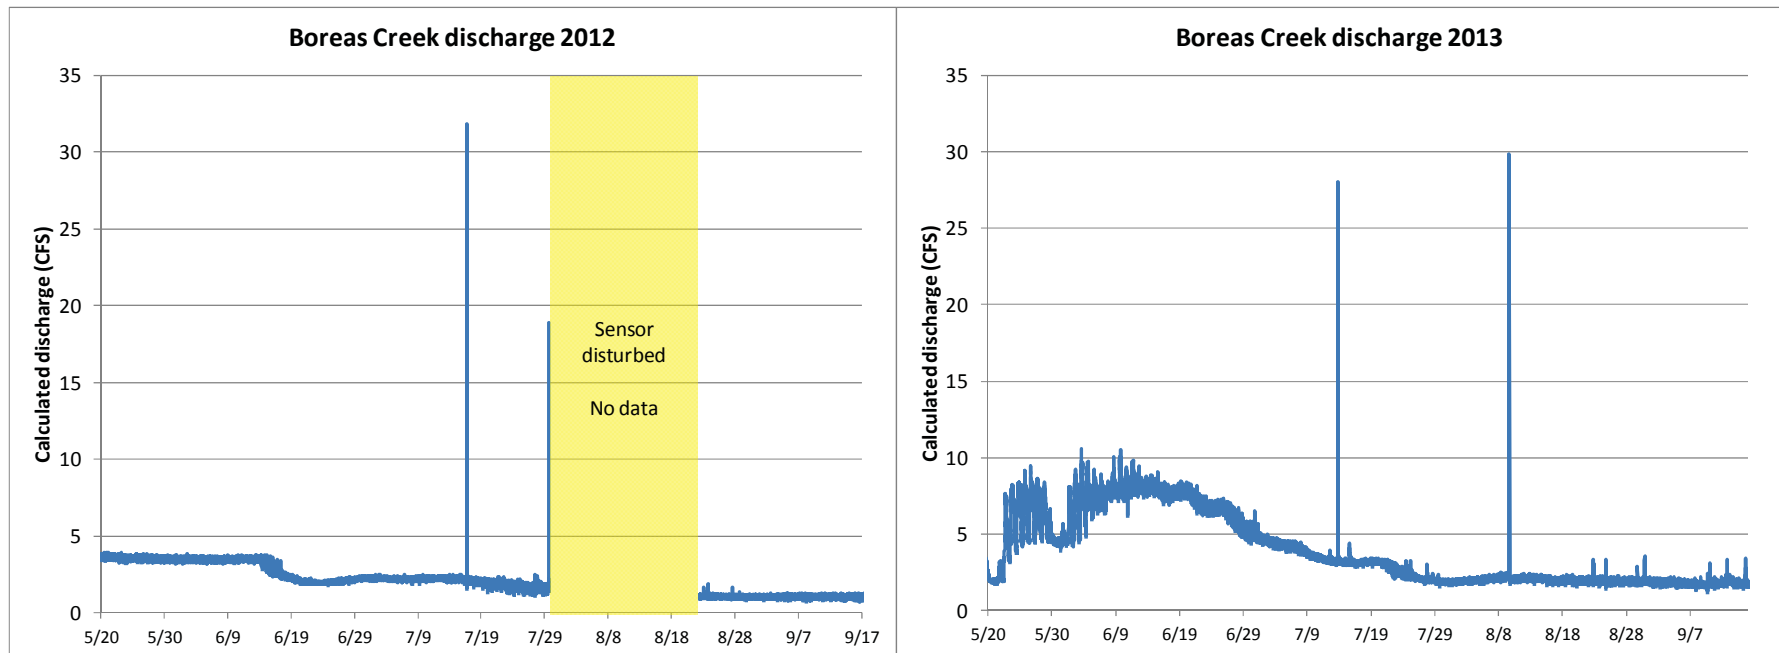
**Fig. D1.** Stream discharge (CFS) in the Boreas Creek Culvert, where it enters CG. Discharge was calculated from measured values of water height and velocity collected and logged every ten minutes from May through September. The overriding influence of snowmelt runoff is apparent on the 2013 hydrograph but was largely absent in 2012 due to low snowpack and early melt-off that season. The spikes observed in July and August correspond to thunderstorm events that also caused spikes on hydrographs for the Blue River gauges (verifying that these were actual hydrologic events). The duration of these peaks was typically less than one hour. Measurements of the magnitude of peak discharge by these methods should not be considered highly accurate due to impacts of sediment and turbulence at these unusually high discharge rates. At the very least, though, it is clear that unusually high discharge, short duration peaks do occur with especially severe thunderstorm rainfall events.

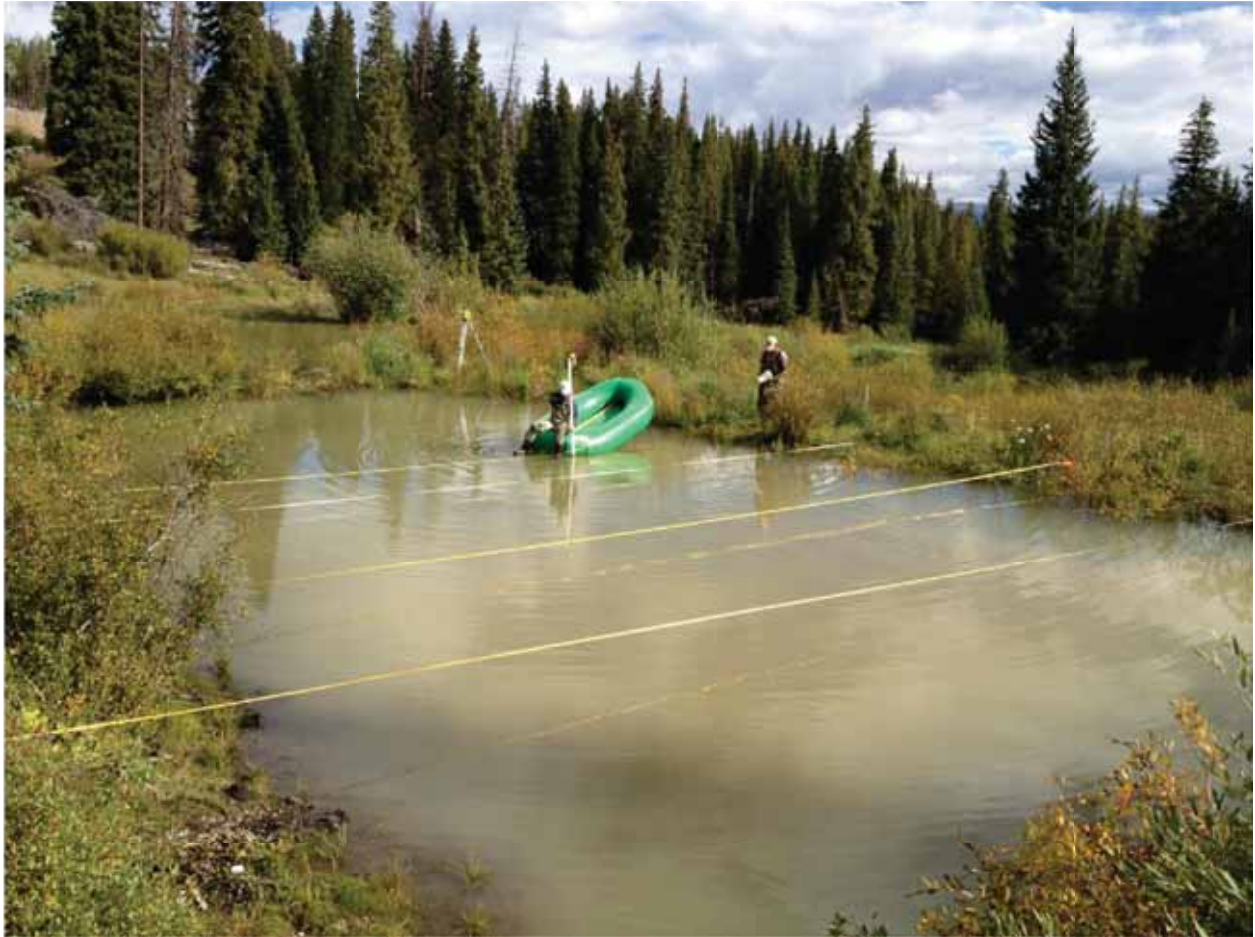
**Photo F1.** *This photo shows the catchment cell of the spreader pond during our September 2013 survey. The northwest cell of the pond is visible in the background. Survey points were taken using a handheld survey grade GPS and laser level. The data were used to generate a contour map for the bed surface of the pond (Fig. F1a-b). The tapes show the location of four monumented cross sections. Cross section survey results are shown in Fig. F3a-d.*

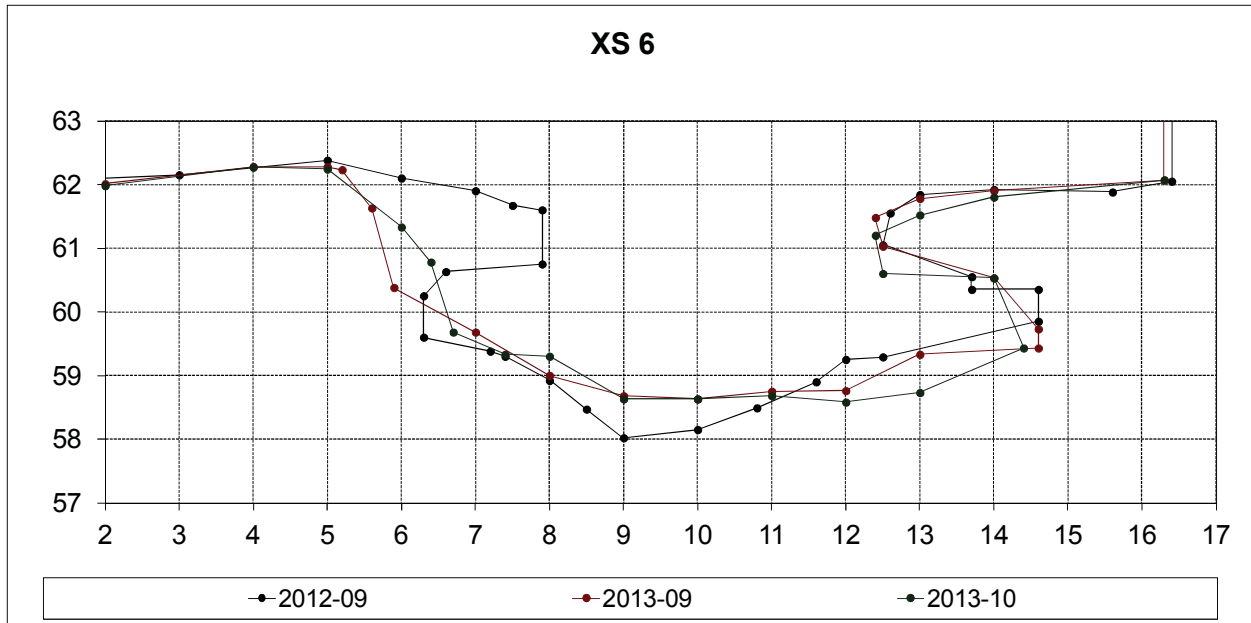
**Fig. G2.** XS 6 survey plots for 2012 and 2013 before and after treatment. The channel cross section changed significantly during the 2013 season. The overhanging left bank was lost to cantilever failure, and redistribution of bend material resulted in a shift of the thalweg towards the right bank and a 0.7 ft decrease in maximum depth. This XS is between major channel treatments and was not significantly affected by construction. Monitoring this XS will show if downstream treatments do effectively cause channel aggradation and mitigation of incision at this location in the future.

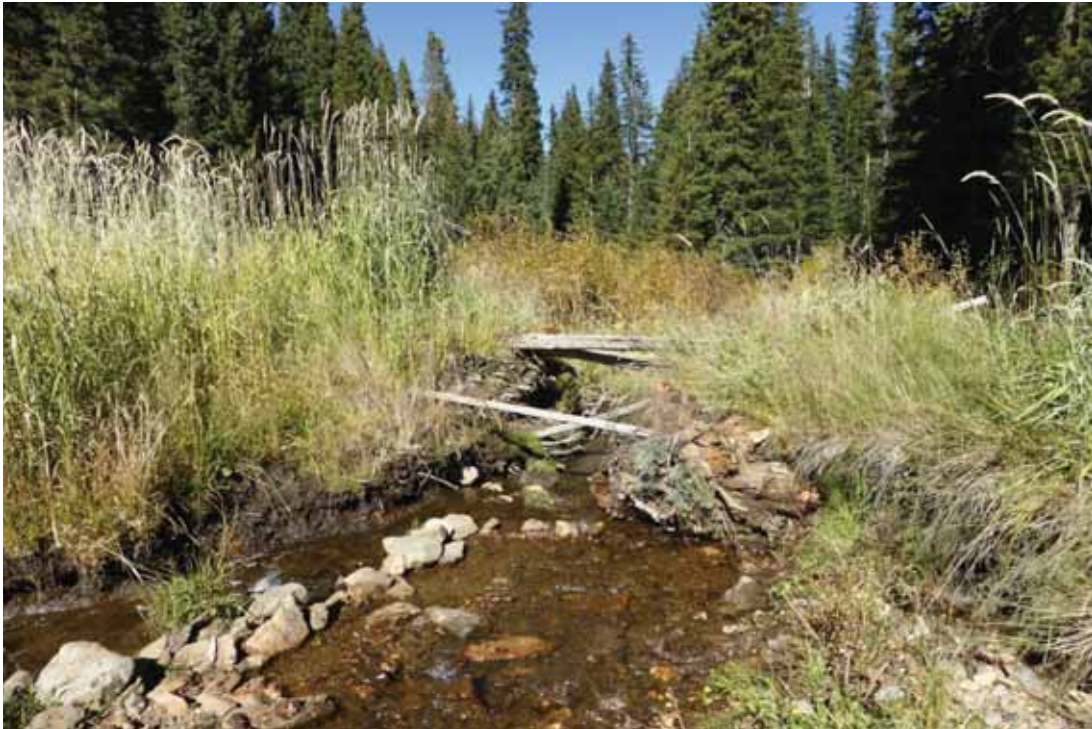
Photo 1. Lower abandoned beaver dam, non functional prior to work, October 2013. Note reed canary grass on left bank, which has spread into wetland complex formerly occupied by beaver pond.

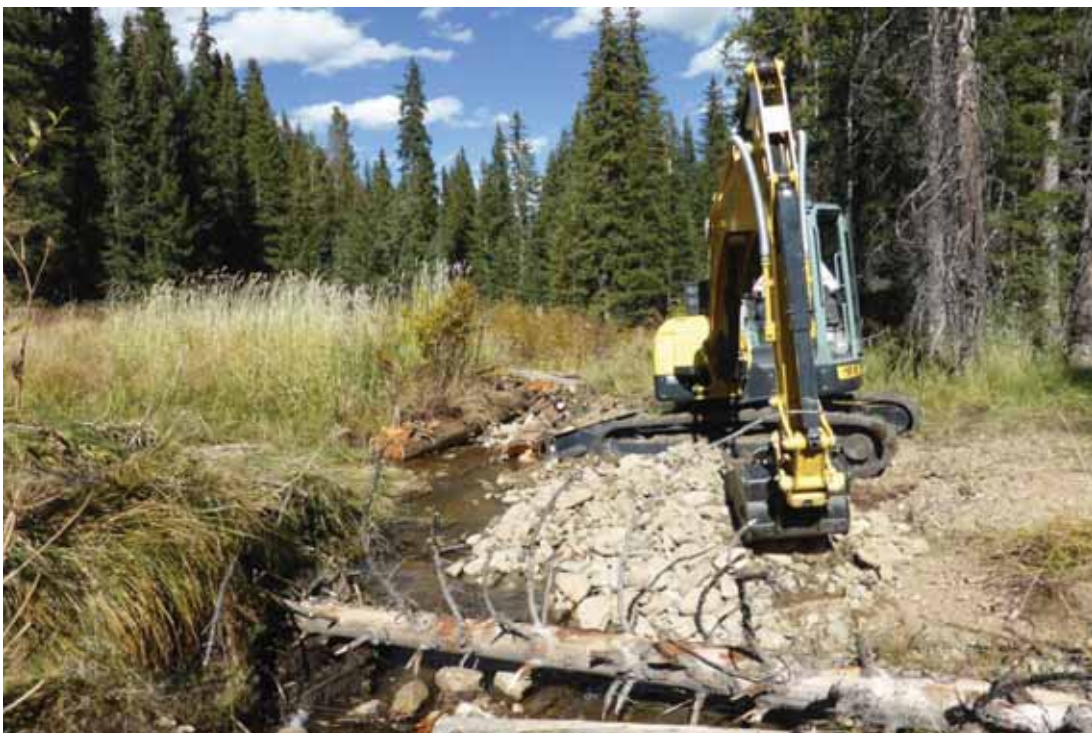
Photo 2. Starting on dam reconstruction at incision using logs, pitrun and whole live willows.

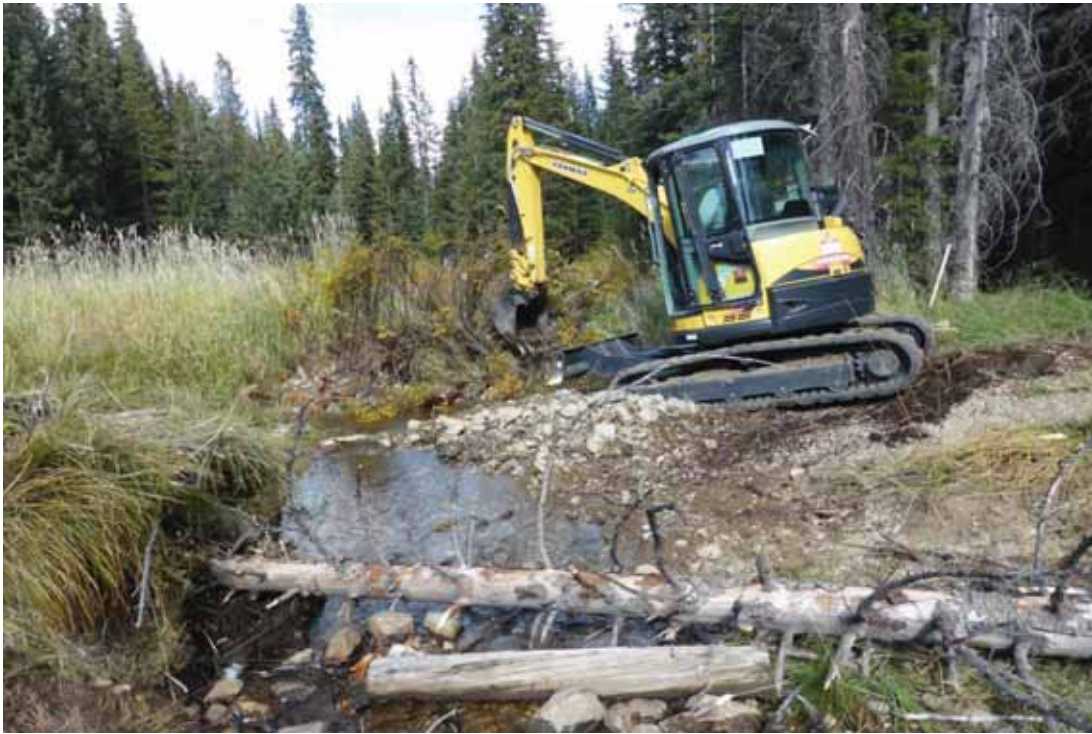
Photo 3. Adding more whole live willows to dam reconstruction.

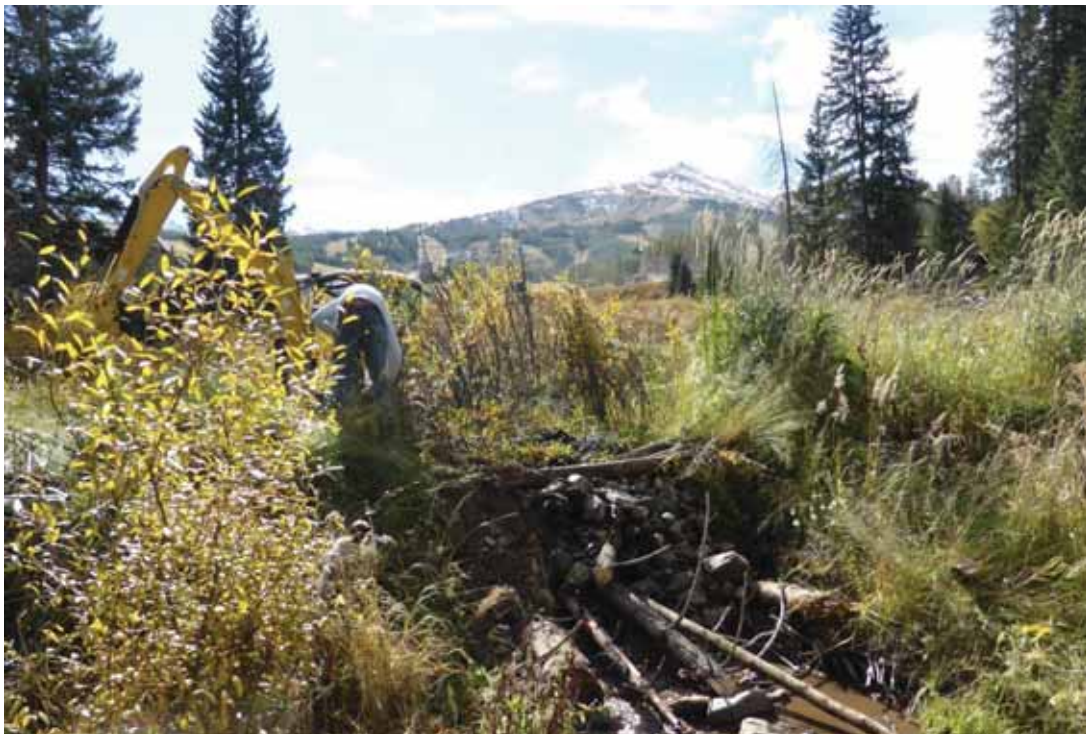
Photo 4. Downstream side of same dam rebuild. Note logs mixed with pitrun for added stability.

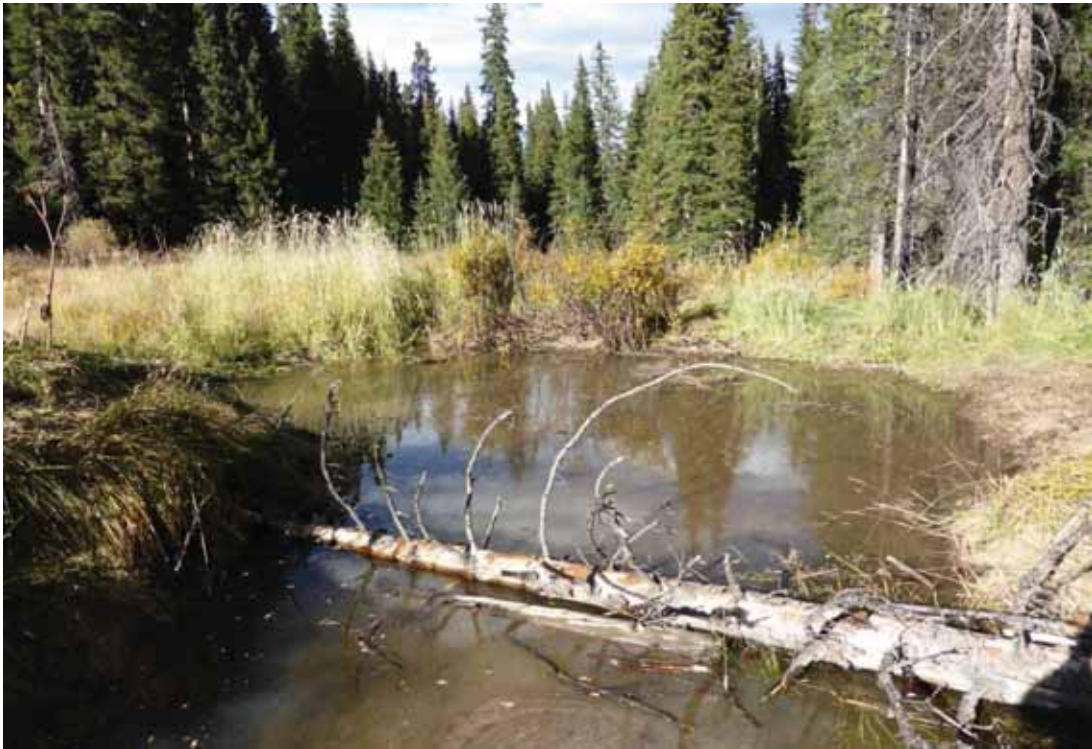
Photo 5. Dam reconstructed, pond forming. Wetland to left of photo is now rewetted.

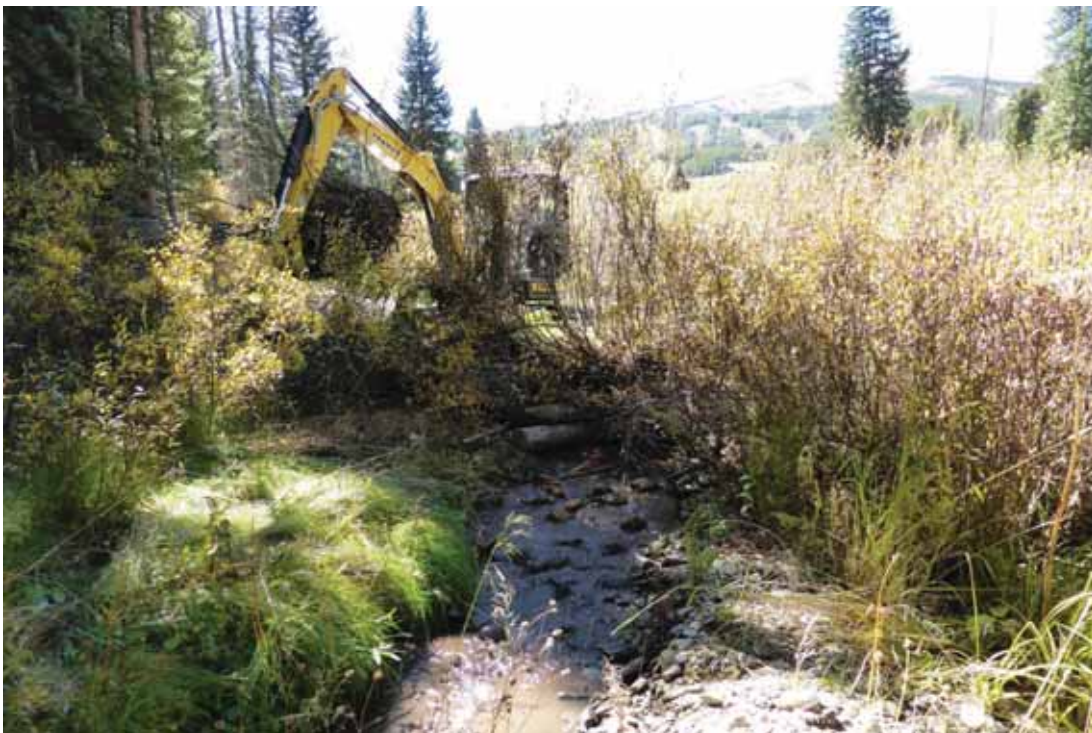
Photo 6. Reconstructing second dam downstream. Adding whole live willows onto of base constructed with large logs and pit run.

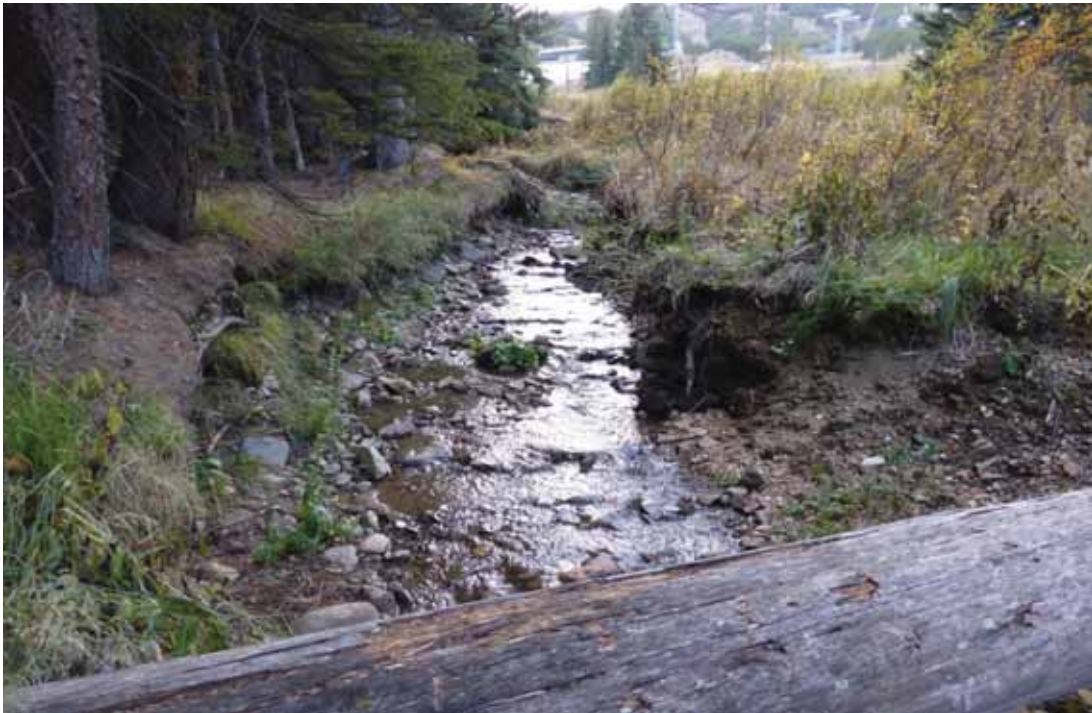
Photo 7. Incised and overwide eroded channel reach upstream of Nordic ski bridge.
