TOWN OF BRECKENRIDGE  
*OPEN SPACE ADVISORY COMMISSION*  
Monday, February 17, 2014  
2<sup>nd</sup> floor, Stephen C. West Ice Arena  
189 Boreas Pass Road

**Memorandum**

**2013 Wetlands Monitoring in Upper Cucumber Gulch Preserve  
Breckenridge, CO:  
Restoration performance monitoring**

## CHANNEL RESTORATION IN UPPER CUCUMBER GULCH

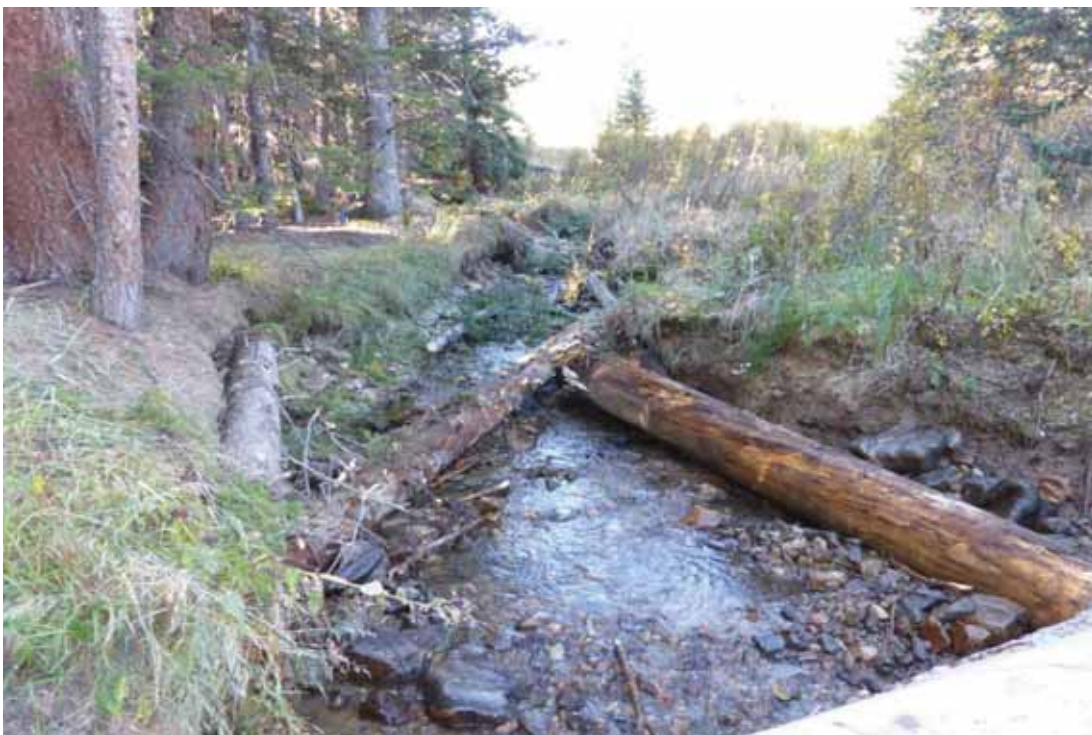
Photo 9. Adding pit run to build lateral bar upstream of V-Log. Note mini 2 yard dump truck which allowed us to move material with minimal resource damage.

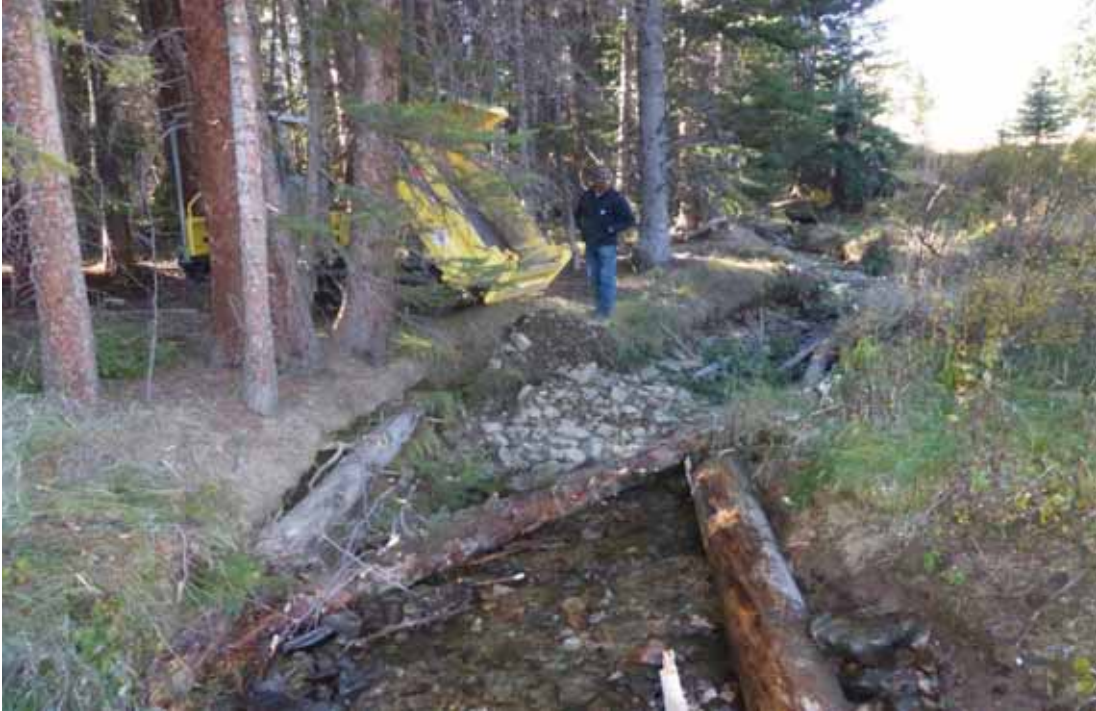
Photo 10. Structure complete. Topsoil added and left exposed on lateral bar to allow sediment (fines) to wash downstream to help seal next structure downstream.

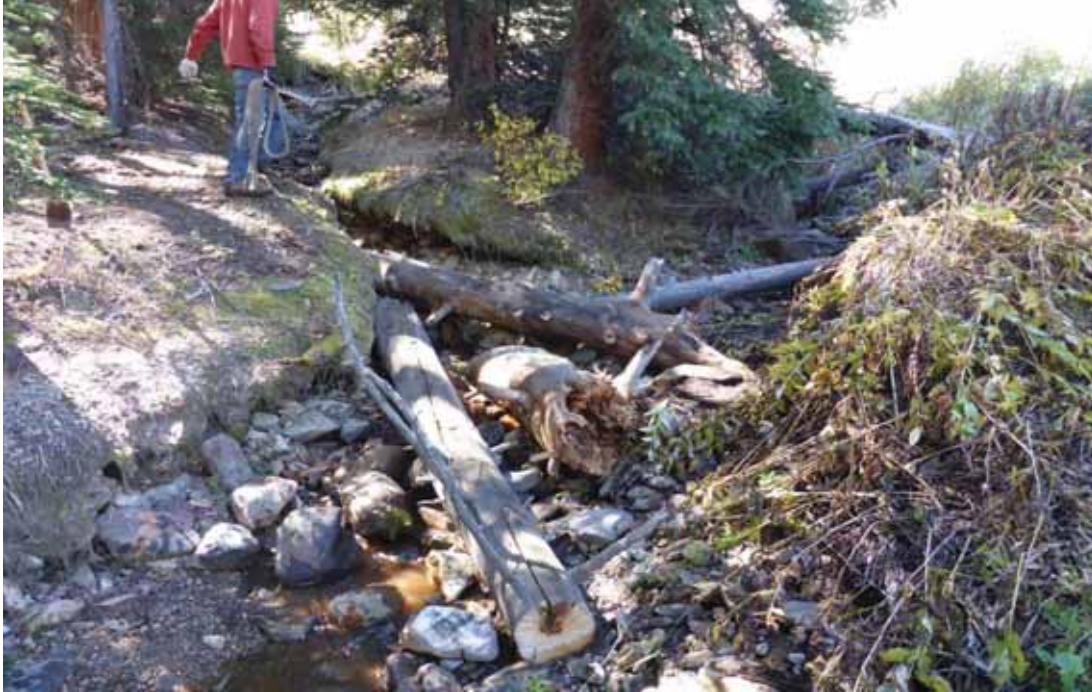
Photo 11. Logs jammed into downstream end of very narrow deep incision. We did not want to fill this section as we would reduce channel capacity to fast, the logs will create sediment deposition stopping the incision.

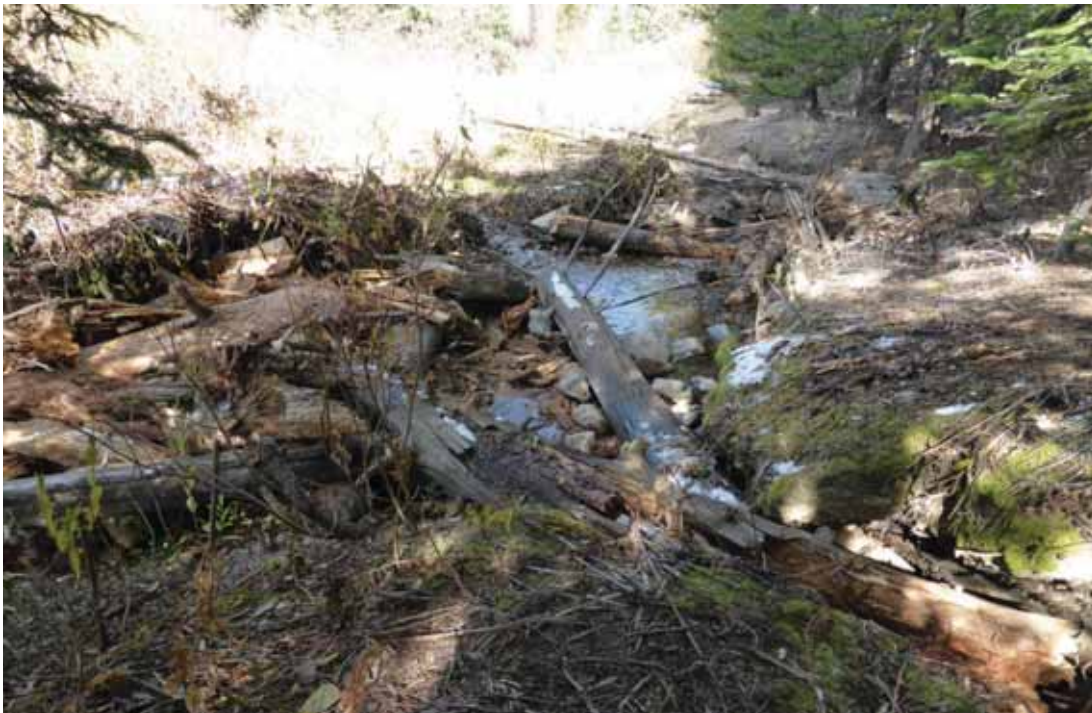
Photo 13. Erosion control and stability measures in overflow channels near downstream dam repairs. Includes seed, straw fabric, heavy coir fabric and wattles.

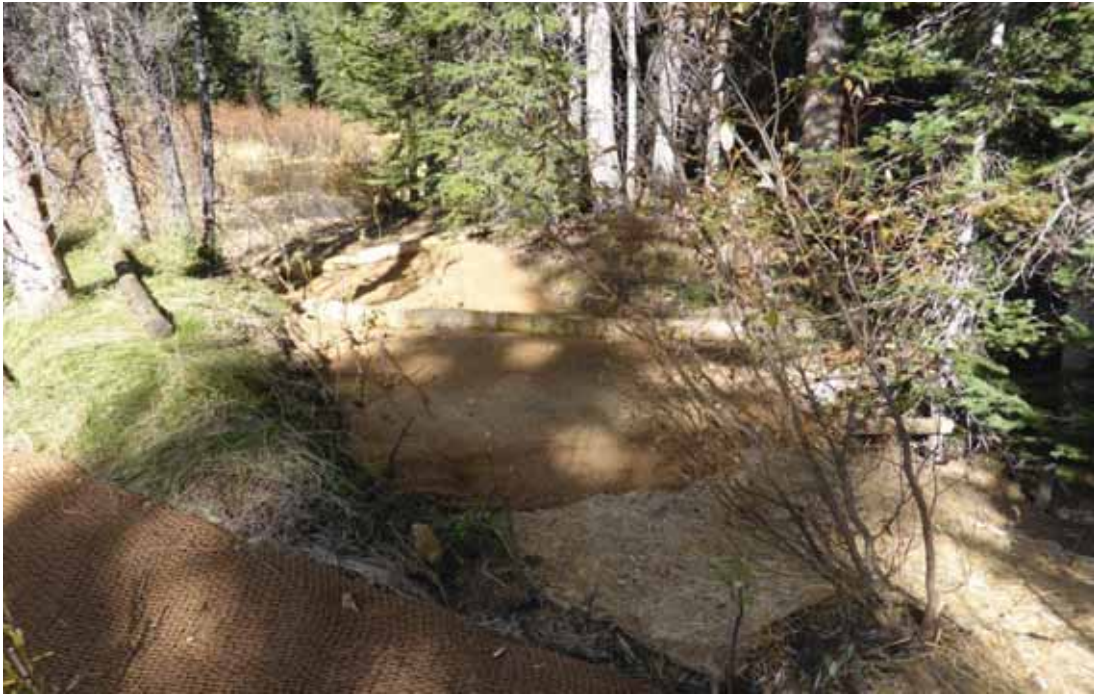
Photo 14. Fabric and new pond, with some of the willow plantings.

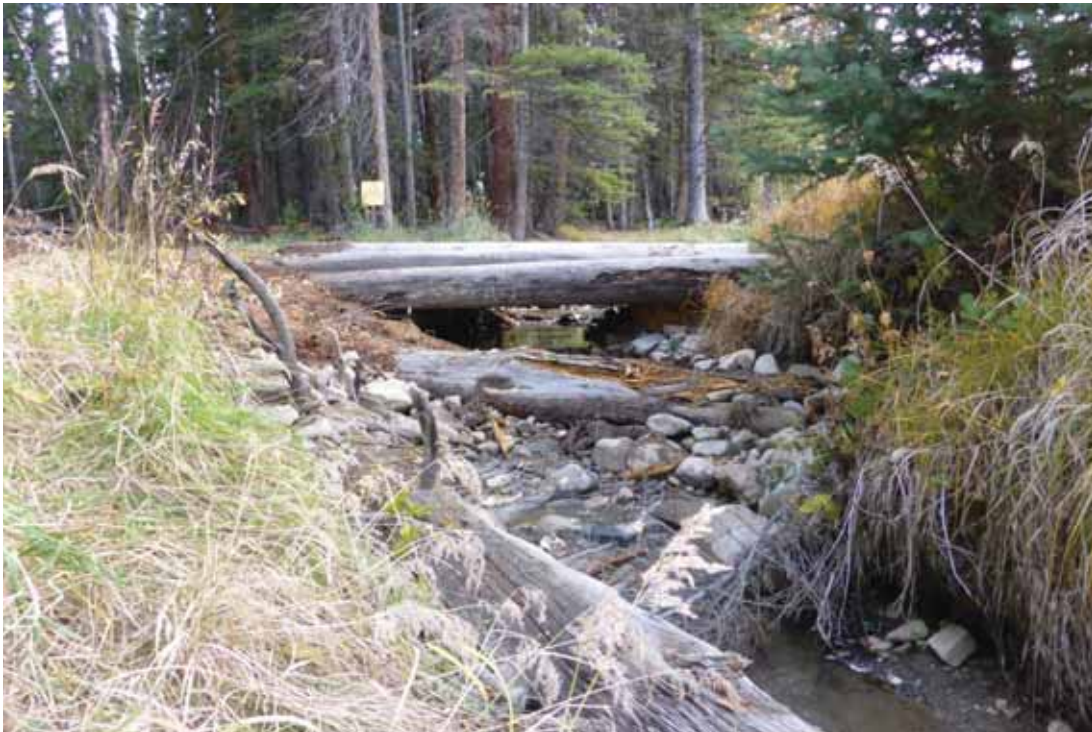
Photo 15. Downstream cross log structure with pit run added just below Nordic bridge.

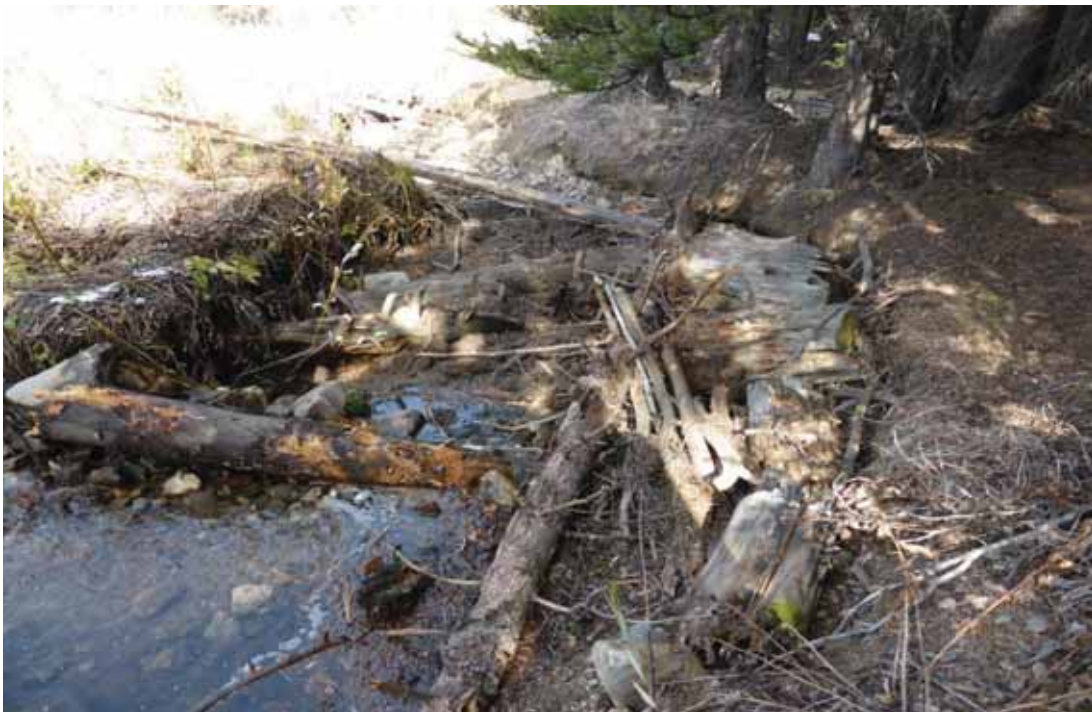
Photo 16. Upstream portion of project, logs and pitrun placed to fill channel, raise grade and slow velocity. Woody debris supported by pitrun will prevent further channel erosion.

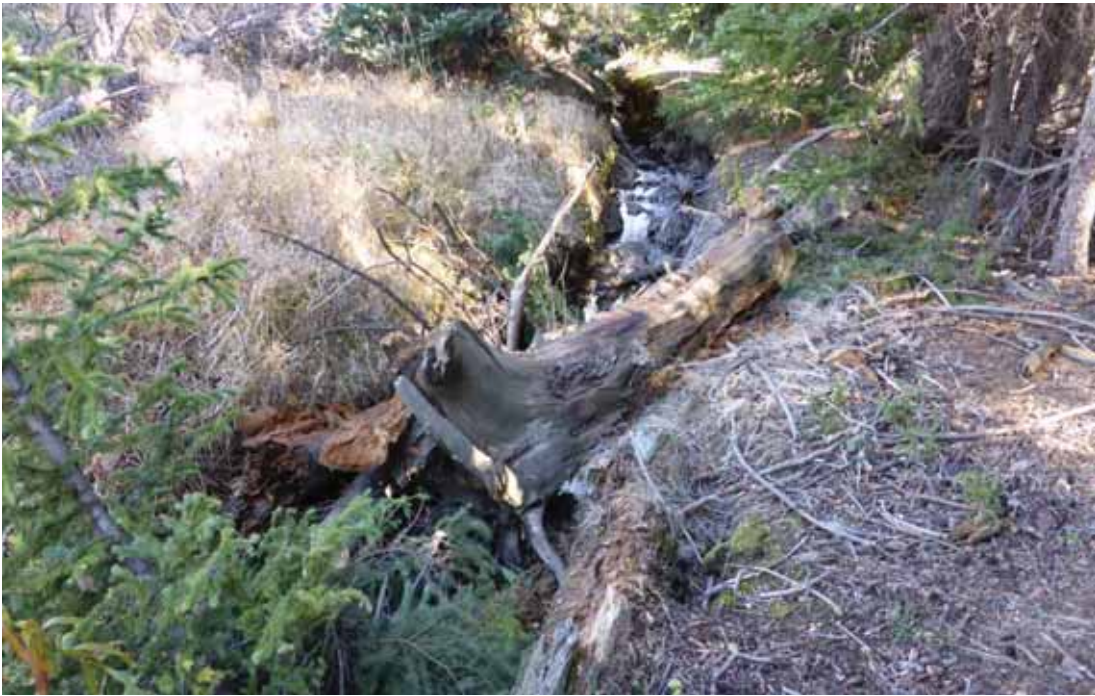
Photo 17. Large woody debris dams just upstream of severe channel incision and narrow section (see Photos 11 and 12). Water will flow through structure but at much reduced velocity, and flows will access the well vegetated floodplain on left descending bank.

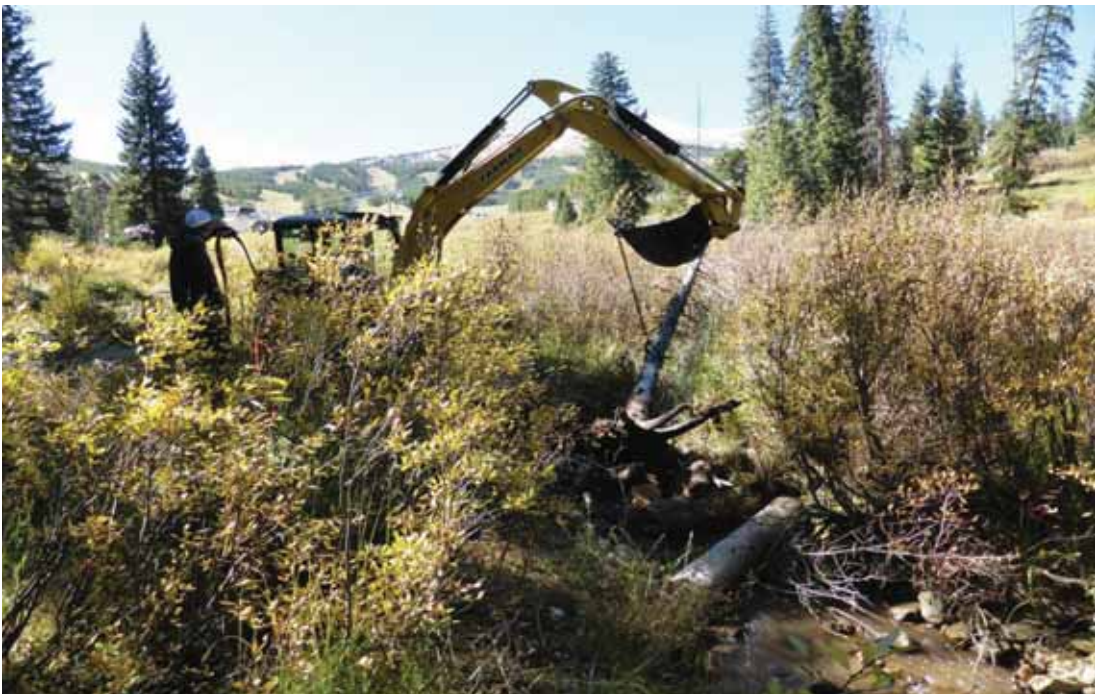
Photo 18. Log with root wad placement in lower dam rebuild. Chain used to maintain integrity of log. With the right operators, track hoe can sit right in wetland and channel with minimal disturbance.

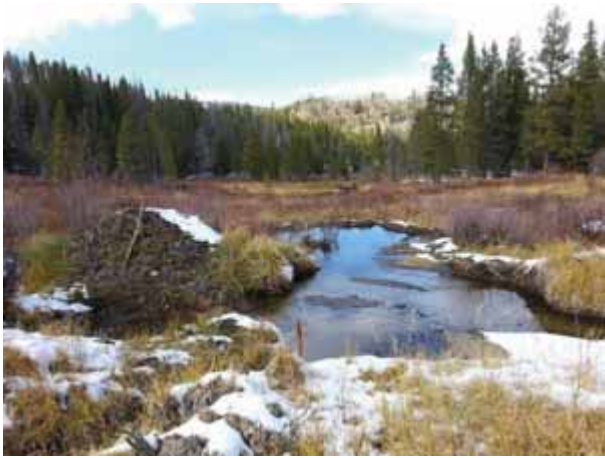
**Photo 2.1: Lodge 2013-1; near Gondola Post 15 in between D1 and SW4; first seen in May, there is obvious signs of work from this year; no recent beaver activity observed near lodge; appears inactive.**

New lodges appeared in 2013 (Photos 2.1 and 2.2) but they do not appear to be active. Photo 2.12 shows lodge 2013-6 (Table 2.2) in a pond with recent dam work but no observations were made showing muskrats or beavers using this lodge. The only other lodge in the gulch that beavers and muskrats were observed using is lodge 2013-4 (Table 2.2) observed from Site 3 (Photo 2.10). This lodge has a motion sensor camera trained on it and activity in this area is constantly monitored.

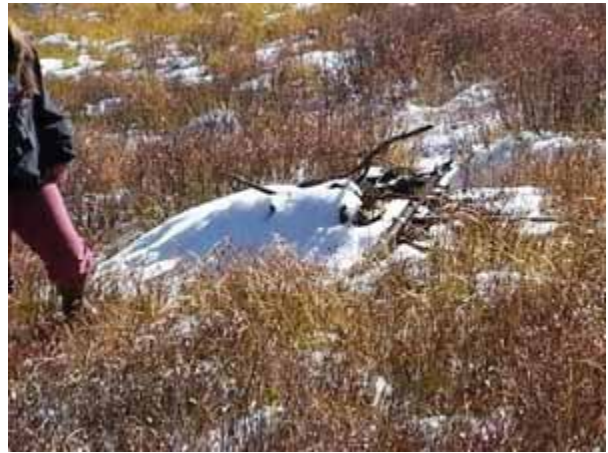
**Photo 2.2: Lodge 2013-2; possible new lodge in between Gondola Posts 16 and 15 (near SW4 and C2); appears to be a few weeks old, no recent beaver signs observed near lodge and lodge not close to any ponds; appears inactive.**

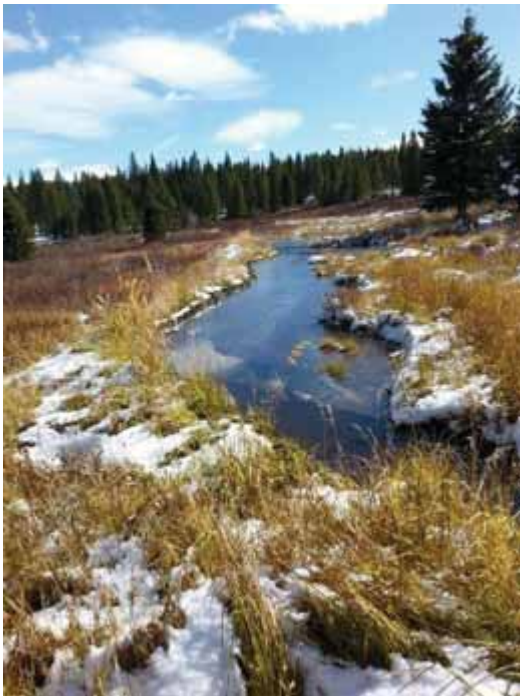
**Photo 2.3: Recent work on dam next to Gondola Post 16; all ponds in between Post 16 and the Moose Interpretive Sign show recent signs of dam work as well as fresh chew and Beaver Runs are obvious throughout wetland in this area.**

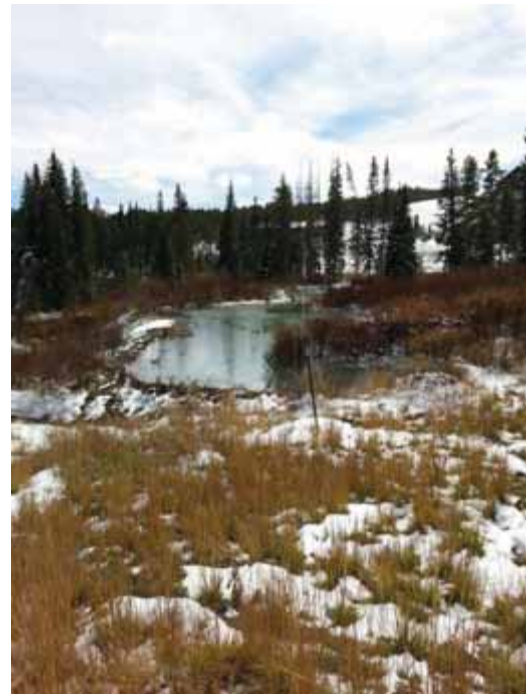
**Photo 2.4: Recent dam work at top of Gulch downhill from Peak 8 Lodge and Ski Hill Road; dam work appears to be about a month old; fresh beaver sign was observed in wetland around A4 (Figure 5) and there is additional flooding in the same area (Figure 6).**

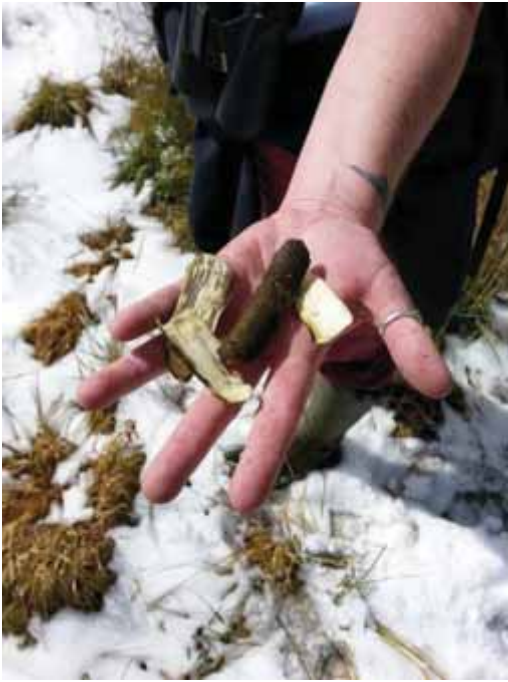
**Photo 2.5: Fresh beaver chew (probably less than a week old) recovered near A4**

An area of note is the upper portion of the gulch near the Peak 8 ski area base where recent hydrologic restoration has been completed. Ponds that have been empty in this area for several years are now flooded providing a large area of new habitat (Photos 2.4, 2.6, and 2.7). While no beavers or muskrats were seen in this area during the surveys, signs of recent activity were observed near Site 4 during the walk-through, most notable was fresh willow chew (Photo 2.5).

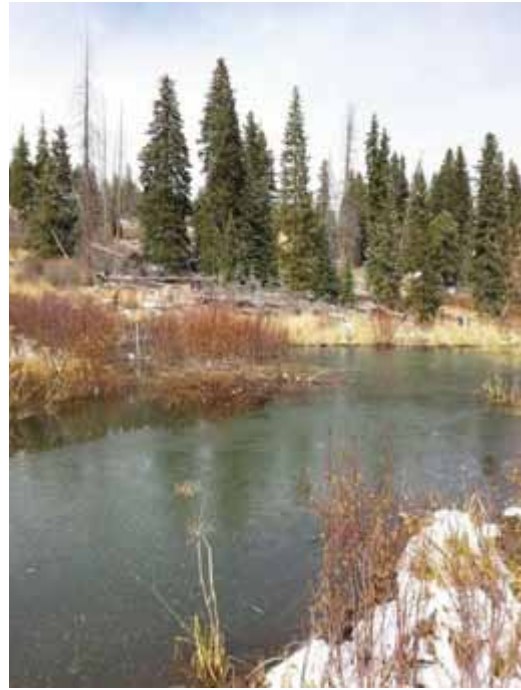
**Photo 2.6: Recent dam work and additional flooding at top of gulch below Ski Hill Road**

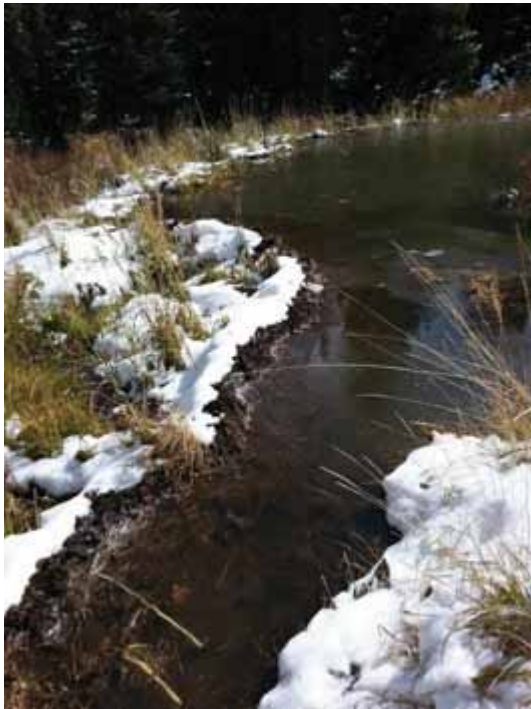
**Photo 2.7: Close-up of dam work at top of Gulch**

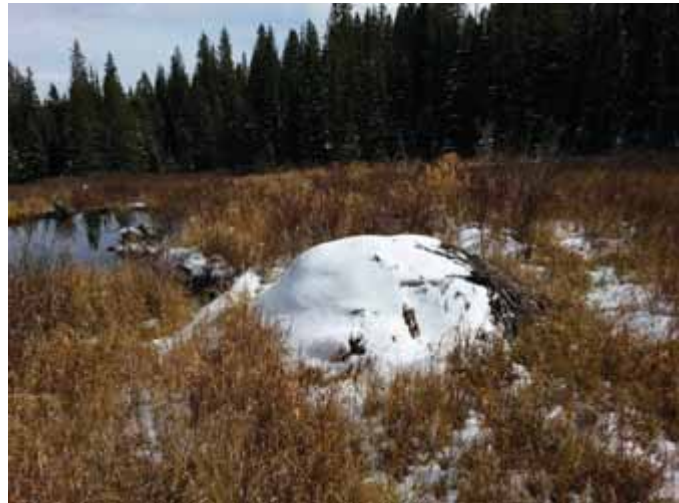
**Photo 2.8: Lodge 2013-3; first appeared in Summer of 2012 about 100 meters SSW of Camera 5; lodge is situated on ground next to a small pond; no recent signs of activity were observed on or around this lodge; appears inactive.**

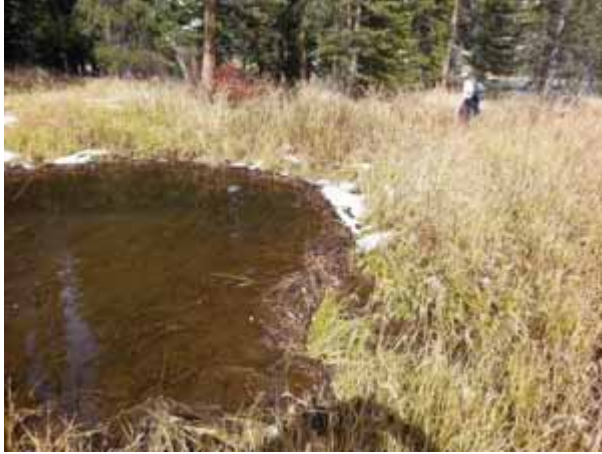
**Photo 2.9: New dam and pond started about 50 meters SSW of Camera 5; dam appears to be about one or two months old; no other obvious beaver signs were observed near this pond.**
