TOWN OF BRECKENRIDGE
OPEN SPACE ADVISORY COMMISSION
Monday, February 16, 2015
Lower Level Conference Room
Breckenridge Town Hall
150 Ski Hill Road

*Breckenridge, Colorado
February 2015*

Prepared for the Town of Breckenridge, Colorado

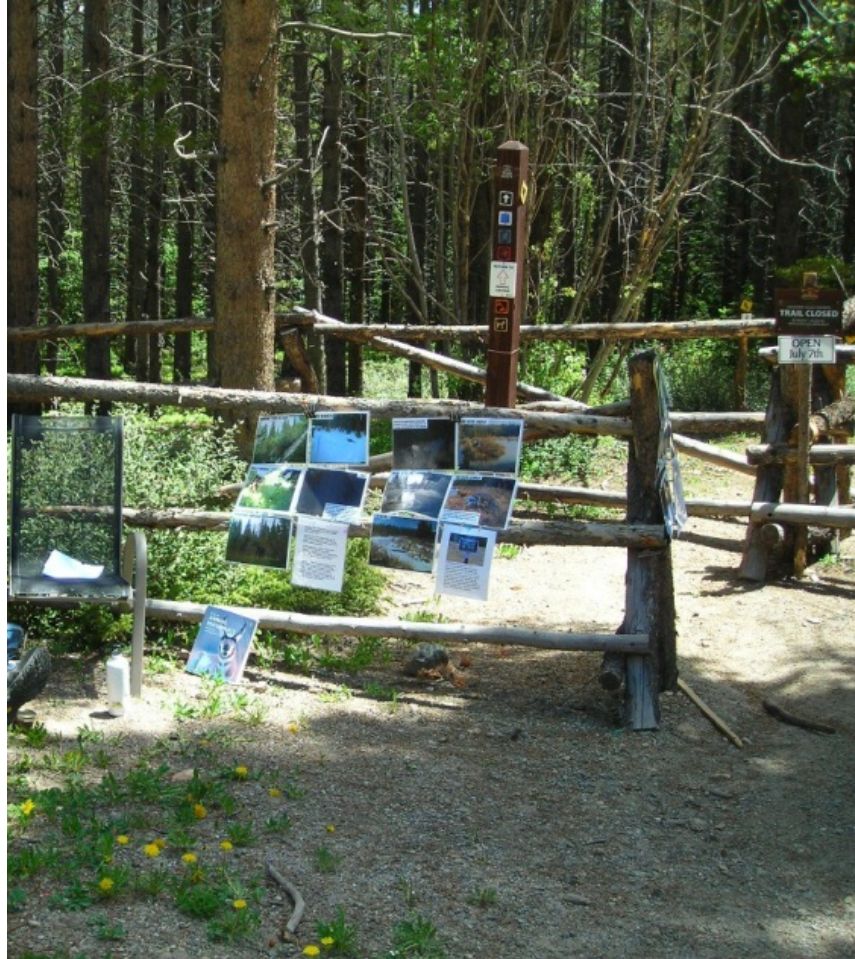
Photo 1 The docent setup located at the Cucumber Gulch trailhead on Ski Hill Rd across from the Peaks trailhead. The educational information boards are hanging from the fence.

For the second summer, a docent was stationed on select days at the Cucumber Gulch trailhead on Ski Hill Road directly across the road from the Peaks trailhead (Photo 1). The acting docents in 2014 were Elizabeth Kelso and Cole Archer. During the trail closure, at least one docent was in attendance from June 25-29 and again on July 3-6 from approximately 9am to 3pm. A docent was also in attendance on Monday July 7 from 9am-3pm, the first day the Gulch trails were open for the summer.

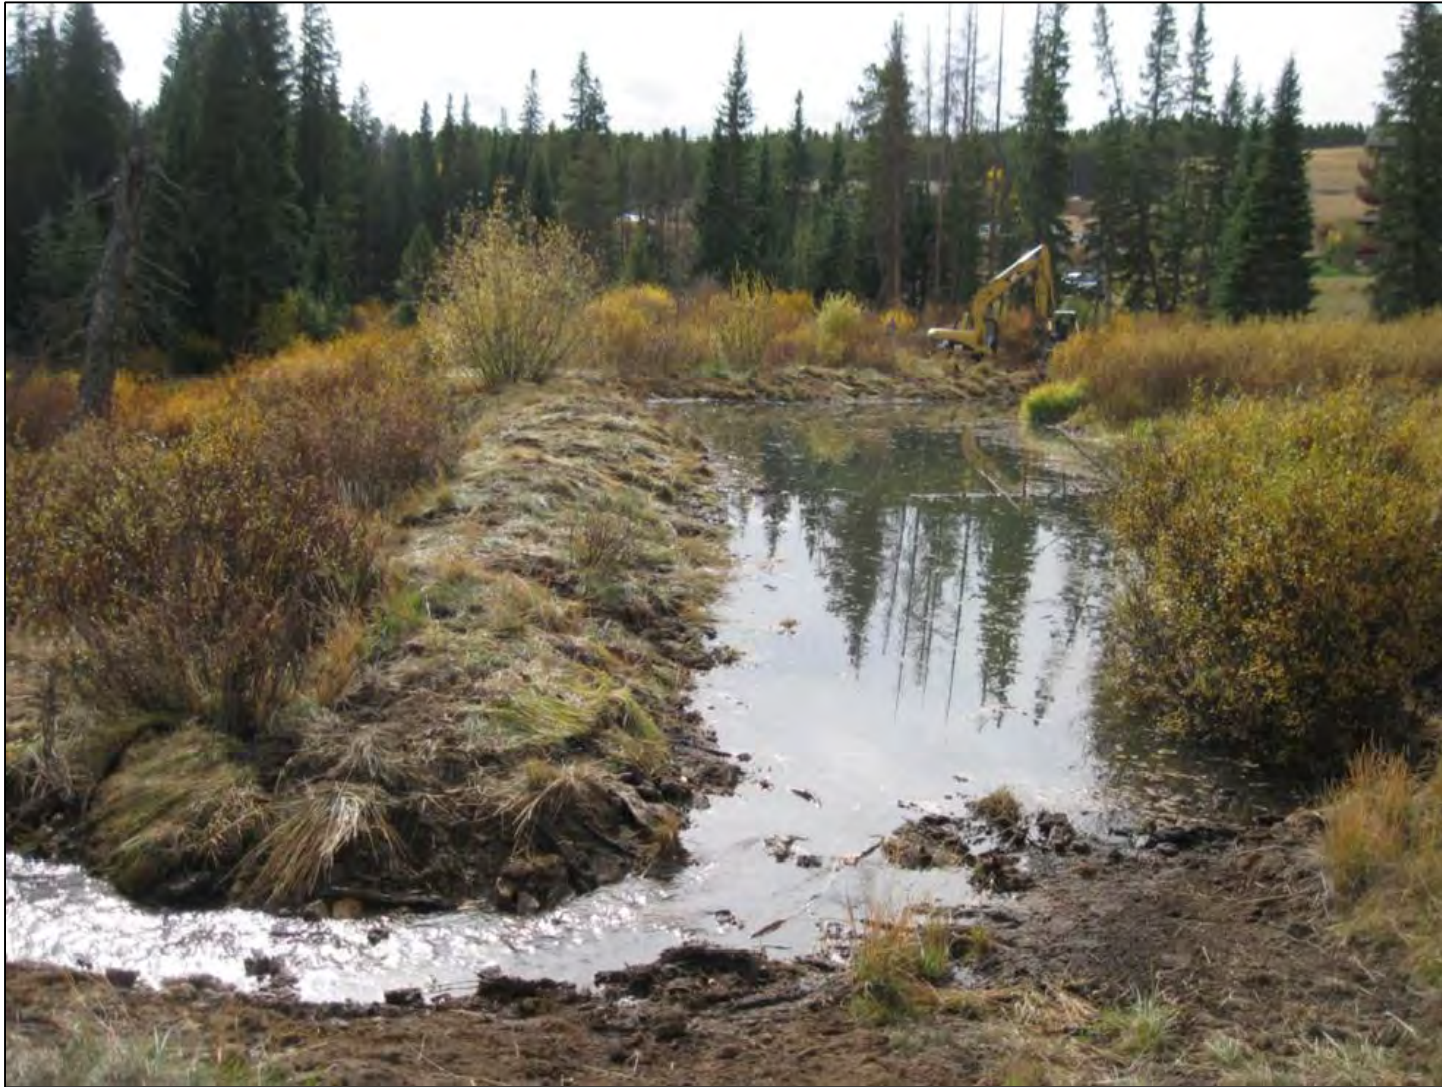
Photo C1a. The outlet spillway of the northern cell of the spreader pond in 2012 immediately after construction.

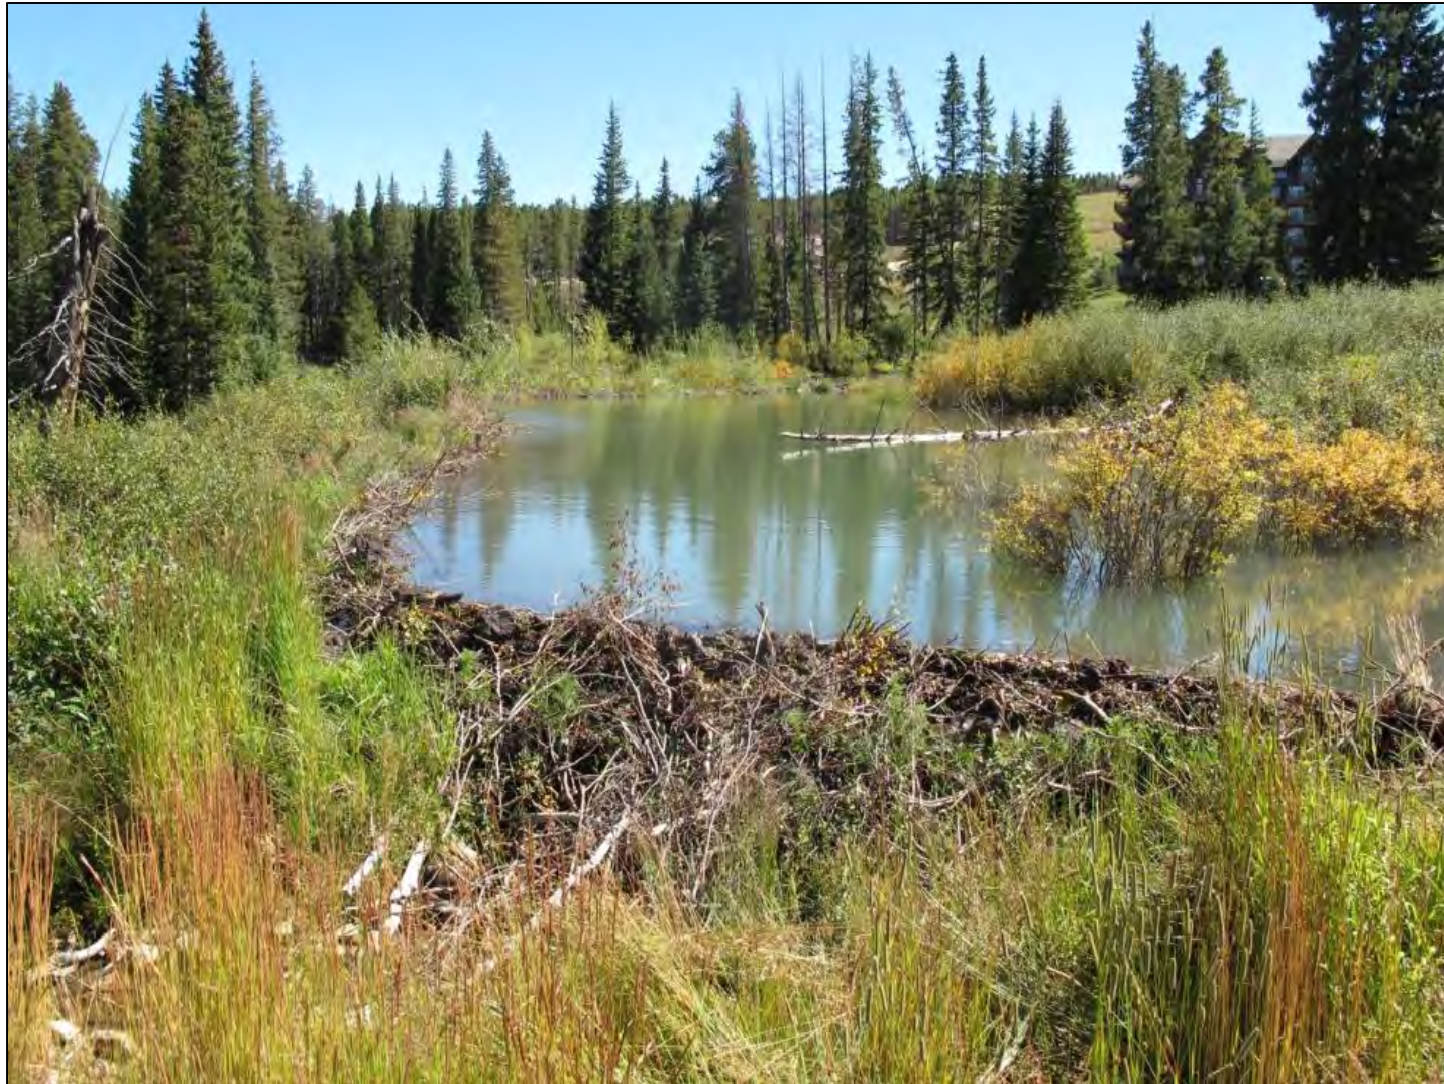
Photo C1c. Two photos showing the upper (eastern) cell of the spreader pond as viewed from upstream in September 2014, when the dam is at its highest. Water flows out of the pond over the dam (right side of photo) at multiple locations, creating natural water distribution.

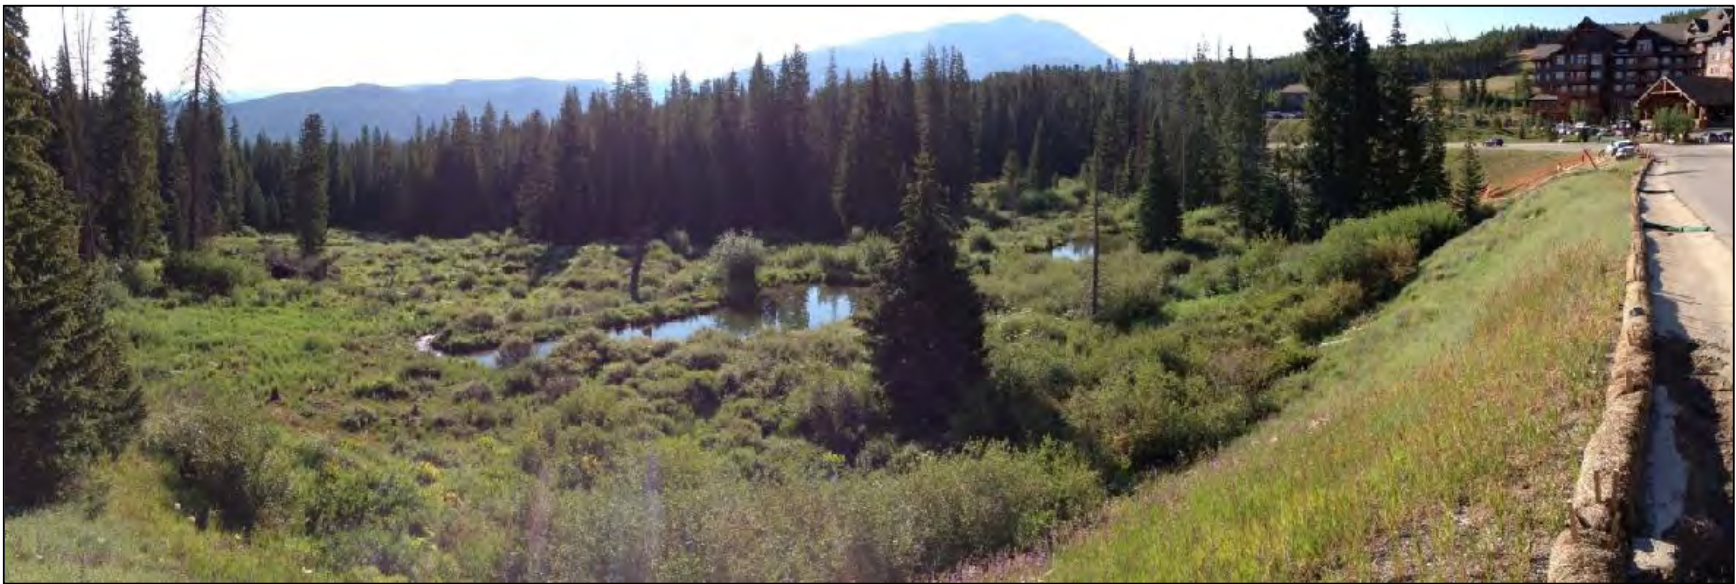
Photo C2a and b. Overview of Upper CG restoration. The upper photo is before treatment in 2012 and the lower photo is from summer 2013.

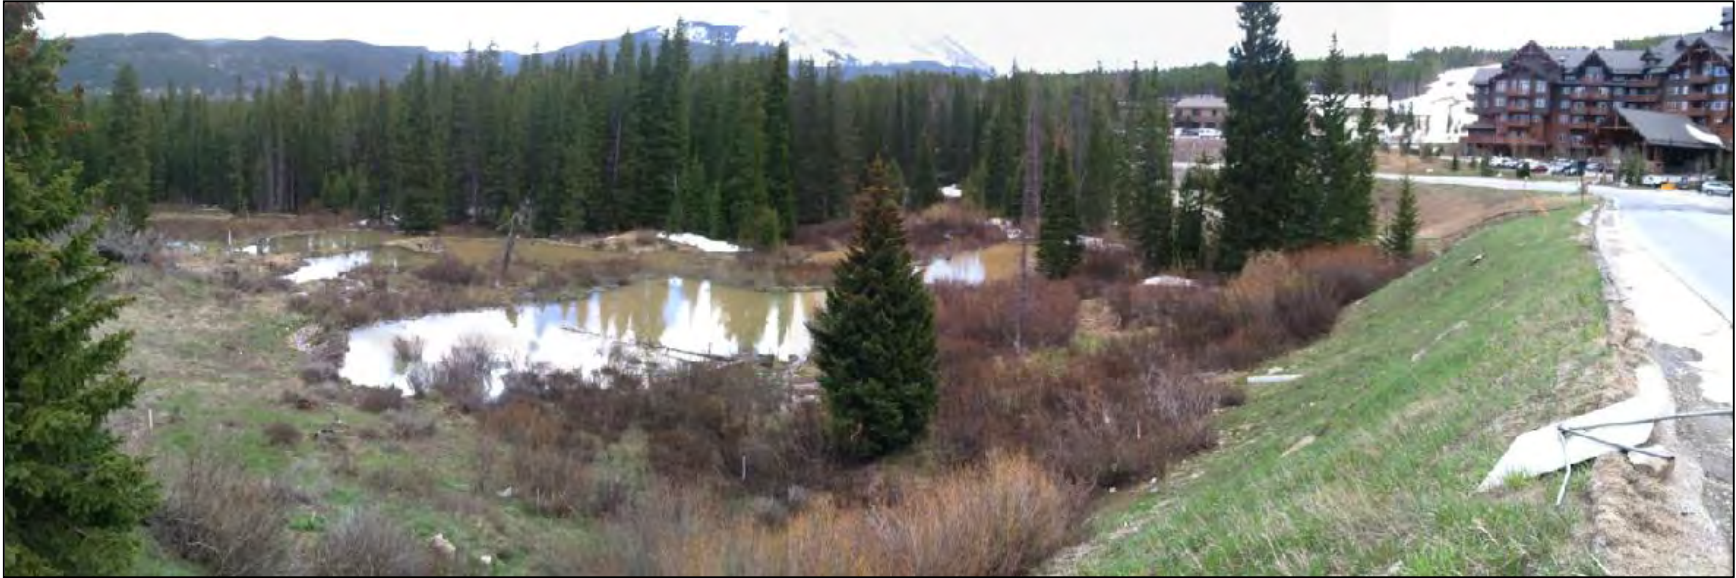
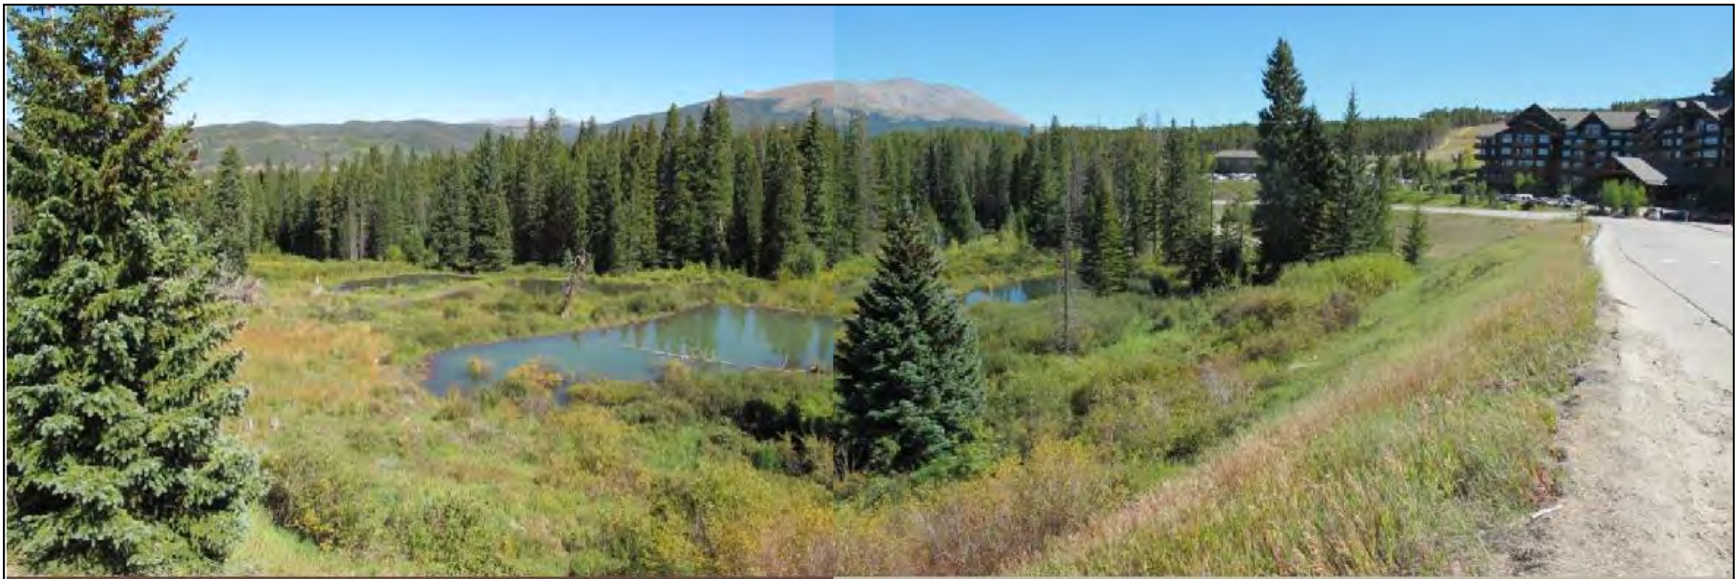
Photo C2c and d. Overview of Upper CG restoration. The upper photo is spring 2014 and the lower photo is from summer2014.

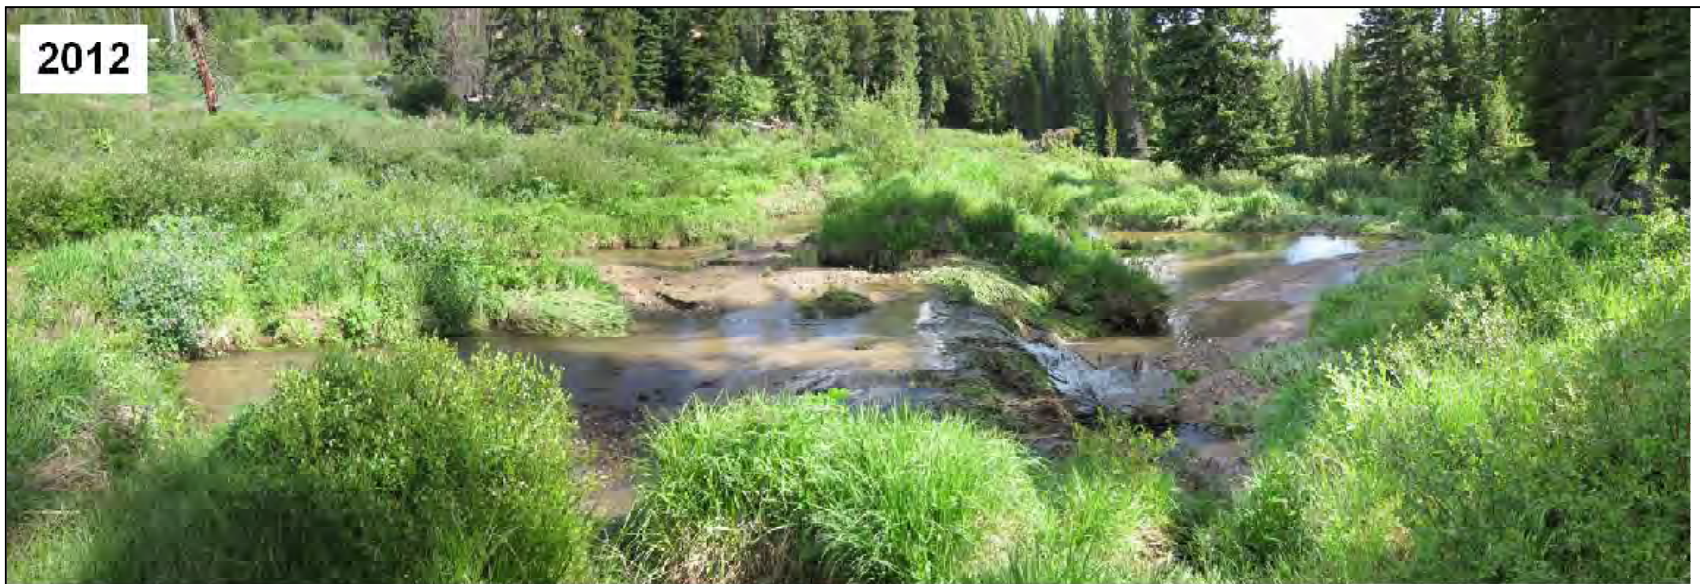
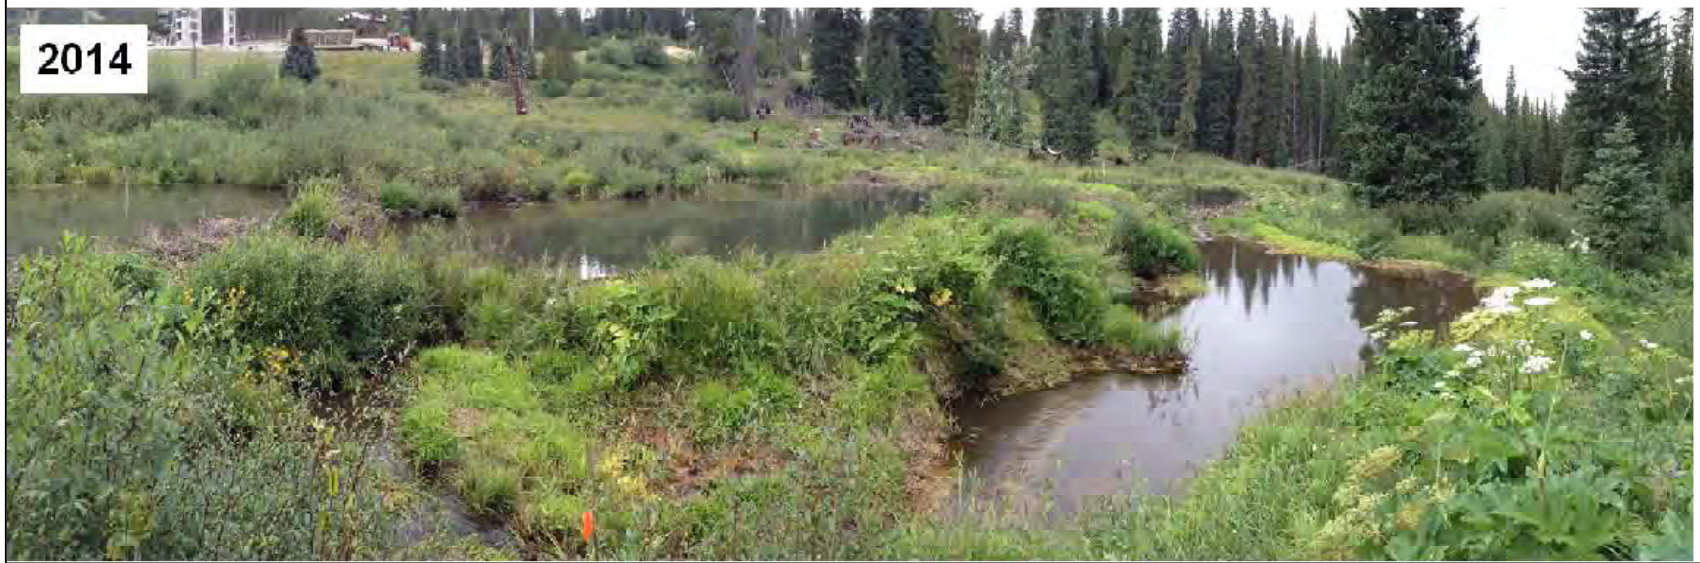
Photo C4a. This photo shows where the lateral channel (green arrow) splits off from Boreas Creek just downstream from a boulder energy dissipation structure.

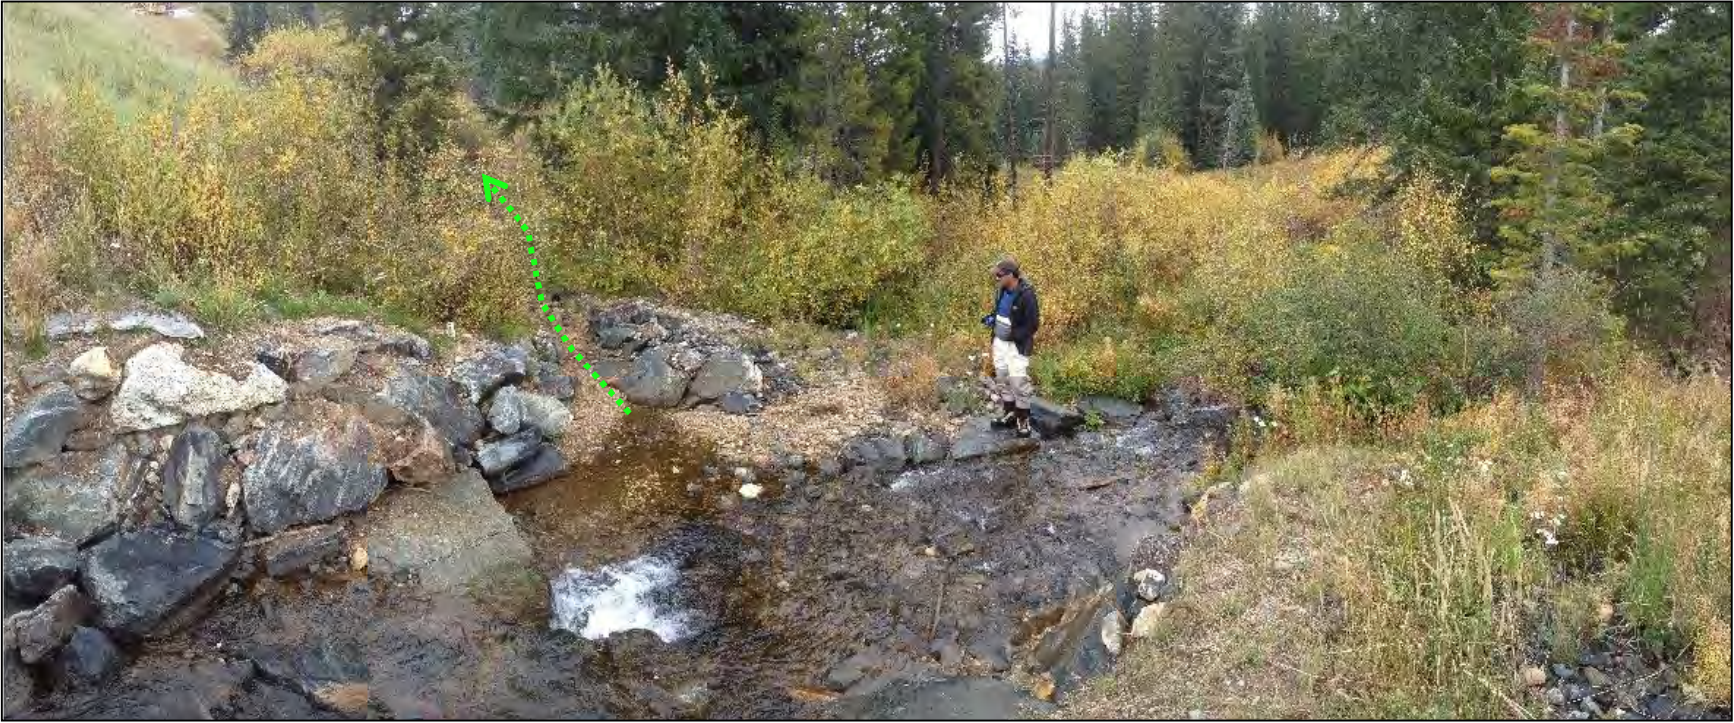
Photo C4b. *The left photo shows the inlet to the lateral channel immediately after construction in 2012. The right photo shows the same area in 2014 after flows to the channel were blocked by accumulated sediment. We restored flows to the channel on this day by digging a small trench through the deposited sand and gravel.*

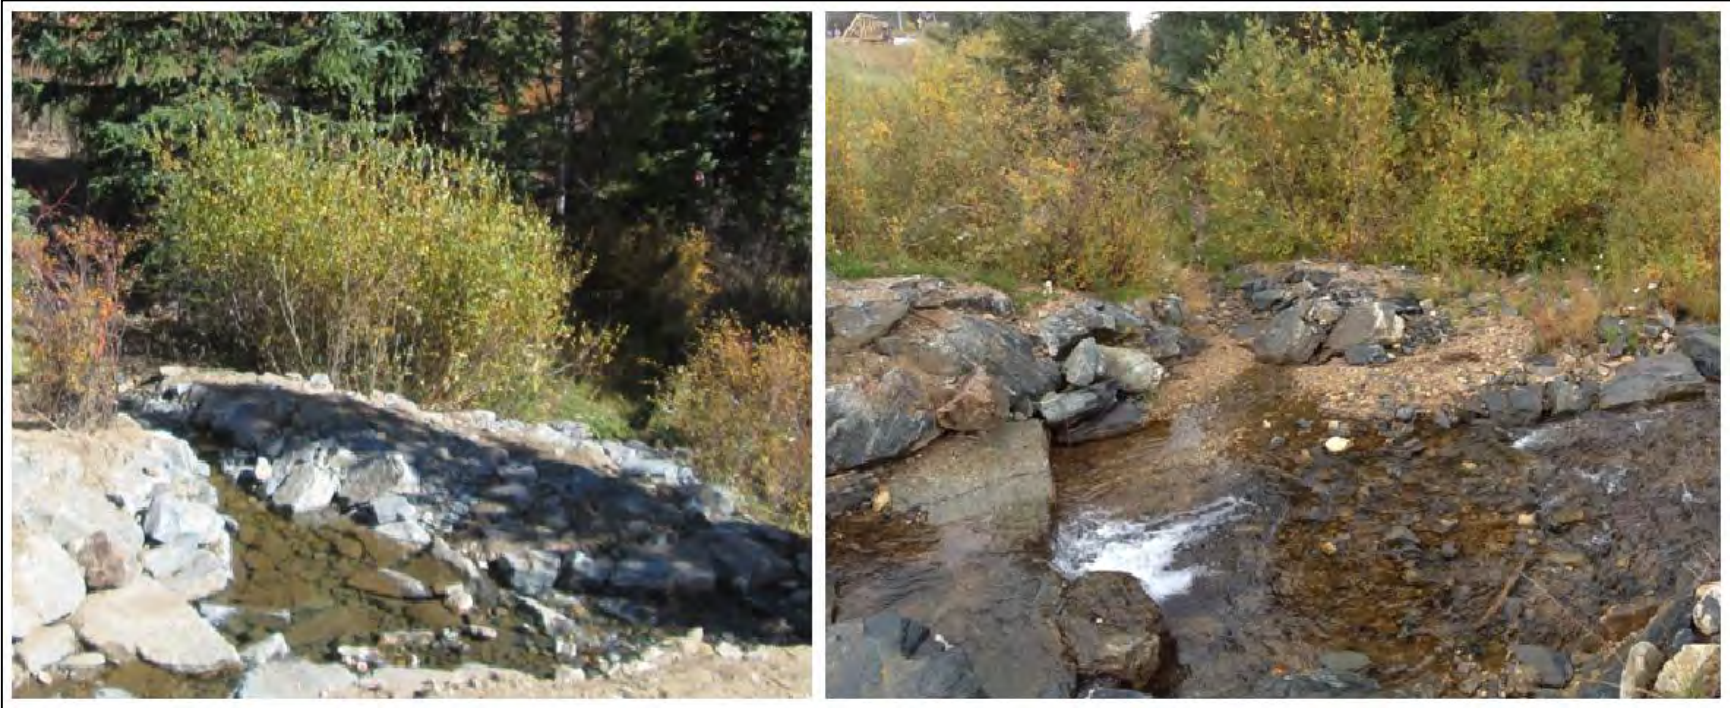
Photo C5. Deposition at Well A. The left photo shows Well A in 2012 and the right photo shows it during runoff in 2014 (from a different angle). The flowing water is outflow from the lateral spreader ditch. Note the amount of sediment deposition.

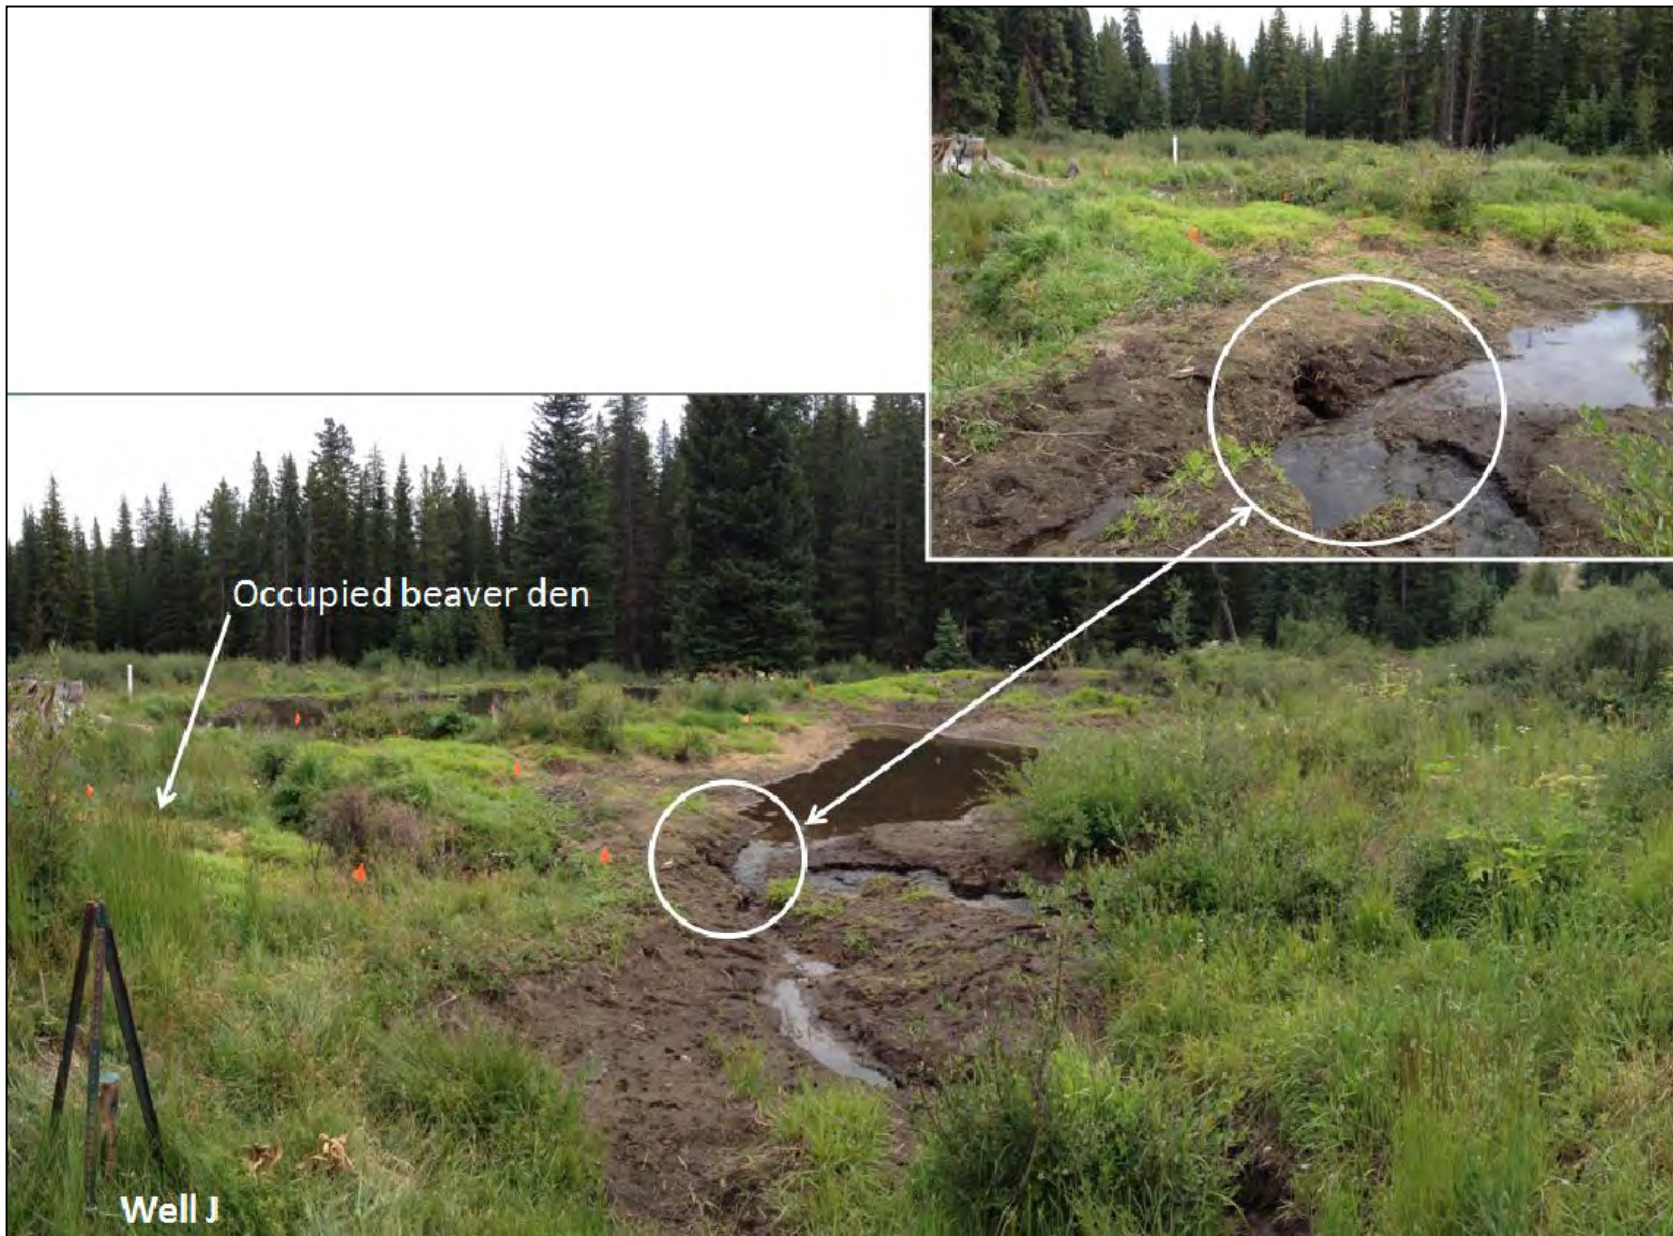
Photo C6. Photos of the pond that drained in 2014. The pond drained through a hole in the dam which is circled and shown in the inset photo. An adjacent occupied beaver den is also shown. Note the proximity of well J to the pond. The water table dropped when the pond drained.

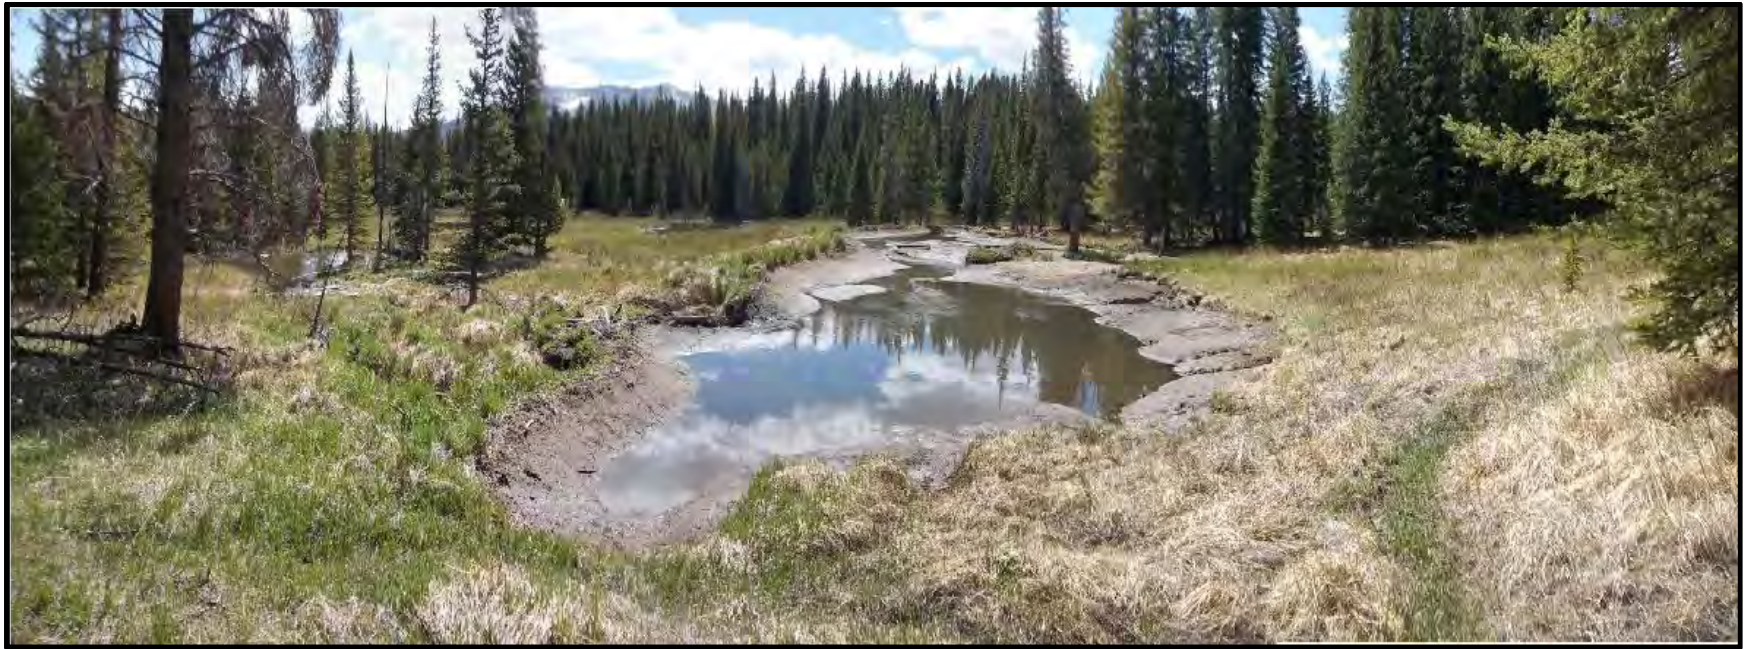
Photo C7a. Reset pond early in 2012, prior to restoration.

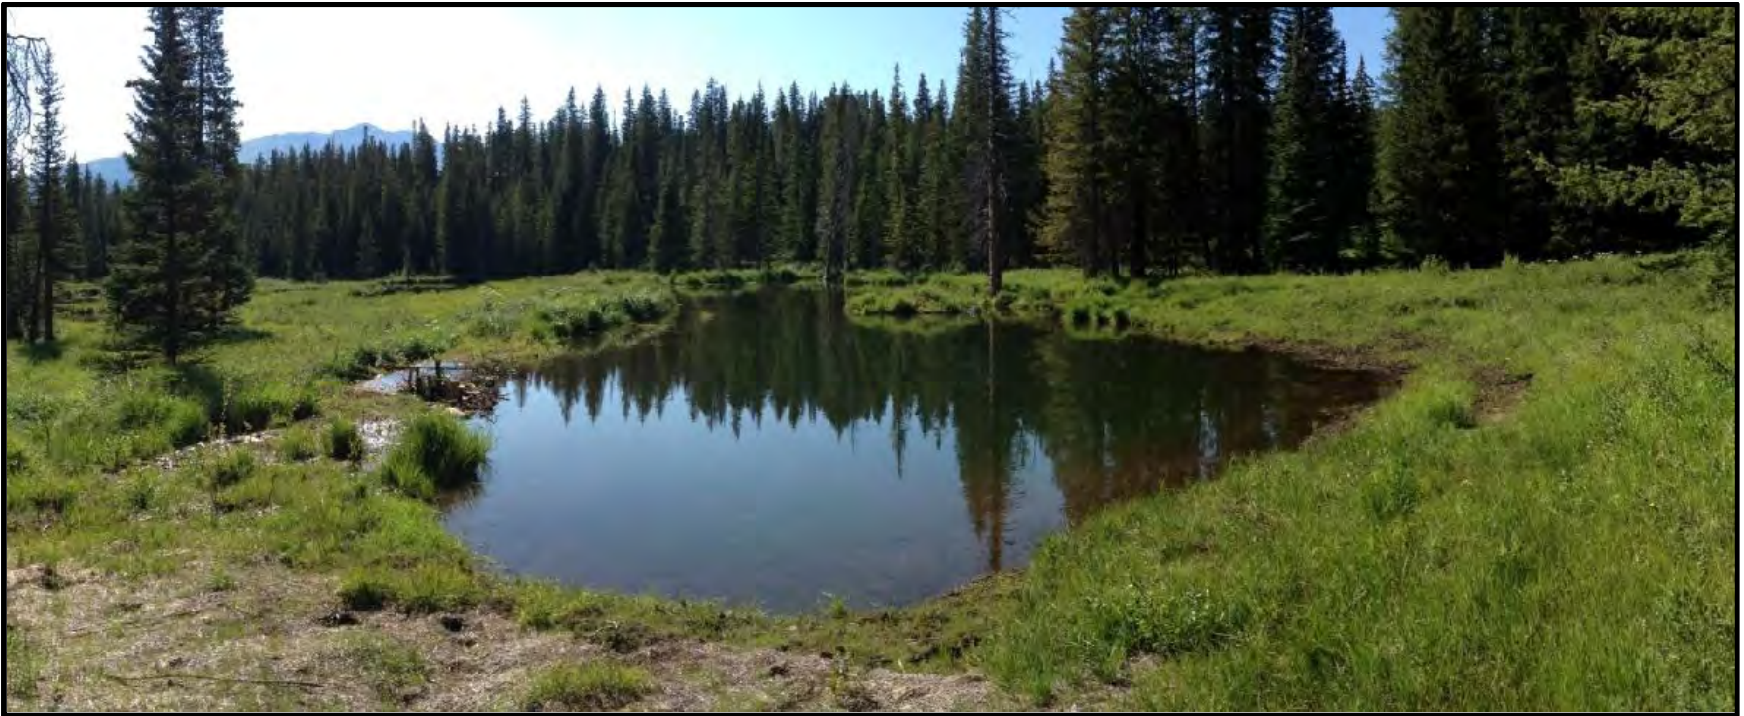
Photo C7b. Reset pond early in 2013, after restoration but before beavers occupation.

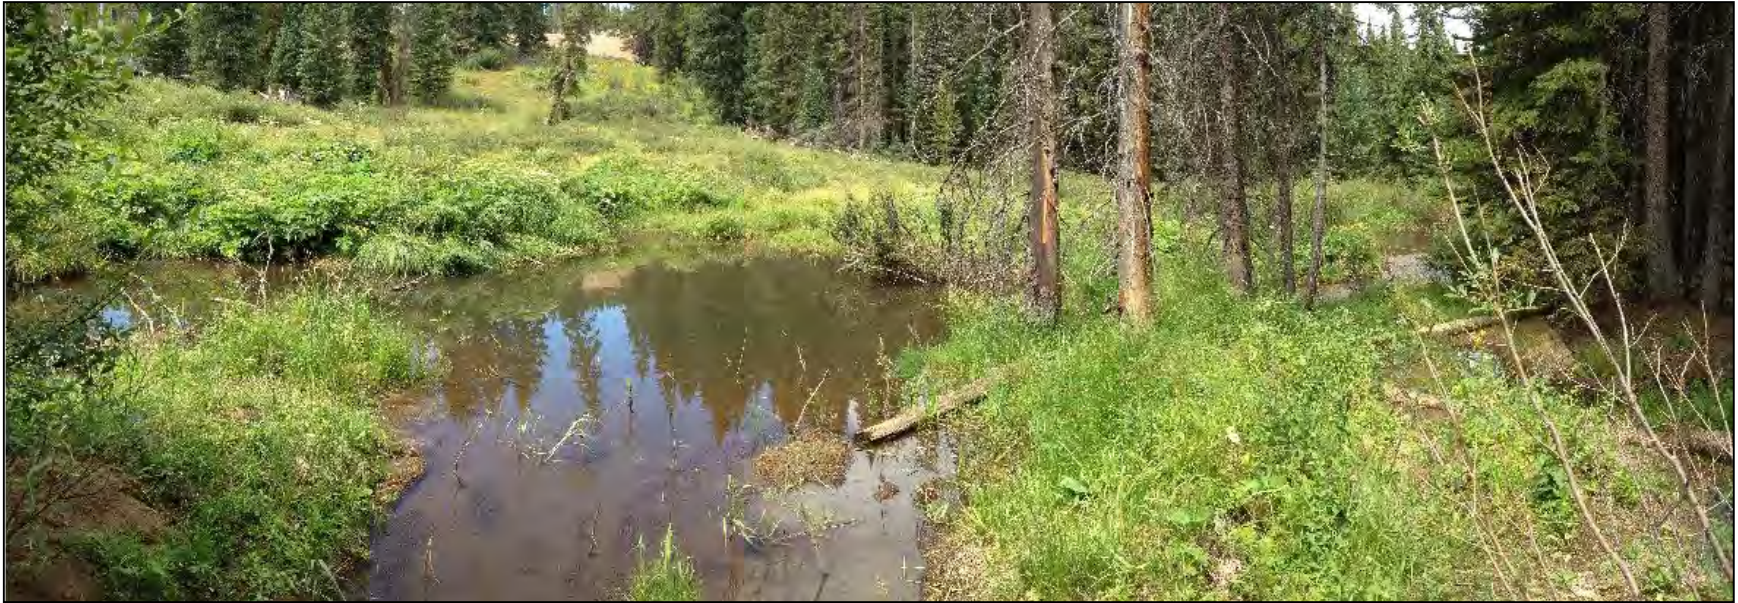
Photo C11. Excess aquatic vegetation and algae was observed in Boreas Creek on the project area in 2014.
