A Comprehensive Assessment of Wetland Condition in Cucumber Gulch Preserve, Breckenridge, Colorado.

Report Submitted to the Town of Breckenridge, CO

10/31/11

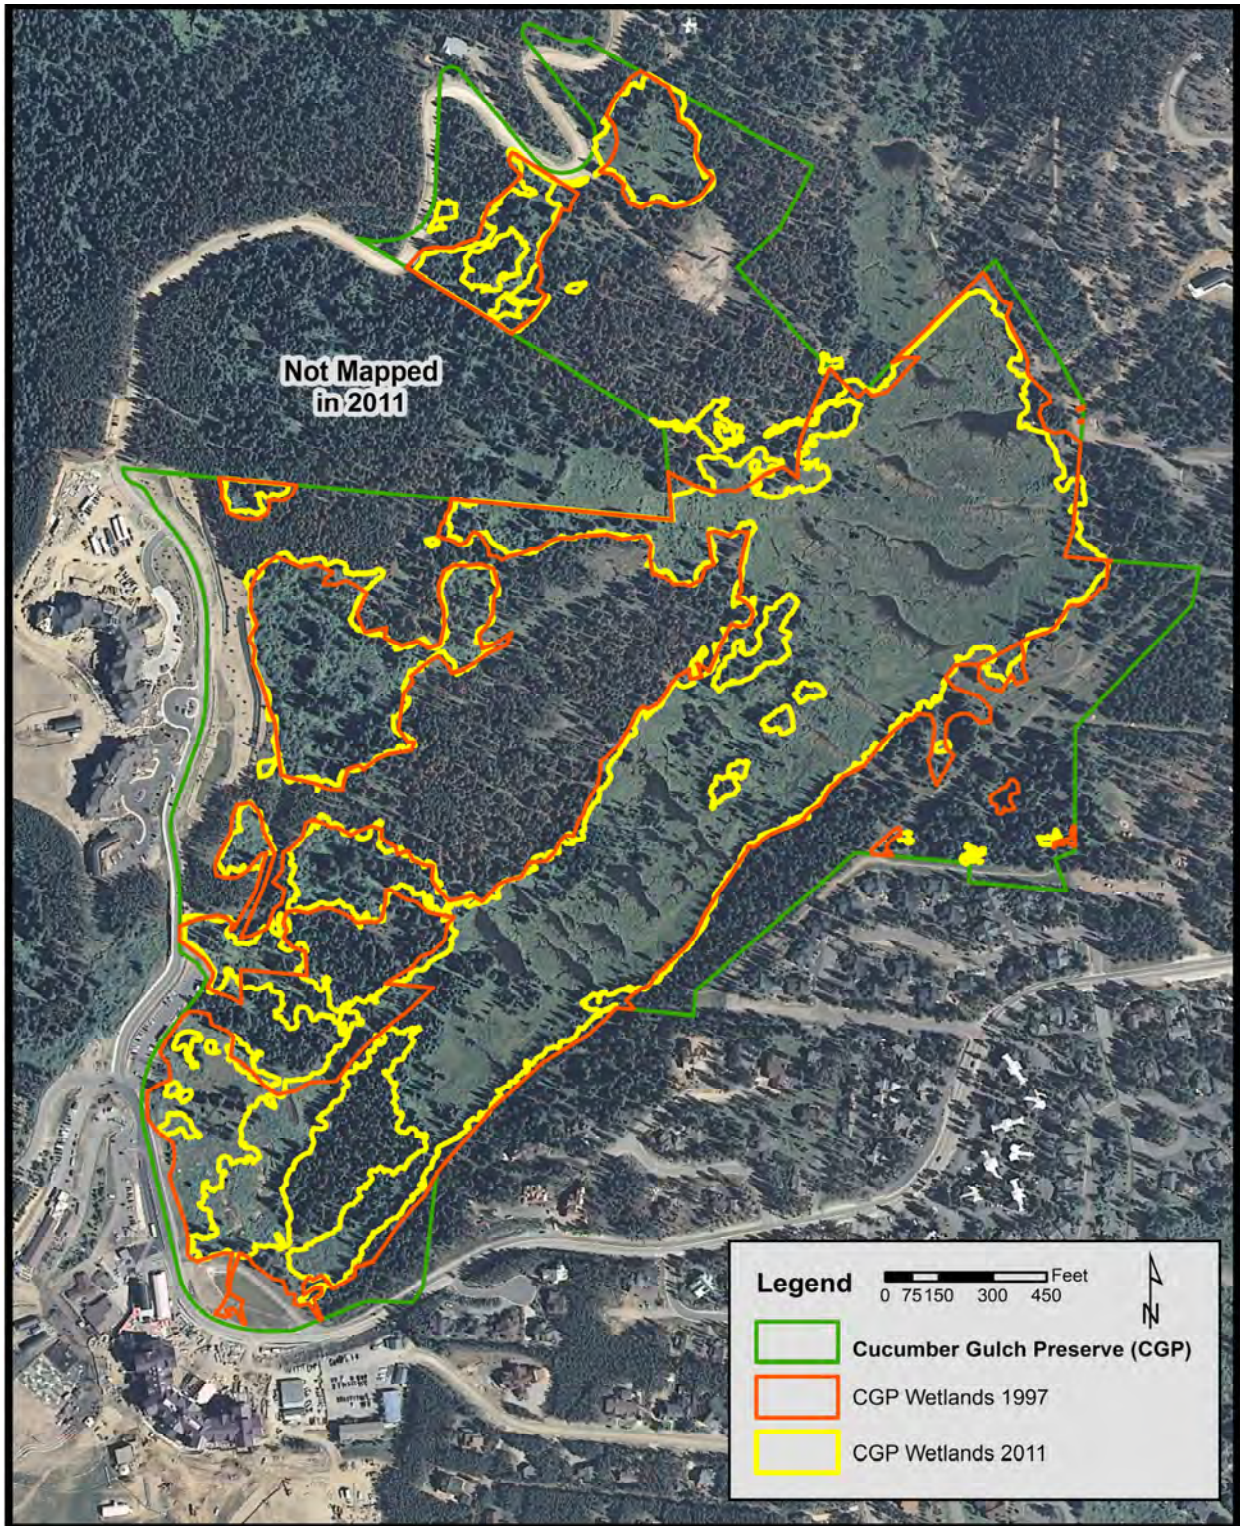
Fig. 6. Map showing the extent of wetlands in the CGP delineated as part of this 2011 study (yellow outline). Previous mapping of wetland extent from a 1997 delineation provided to us by the Town is also shown for reference (orange outline).

Given the uncertainties about the accuracy and precision of past delineation maps, we are unable to provide a precise numerical estimate for the degree of change in wetland extent from 1997 to 2011. Still, visual comparisons between past and present wetland boundaries may be made to identify broader trends in wetland coverage. In general, differences in wetland boundaries between the previous and current mapping can be attributed to: 1) technological advances between 1997 and 2011, 2) presumed differences in methodology, 3) mapping or file errors, or 4) actual physical changes in the extent of wetlands.

For the most part there is good correspondence between the two mappings, although the 2011 map has a much finer resolution than the 1997 map. The 1997 map, however, contains several obvious anomalies and omissions. For instance, in an outlying area south of the main CG wetland, we found that one small patch mapped as wetland in 1997 is actually upland (Fig. 6). We did not observe any obvious relict wetland features at this location or any obvious factor that could have led to the extirpation of the wetland; thus we conclude that the 1997 delineation of this patch is most likely an error. Similarly, the original mapping appears to have missed a large inland of upland habitat between the north and south arms of Upper CG.

In Upper CG, a comparison of the past and present wetland delineations shows an inward movement of the boundary. Based on an overwhelming amount of evidence, the change in the wetland boundary location documents a real phenomenon of wetland recession, rather than an aberration of mapping. The trend in habitat loss is corroborated by the WER 2008 study²⁵ which revised a portion of the wetland boundary inward based on results from a delineation that they performed in 2007, combined with quantitative monitoring data. Together the 1997, 2007 and 2011 mappings neatly describe an east and southeastward trajectory of wetland recession which spatially follows the terrain and temporally tracks adjacent development activity (Fig. 7). In other words, the wetland has been retreating down valley in step with intensifying land use in the adjacent, up-gradient Peak 8 base area development.

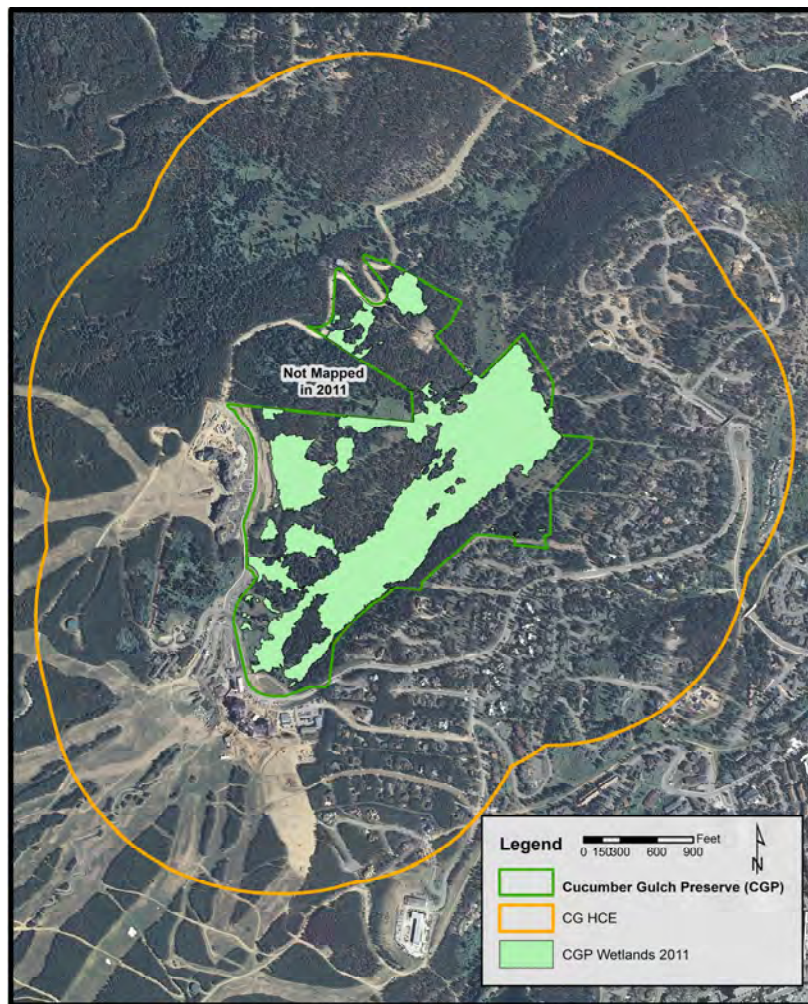
Fig. 8. The Habitat Connectivity Envelope (HCE) around Cucumber Gulch Preserve is identified as the area surrounding it within the orange boundary. Substantial migration and dispersal barriers exist along much of the perimeter of the Preserve. Additionally, development has led to known, but un-quantified, loss of wetland habitat within the HCE. Important connections to neighboring wetlands north (Cucumber Gulch) and northwest (Cucumber Creek) are still intact, however.

from the boundary of the area being assessed, and it is evaluated according to the degree to which the historical habitat wetland/riparian habitat connections have been lost due to habitat destruction or constructed barriers. The Breckenridge ski area, base area, residential development, and roads fill nearly the entire width of the HCE in its up-gradient portion. Given the nature of these land use changes, we assume that this development involved some loss of historic neighboring wetland, but the amount is uncertain and we did not attempt to further quantify such losses. Roads, retaining walls, culverts, and development also pose moderately impermeable barriers to most wildlife between the AA and any remaining wetland habitats that neighbor CGP to the south (towards Peak 8) or east (towards town). Ski Hill Road and the Peak 7 Base area form less severe barriers between the AA and remaining wetland areas on the Peak 7 portion of the ski area to the west.

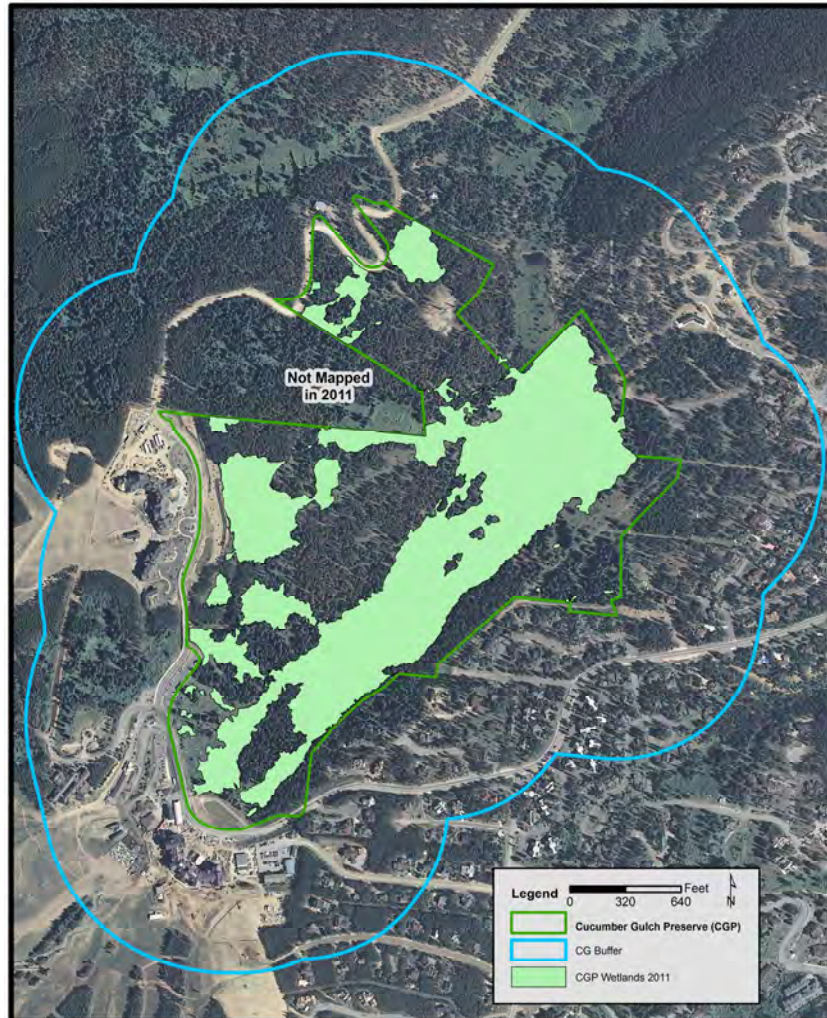
Fig. 9. Buffer area around CGP is the area between the Preserve boundary and the blue line. Much of the buffer area has undergone land use change, particularly up-gradient from the AA, so buffering capacity is often extremely limited.

Given the geographic distribution of impacts within the buffer area of CGP from severe to minimal, buffer capacity varies significantly from place to place. Because of the prevalence of high-intensity land uses along most of the up-gradient perimeter of Upper CG, buffer capacity for this area is rated ***non-functional (F)***. Buffer impacts around Peak 7 are equally severe but less extensive. Only about half of the CGP perimeter along the Peak 7 Side Slopes is severely impacted (along the Peak 7 Base Area) while the rest of the Peak 7 SS has only minor impacts to buffer capacity (north of the base area). Overall, buffer capacity for this area warrants a rating at the lower end of ***functioning (C-) to functioning impaired (D)***. The buffer area around the Lower CG, on the other hand, is rated as ***highly functioning (B)***. Impacts to the buffer area around Lower CG are limited to the moderate stress from residential development on the eastern edge, while the rest of the perimeter is essentially unimpacted.

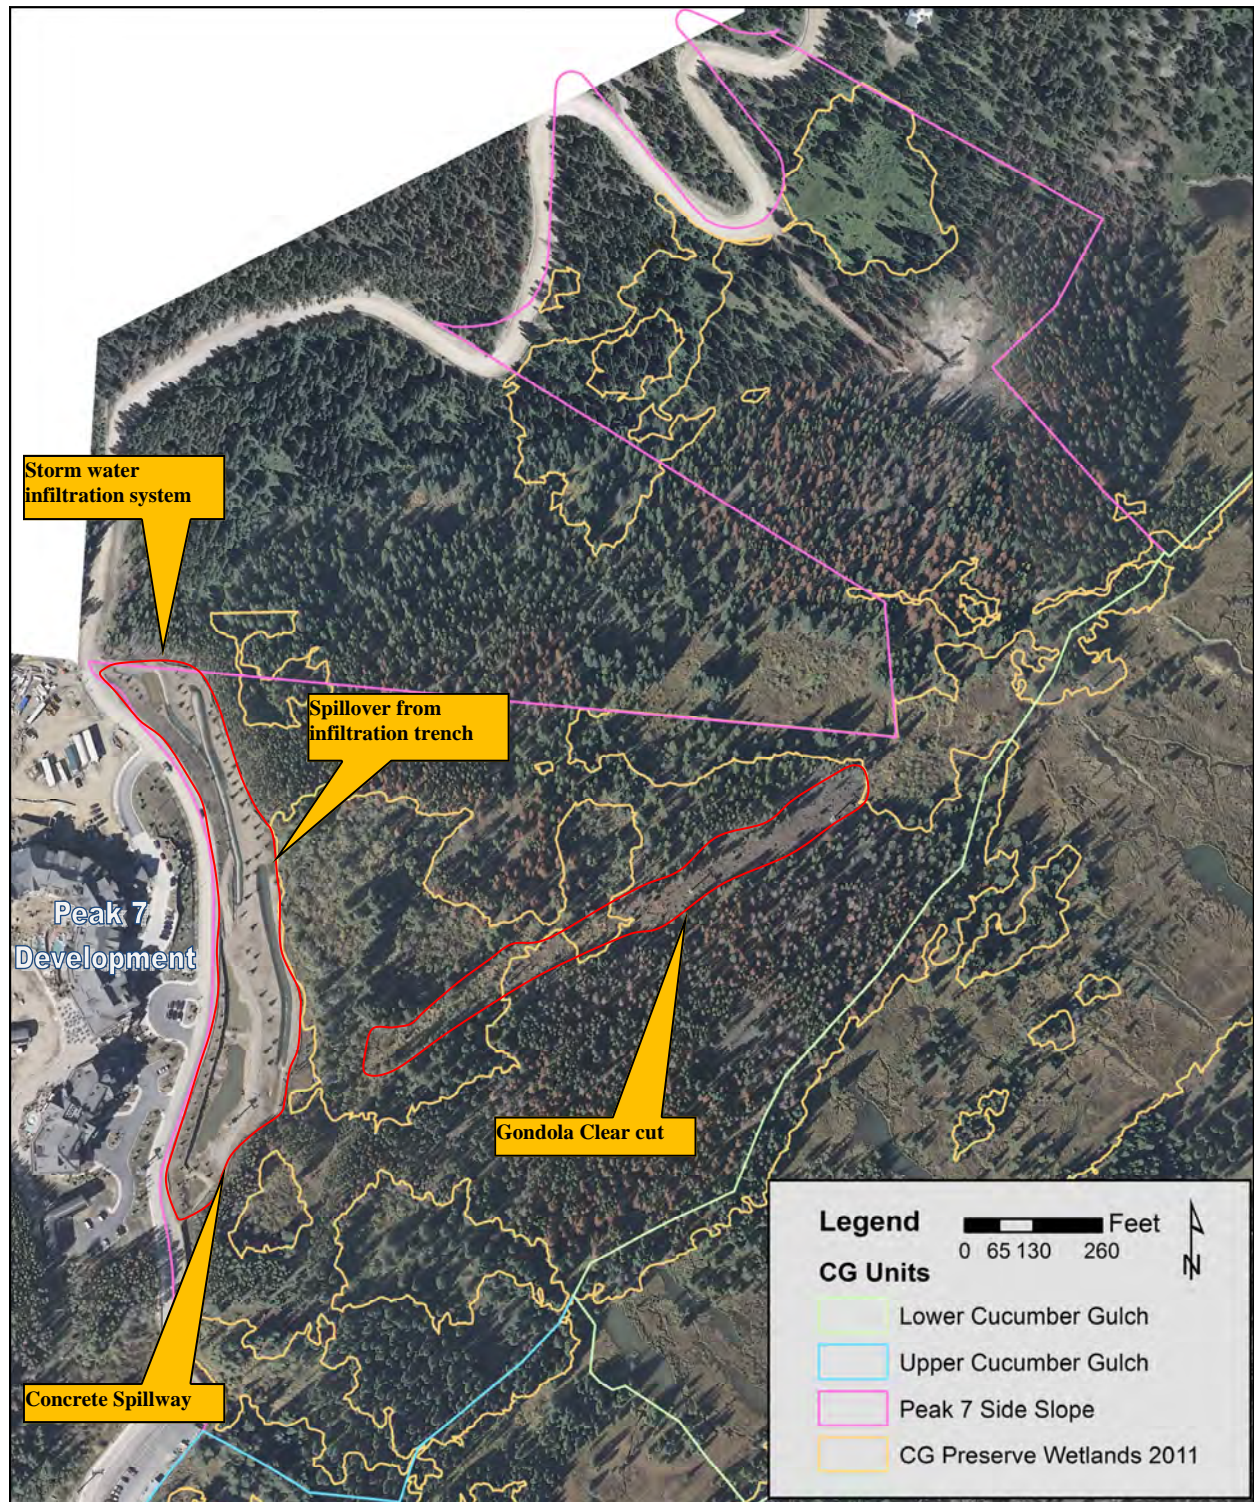
Fig. 10. Peak 7 Side Slope assessment unit.

The one interior stressor of note within the Peak 7 SS is the gondola line. The gondola line is a swath of cleared forest canopy that cuts diagonally through the unit from top to bottom (Fig. 10 and Photo 9). Clearing the canopy here resulted in a loss of shading which causes increased ground temperatures and drying. During our delineations of this area, signs of temperature and drought stress were apparent on wetland plants. It would seem to follow that

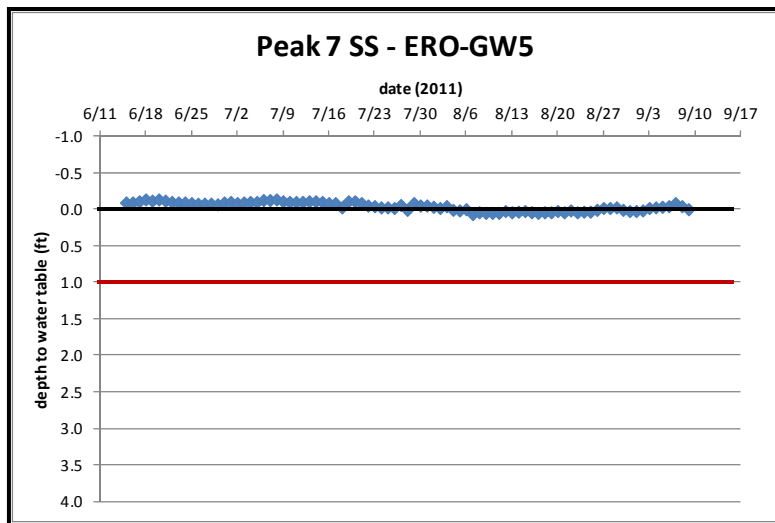
In a 2009 report, ERO₃ cautioned about potential wetlands impacts downstream of the new bridge. These findings were based on a reported groundwater level decline of 2 feet between May and October 2009 at the ERO-GW5 monitoring point. According to the report, this would have been "*the largest seasonal decline measured in a Cucumber Gulch well during seven years of sampling,*" and dewatering of this magnitude would surely be a serious threat to wetland function. To follow up on this potential threat, we visited the site in May 2011, and

found the ERO-GW5 well at that site to be functioning improperly. We also installed a new automatic data-logging shallow groundwater well at this site (Photo 8) which has been collecting water table data daily since June 15, 2011. The results (Fig. 11) show a consistent water table within 0.2 ft of the ground surface throughout the season, which is consistent with the GL&A results described above that show no significant impacts at this location. We conclude that the reported water table decline in 2009 can be attributed to error or malfunction.

Fig. 11. Hydrograph from the shallow groundwater well at site ERO-GW5 in the Peak 7 Side Slope near the Bridge Creek Bridge and the Stables Lot. The black line is ground surface. Blue diamonds are readings of water table elevation. The red line shows a depth of one ft below ground surface. The water table at this site remained within 0.2 ft of ground surface for the 2011 season. That is, it was perpetually saturated.

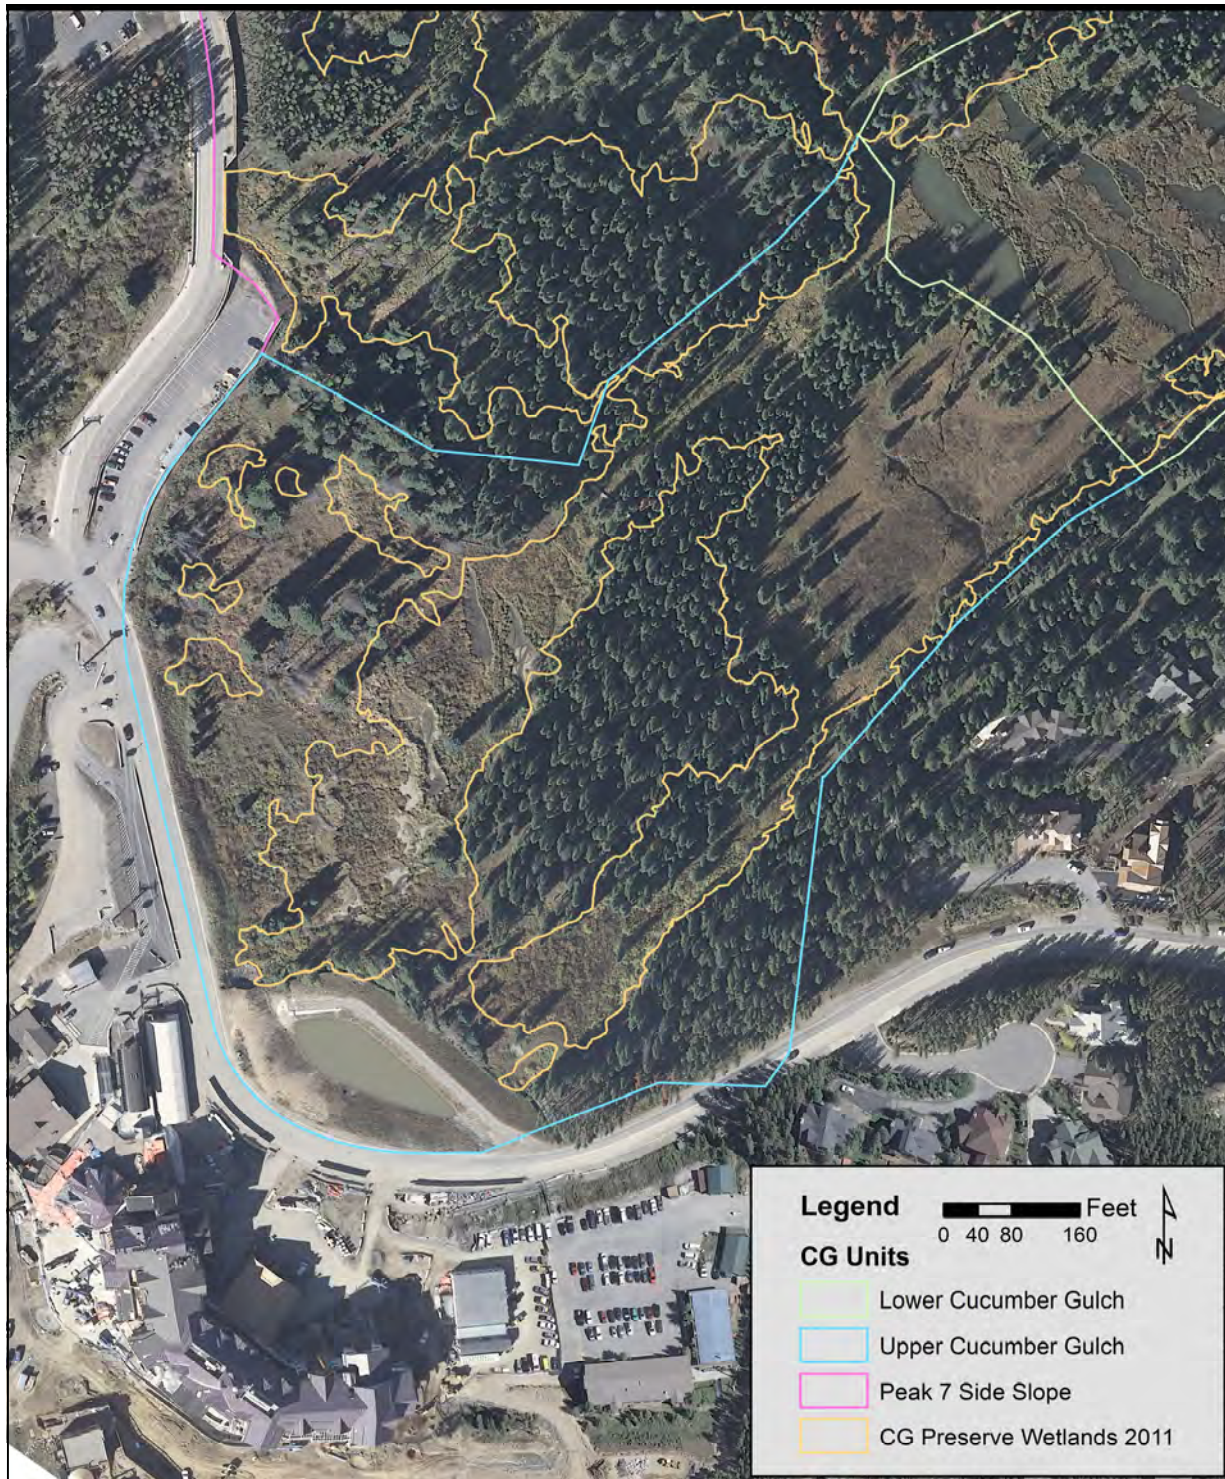
Fig. 12. Upper Cucumber Gulch is comprised of two wetland arms which come together in the lower portion of the unit. The north arm contains Boreas Creek which transports the majority of the runoff from the Peak 8 watershed and is a highly impacted, surface water system that was formerly maintained by beaver. The south arm is primarily a groundwater, spring-sourced slope wetland with fewer impacts.

The water source for the north arm of Upper CG has been highly altered from its natural state and the stressors underlying the changes result from both watershed-scale land use changes, as well as local site modifications. It is clear from a number of lines of evidence that human activities within the Peak 8 watershed directly impact the quantity, timing, and energetic characteristics of water flow into Cucumber Gulch and are thus seen as significant stressors to the wetland system (Photo 13). To our knowledge, there has been little quantitative characterization of the cumulative effects of land use changes, development and infrastructure on the Upper Cucumber Gulch water source. Consequently, most of the discussion below is based on our interpretation of the situation from first principles and direct observation.

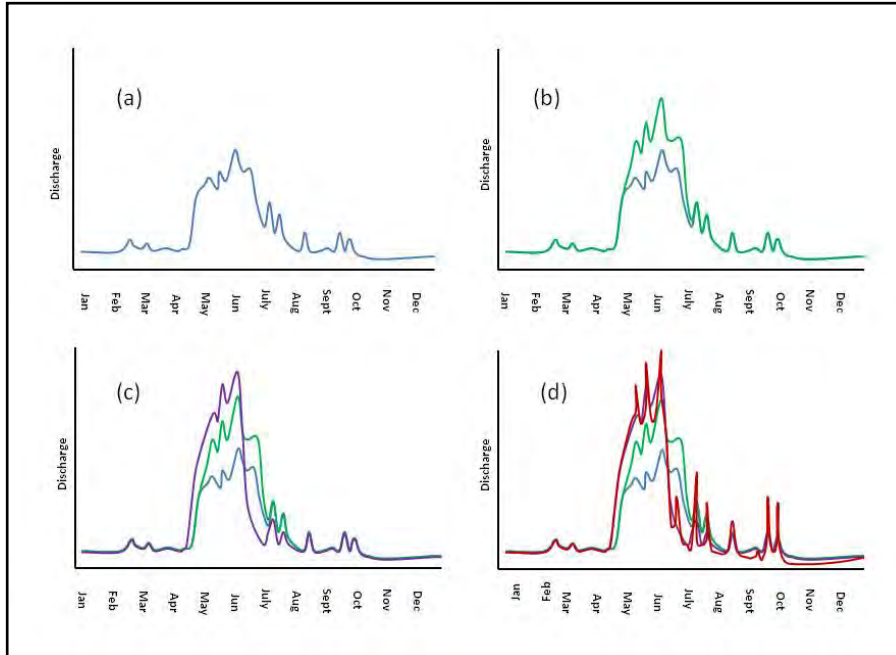
Fig. 13. Diagrammatic representation of inferred hydrograph shifts to the water source for Upper CG using a hypothetical hydrograph to show expected impacts of stressors. (a) A natural hydrograph would have the bulk of water entering the system during the snowmelt period, with more acute peaks from rainstorms and spates. (b) Augmentation from snowmaking would increase the discharge to the site during the snowmelt period. The area between the curves is the volume of water added to the system. (c) The effects of forest clearing on snowmelt would be to compress the same amount of volume released from snowmelt to a shorter, and probably earlier, portion of the season. (d) Decreased infiltration and surface runoff from impervious surfaces would make the hydrograph flashier. The difference between the blue and red curves represents the cumulative impacts from these sources. Actual hydrographs and changes have not been measured quantitatively.

Snowmaking began on Peak 8 in about 1997 and is now applied over a large percentage of the watershed area below tree line. An unknown, but substantial, amount of water is brought into the watershed during the fall and winter and applied to the slopes as artificial snow. When this bolstered snow pack melts, it constitutes a direct augmentation of the amount of water that flows into the gulch. The timing of augmented flows from snowmaking are coincident with the snowmelt period (typically May-June, though it varies by season) which is when the magnitude of inflows to the Gulch are

conditions). The result of forest clearing is that the hydrograph is shifted upwards during the snowmelt period, and downwards later in the season (Fig. 13 a-c).

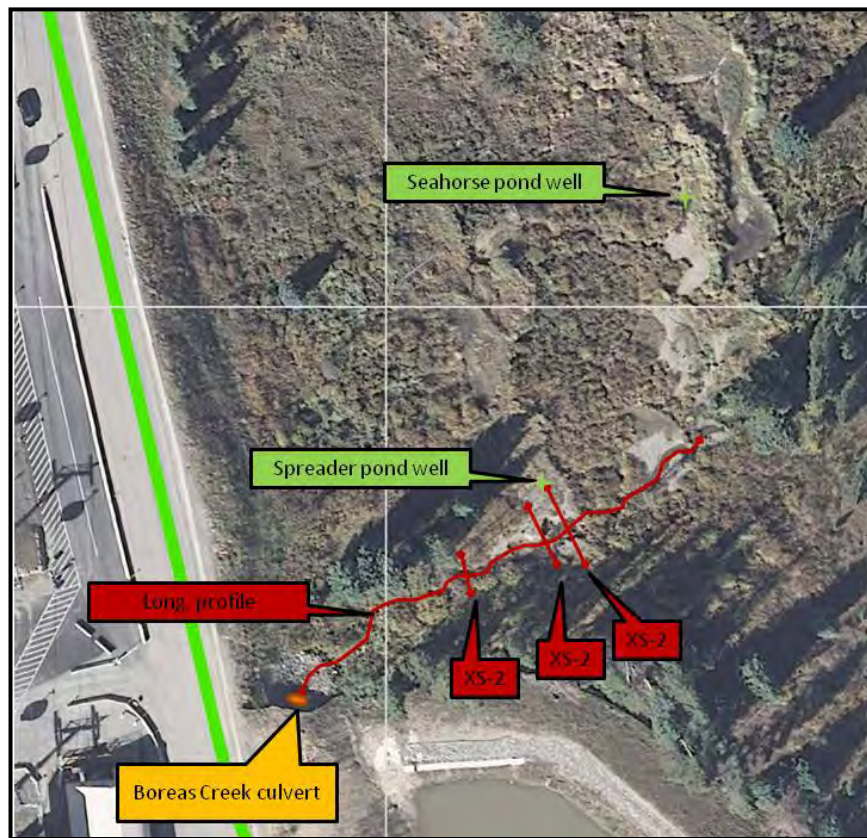
Supplemental water table monitoring data provides direct evidence of the recently diminished hydrology associated with drying ponds. In June 2011, we installed a shallow, data-logging groundwater well into the bed of what used to be the Spreader Pond, approximately 10 m from the Boreas Creek centerline (Fig. 15). The logger has been measuring water table depth daily since June 28, 2011.

Fig. 15. Location of Boreas Creek channel surveys and supplementary well locations in Upper CG.

On June 2, 2011 we completed a longitudinal profile survey and several cross section surveys of the upper 300 ft. of Boreas Creek in Upper CG (Fig. 15). Cross section end point and longitudinal profile stations were monumented to allow us to repeat these surveys to document geomorphological changes to the channel over time. We resurveyed the channel on August 5, 2011 for this purpose.

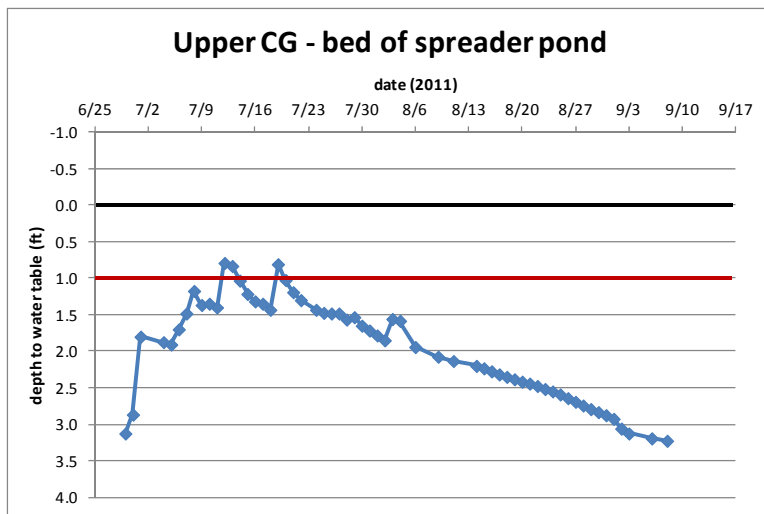
The results are plotted in (Fig. 16). This area, which was aquatic habitat (Photo 18) with perennial surface water as recently as 2007, now not only lacks surface water but appears to lack wetland hydrology altogether. Water table depth shallower than 1.0 ft. was measured on only four days during the 2011 season, in two peaks that followed large rainstorm events. An additional well and data-logger was placed in the bed of the “Seahorse Pond” about 40 m down-valley from the Spreader Pond (Fig. 15). This location is also within a pond that has been dewatered since 2007 (Photo 19). The water table hydrograph at this location does not show a complete conversion to upland hydrology (Fig. 17) since we recorded groundwater depth less than 1.0 ft. on 25 days. The reason for the peak in hydrology appears to be that the Seahorse Pond is located downstream from the first large sediment deposition area on Boreas Creek. During high flows, the deposition in Boreas Creek diverts water over the left bank and into the Seahorse Pond where it is impounded by a dam which is still mostly intact.

Fig. 16. Hydrograph showing water table depth in a shallow groundwater well that was placed on the bed of the recently-dried Spreader Pond in Upper CG. The black line is ground surface. Blue diamonds are readings of water table elevation. The red line shows a depth of one ft. below ground surface. The water table at this site was deeper than 1.0 ft. for all except four days of the 2011 season, indicating that wetland hydrology may no longer be present at this site.

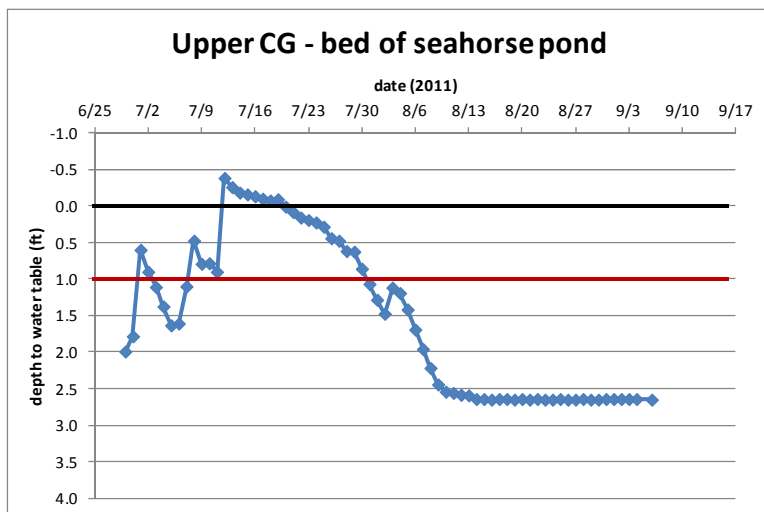
Fig. 17. Data from the well in the Seahorse Pond shows that impounded surface water was present in July. The water table was shallower than 1.0 ft for approximately 25 days this season, indicating the presence of wetland hydrology at this point.

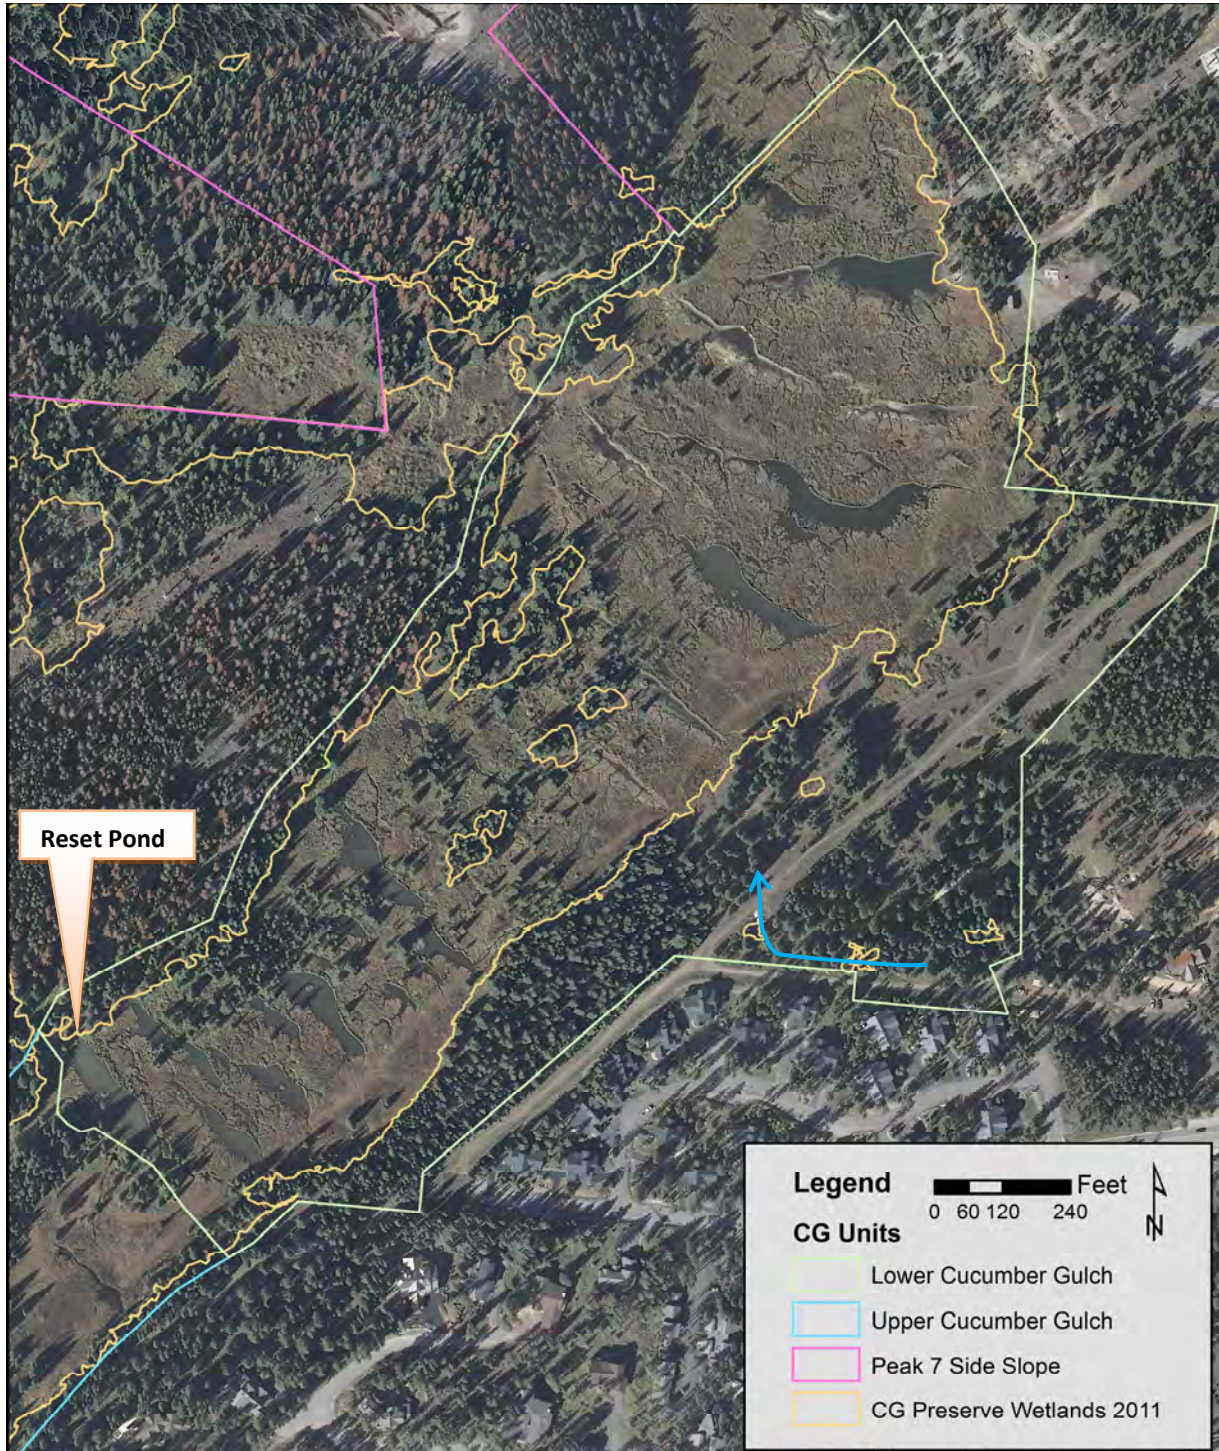
Fig. 23. A 2010 aerial image showing the Lower CG assessment unit and the extent of wetlands within. The blue arrow shows the flow path of residential runoff. The wetland nearest the arrowhead is in the vicinity of the location the suspicious water sheen that was sampled (see Water Chemistry section, below).

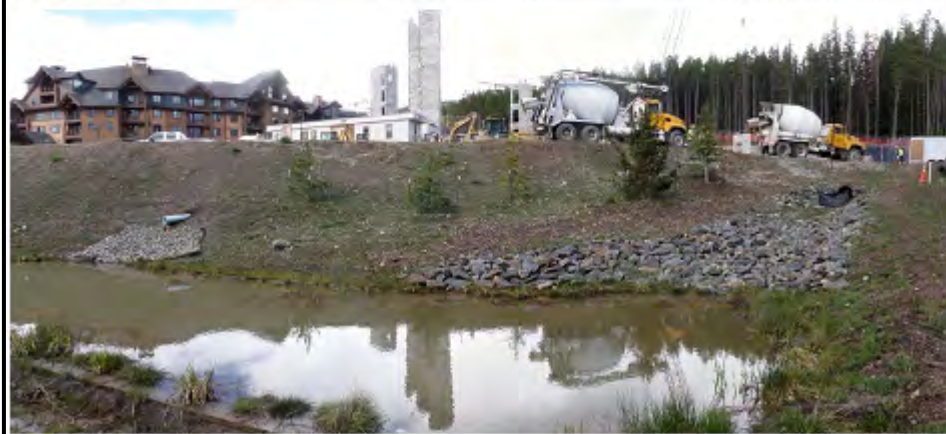
Photo 3. Major stressors to habitat connectivity and buffer capacity along the Upper CG edge include the Peak 8 base area developments, Ski Hill Road, detention ponds, and an engineered drainage system.

The lower photo shows the Peak 8 detention pond with Ski Hill Road and ski area base facilities in the background. The culvert in the foreground is Boreas Creek. Nearly all of the surface runoff from the Peak 8 watershed enters Upper CG at this point. Peak 8 watershed, the primary water source for Upper CG is entirely within the ski area.

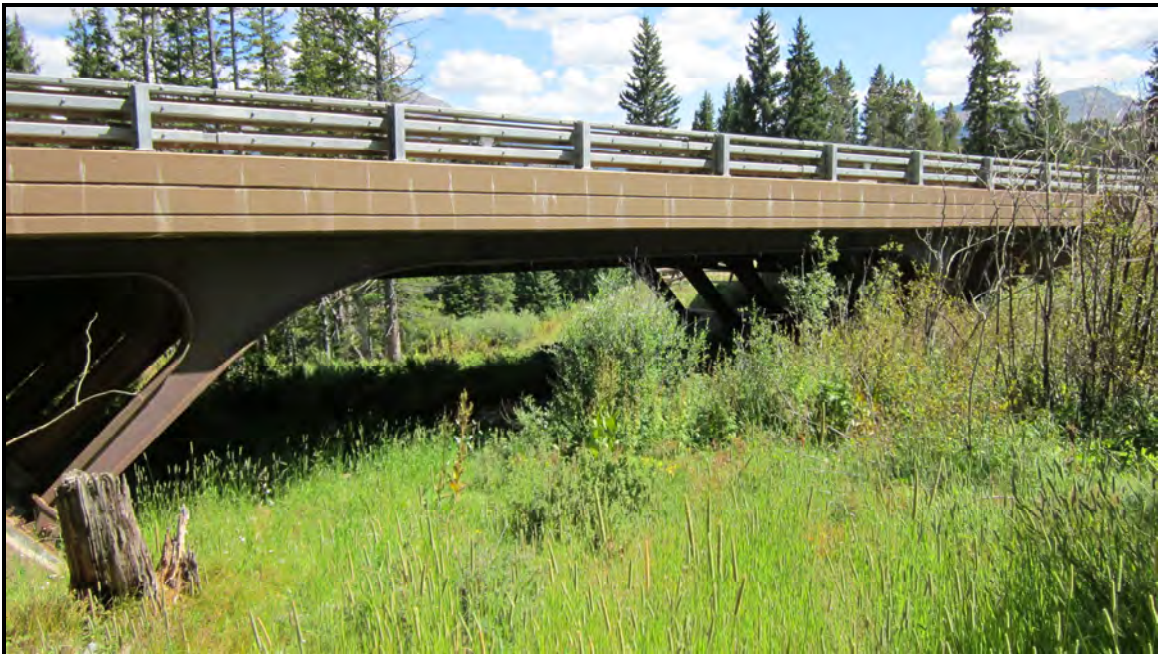
Photo 7. The realigned Ski Hill Road crosses over Bridge Creek via a bridge span rather than a culvert allowing much better hydrologic and migration connectivity between CGP and wetland habitats upstream. The bridge is high enough that everything from aquatic organisms to moose can pass through the opening.

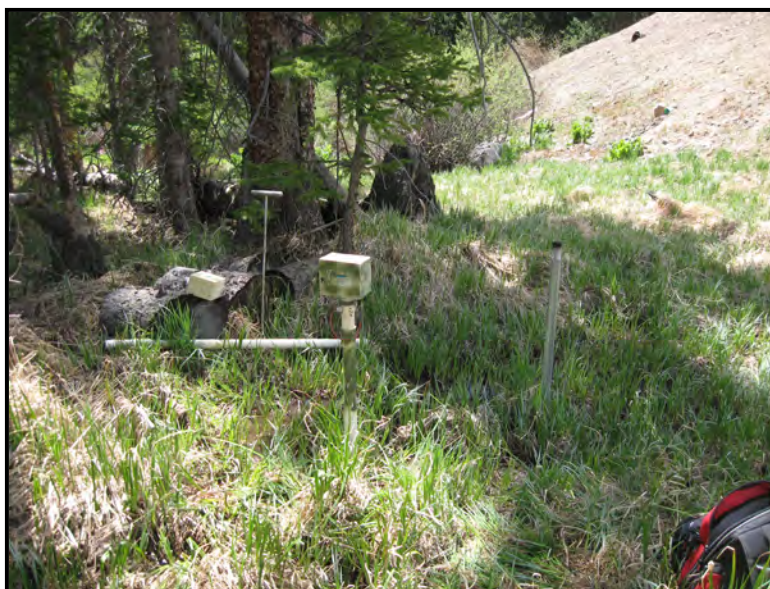
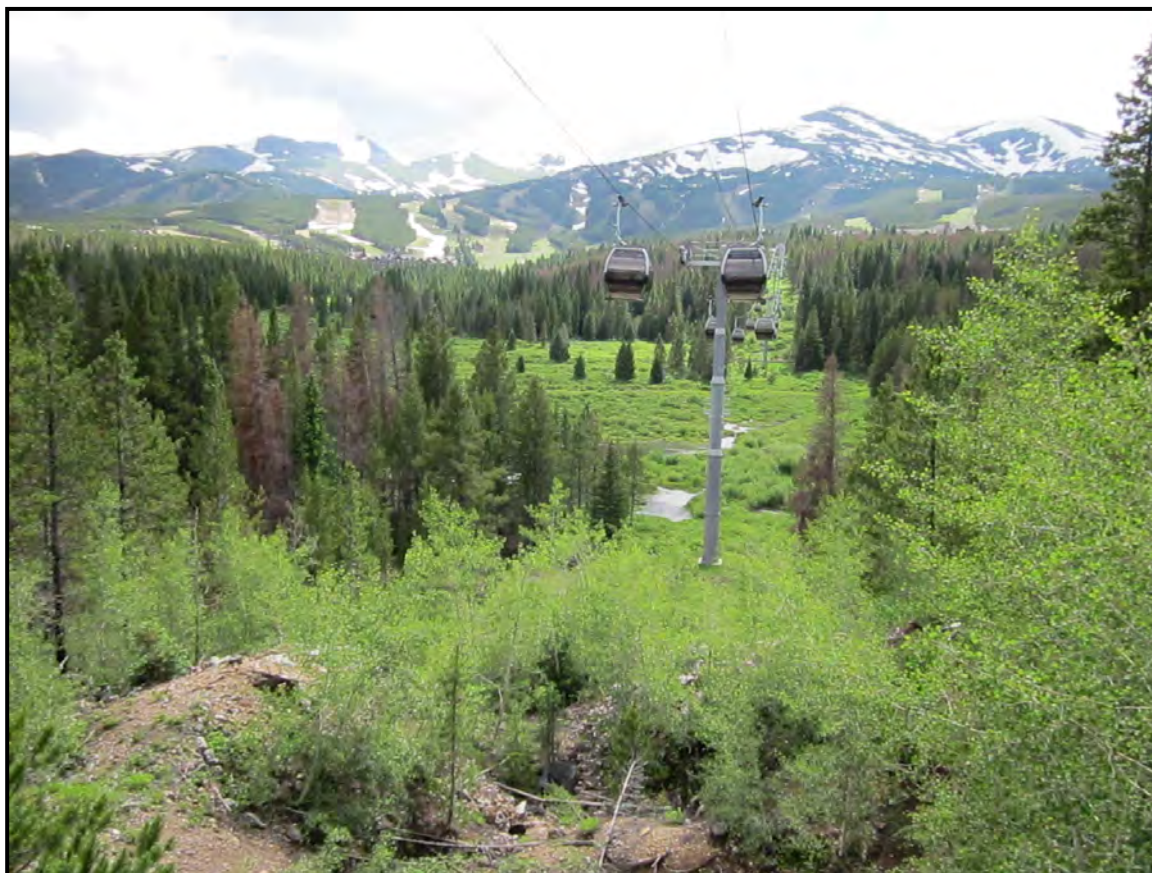
Photo 9. A gondola crosses CGP from Shock Hill (foreground), across Lower CG (center), and back up through the otherwise forested Peak 7 SS (background). Within the Peak 7 SS unit, the clear cut lift line is recognized as a direct stressor on vegetation, and an indirect stressor to water distribution and abiotic habitat via temperature and drying effects secondary to the removal of the shading canopy and shrub clearing.

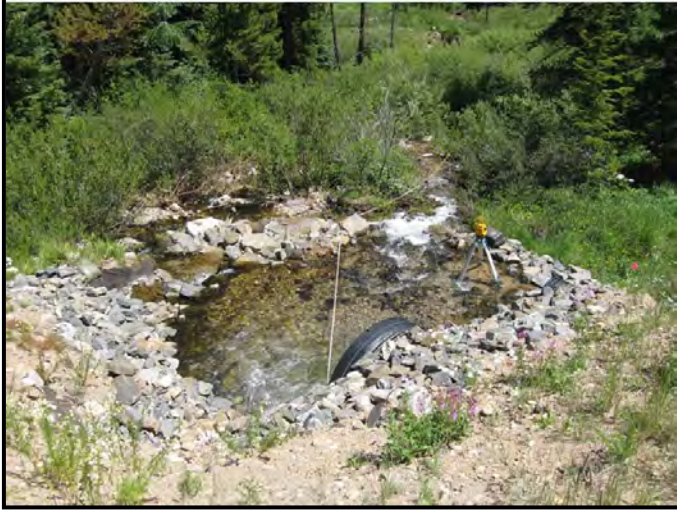
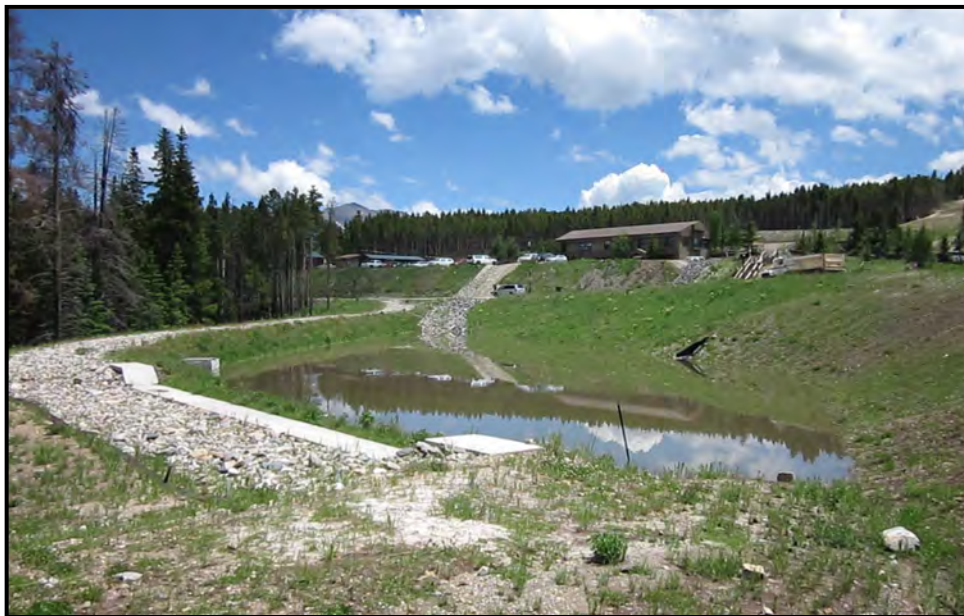
Photo 15. Surface runoff from some of the Peak 8 base area flows into this retention pond which held water for the length of the 2011 season.

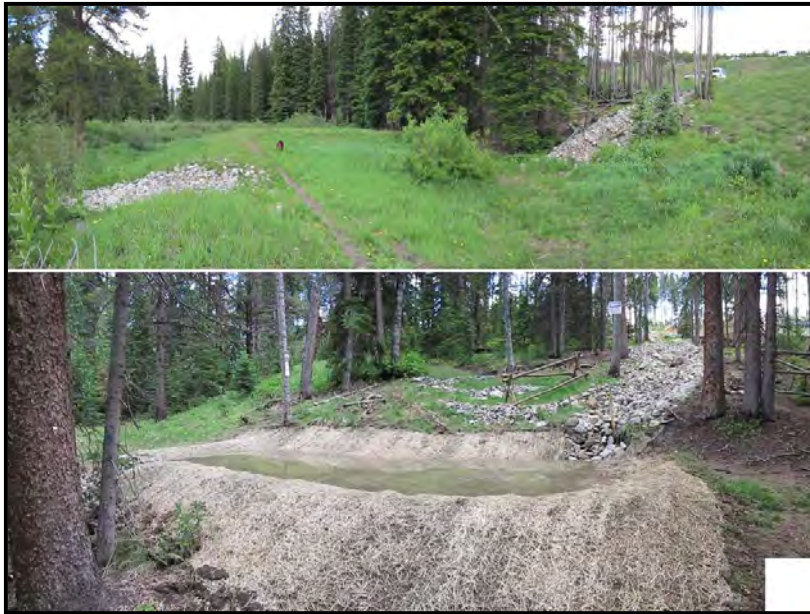
Photo 22. In addition to the main Peak 8 detention pond, two other primary storm drainage-ways enter CGP on the south arm of Upper CG. The Admin. drainage/detention pond (upper photo) was never observed to hold water during the 2011 season.

The Glenwild detention pond (lower photo) was just constructed during July, 2011. This channel did run during rainstorm events.

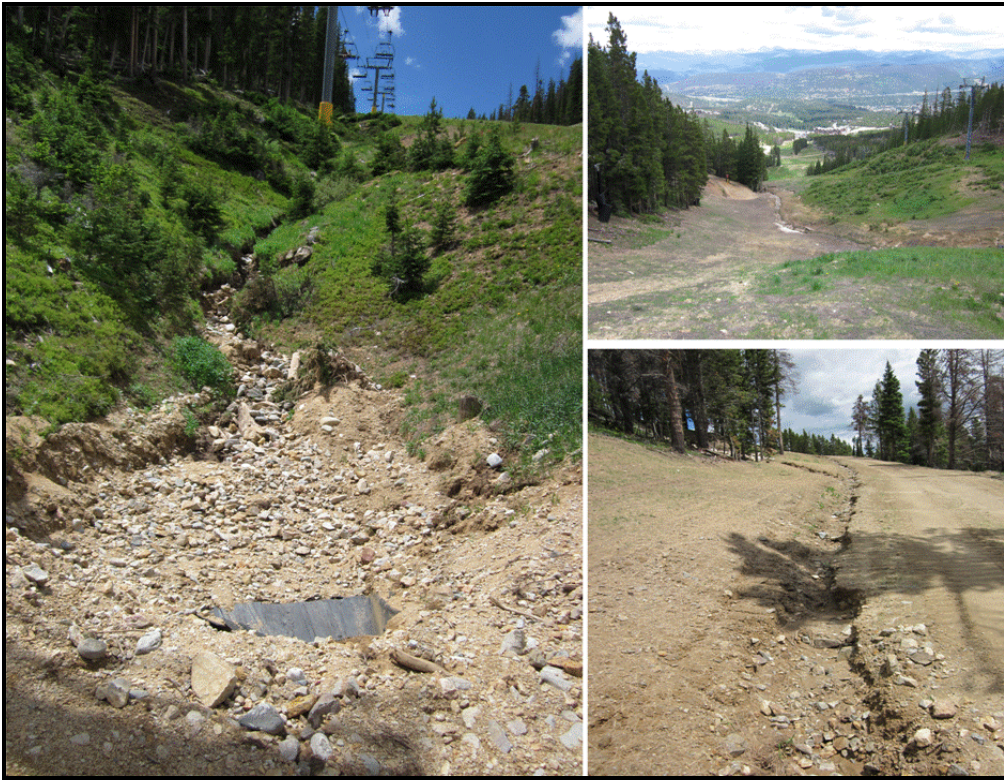
Regardless of origin, mobilized sediment was variously transported and deposited along the Boreas Creek track. Sediment has commonly accumulated in the lower beaver ponds in the unit and has formed several large depositional features along Boreas Creek (Photo 24). These deposition fans constitute wetlands fill that creates localized areas of elevated ground surface.

Photo 24. The source watershed for Upper CG is entirely within a ski area. There are many signs which indicate that activities within the watershed have an impact on the sediment regime.

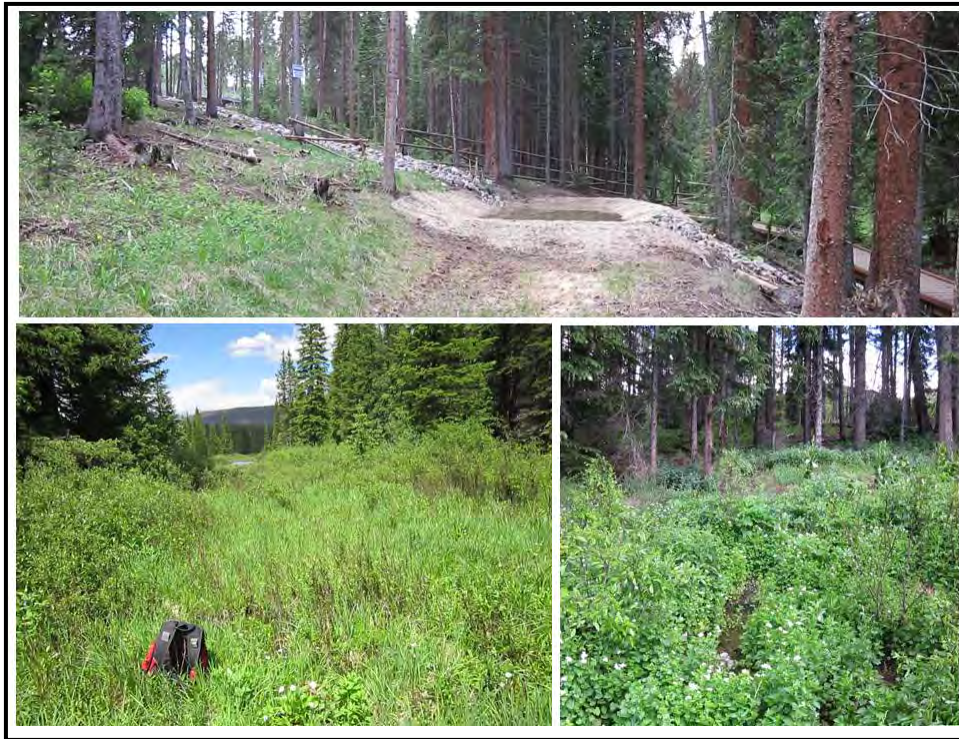
Photo 31. These photos show sites important to the investigation of alleged surface water contamination in the south arm of Upper CG. The lower left photo is of the ERO-SW9 sampling location, where somewhat elevated salt concentrations were reported in 2010.

The upper photo shows the Glenwild storm drainage channel and a new small detention pond which was built in 2011. In 2010, past researchers suspected that the Glenwild drainage was a source of contamination to SW9, and the detention pond was built as a mitigation measure.

Our work, however, suggests that the relatively high solute readings at SW9 are natural since the primary water source for SW9 (the spring showed in the lower right photo) has similarly high conductivity.

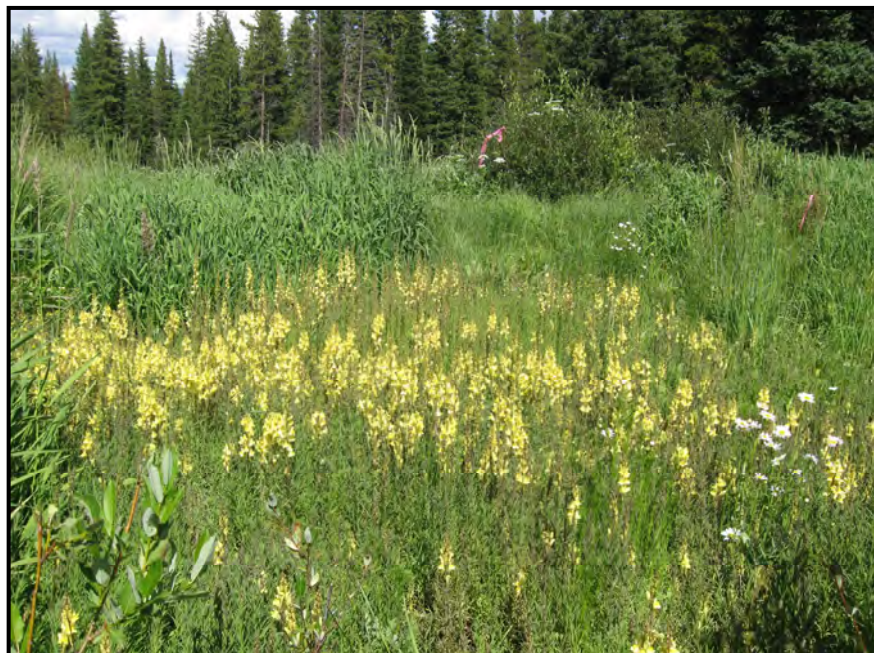
Photo 32. In upper CG, recently dried ponds are proving to be opportune places for weeds to become established. Here, weedy species are strongly dominant.
