A Comprehensive Assessment of Wetland Condition in Cucumber Gulch Preserve, Breckenridge, Colorado.

Report Submitted to the Town of Breckenridge, CO

10/31/11

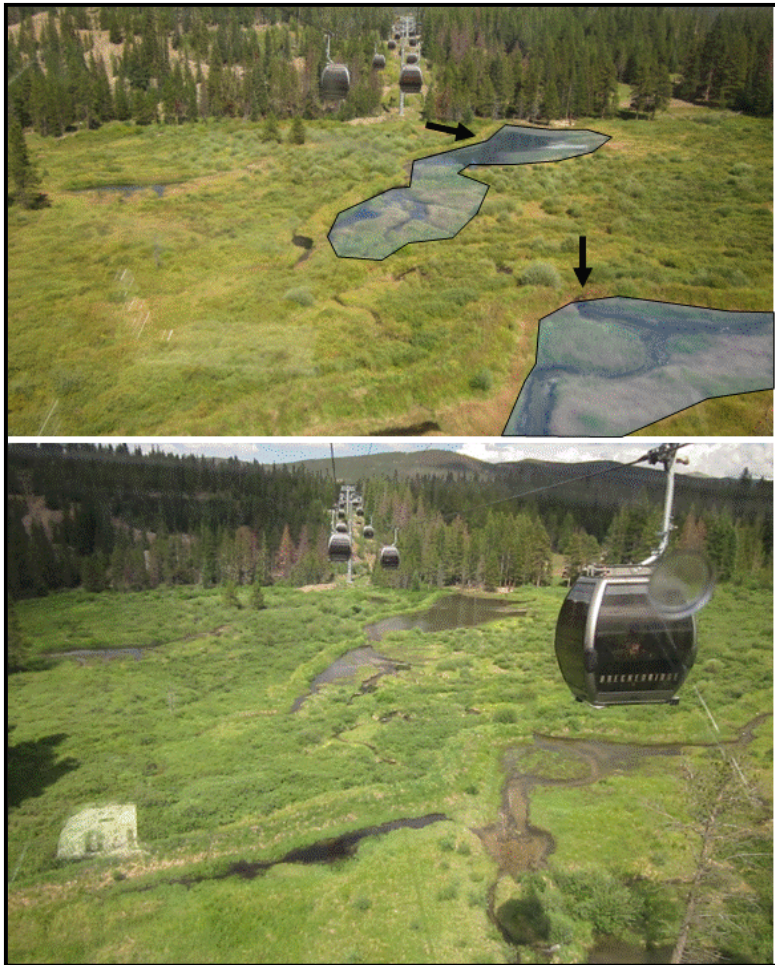
Photo 29. The upper photos shows some ponds in Lower CG as viewed from the gondola in September, 2011. The approximate extent of ponds is shaded as if they were filled. The pond in the lower right of the frame was dry throughout the 2011 season as its dam was breached (arrow) and not repaired by beavers. The pond in the center of the frame also had a breached and unrepaired dam (arrow), but this pond retained some impounded water as its dam breach was only partial (this is the breach shown in Photo 34). The lower photo shows the ponds as they appeared earlier in July.

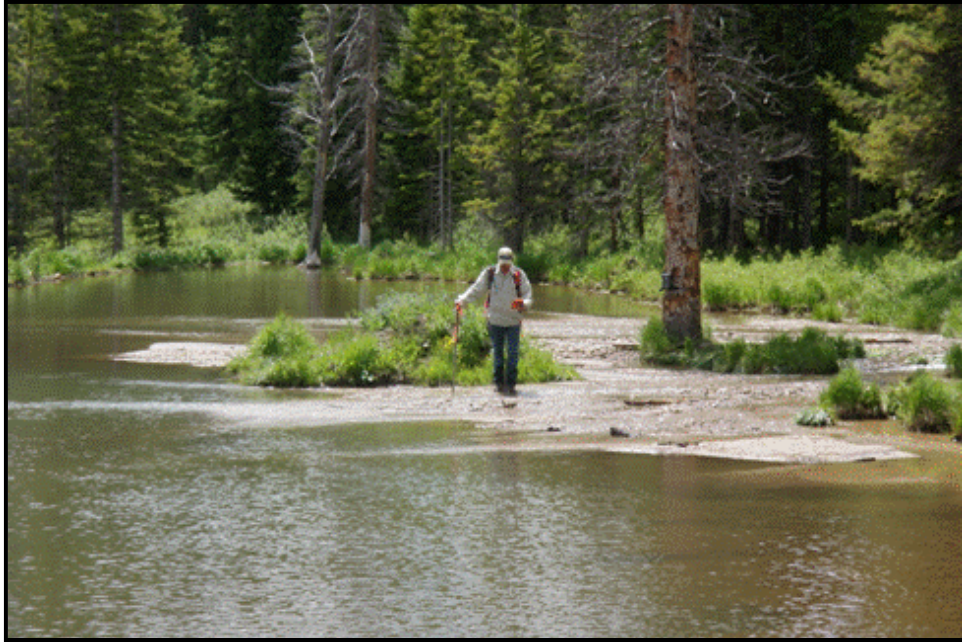
Photo 32. This photo shows the sediment delta that was deposited in the Reset Pond at the head of Lower CG during July, 2011. The delta is estimated to contain tens of thousands of cubic feet of sediment. The vegetated mound behind the biologist in the photo is a beaver lodge which used to be an island. It is now on land, which makes it more vulnerable to predation. We do not know if it is still functional as a lodge, but there is a camera trained on it (visible on the tree) that monitors beaver activity.

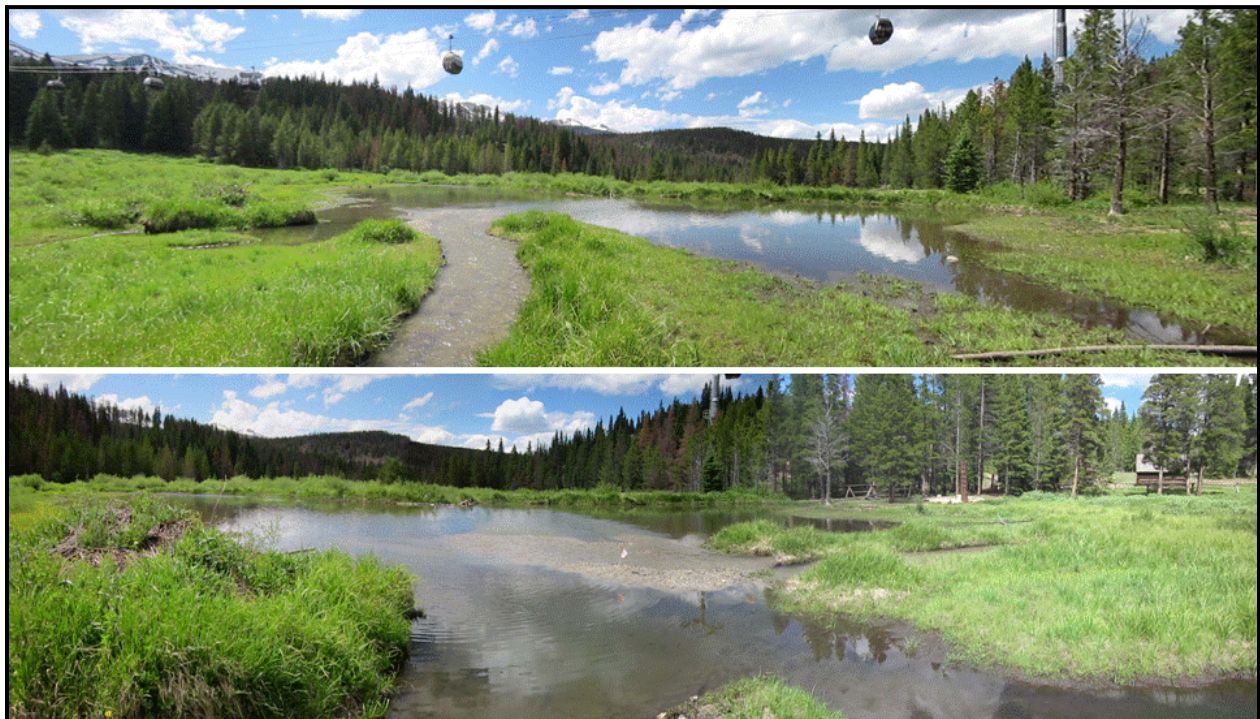
Photo 33. These photos show formation of a sediment delta in a large pond near the lower end of Lower CG in early July. Without more quantitative investigation, it remains unclear whether these rates of sedimentation are unnatural at this location, but the rapid formation of deltas of this size do "raise a red flag" of concern about sedimentation impacts.

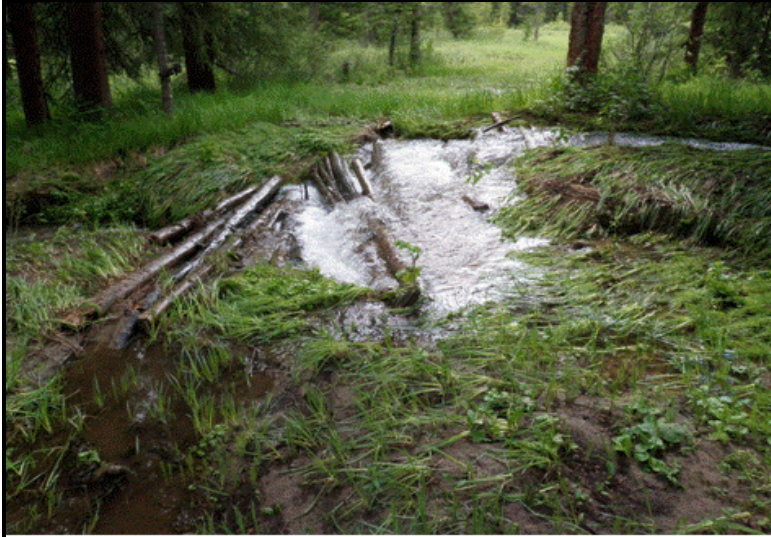
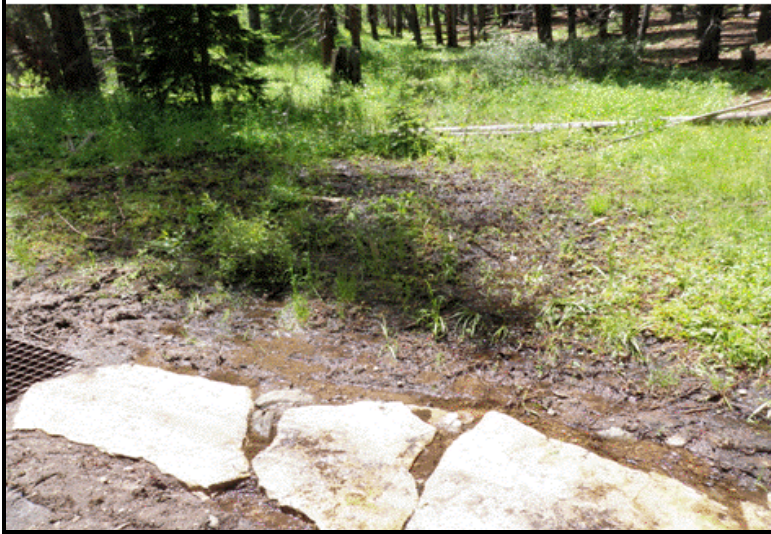
Photo 34. These photos show impacts of Nordic ski trails (upper) and foot/bike trails (lower) on geomorphology and vegetation in Lower CG

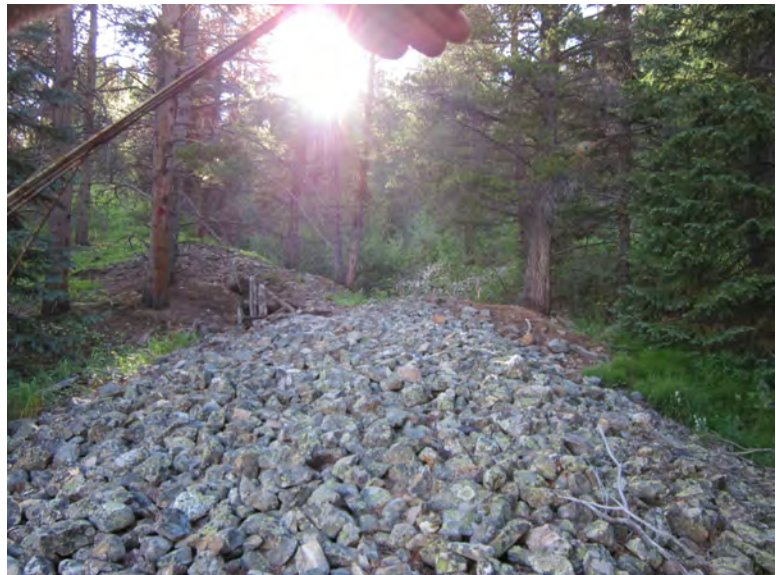
Photo 35. Relic mine tailings, gullies, and deposition exist adjacent to wetland habitat near the bottom of the Lower CG unit. Generally outside the wetland area, these are minor stressors to geomorphology and vegetation.

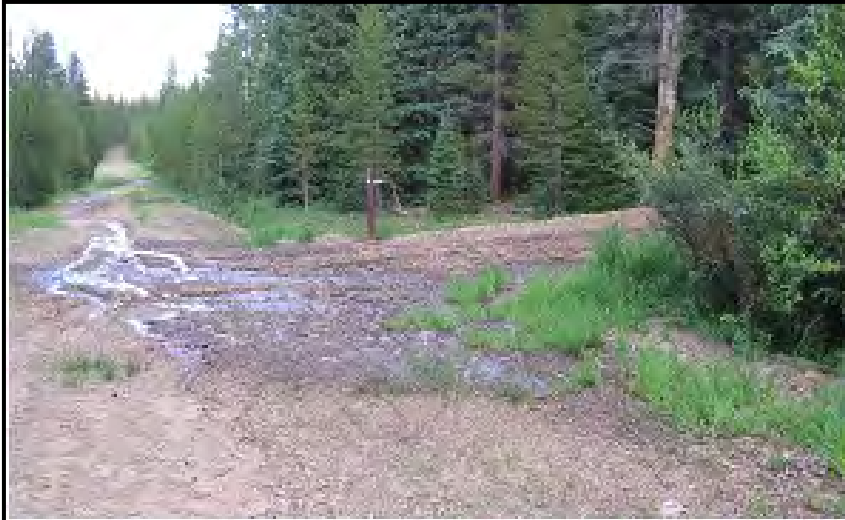
Photo 36. Water emanating from a residential area above Lower CG near the Breckenridge Nordic Center was investigated in July due to concerns about a "curious sheen". Laboratory samples ruled out petroleum and *E. coli*, so the sheen was assumed to be a natural metabolic by-product rather than the product of a petroleum or septic contamination.

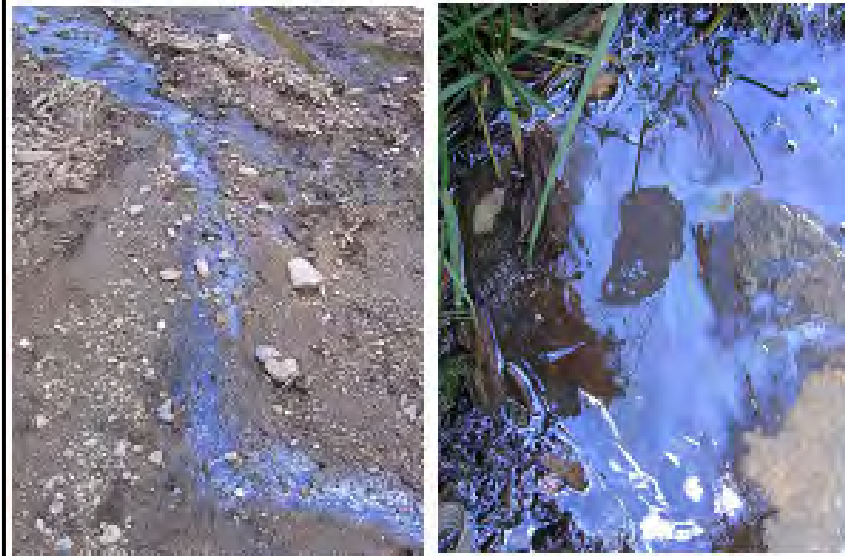
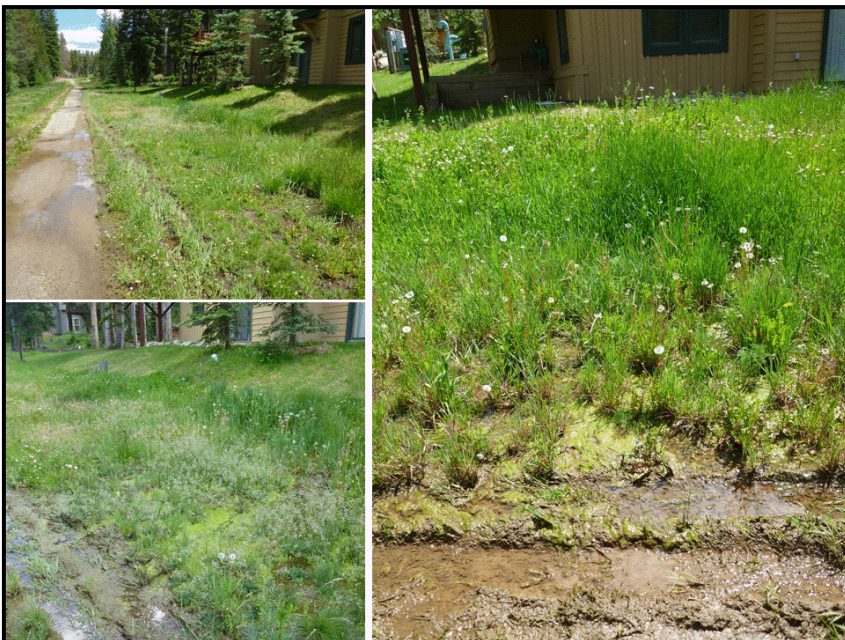
Photo 37. Algae in the water was taken as a possible indicator of eutrophication or nutrient enhancement which raised concerns about septic system failure in this residential area within the buffer of Lower CG. Laboratory tests did not indicate septic leakage, however.

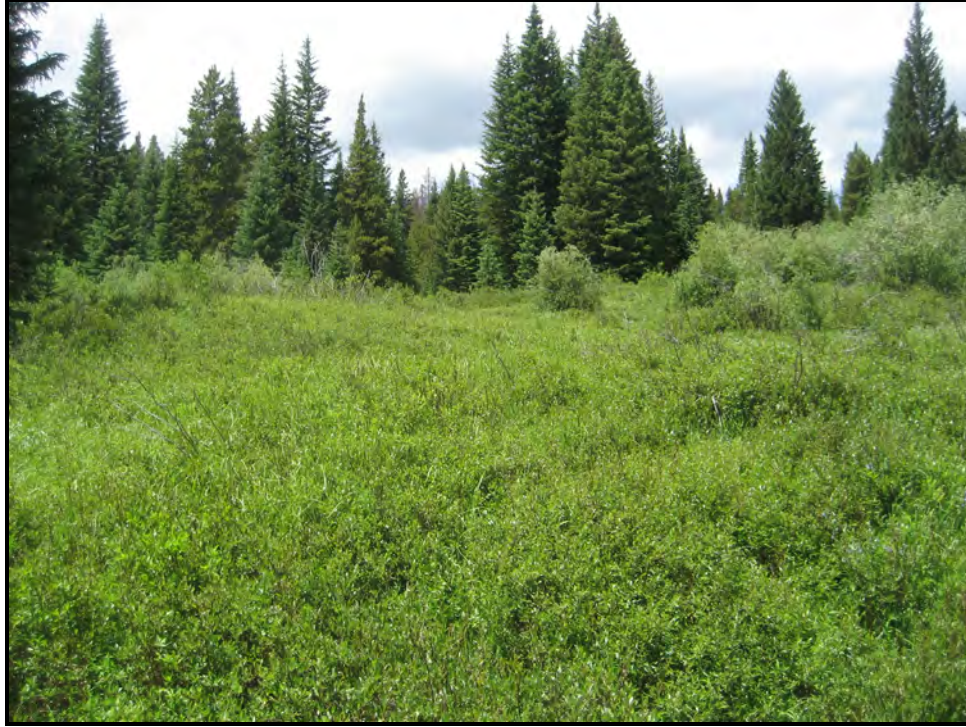
Photo 38. This photo shows where a Nordic ski trail crosses the wetlands of Lower CG. The observed difference in height of willows at this location is interpreted as a very minor impact to the vegetation variable.
